RATTLE NOISE FROM THE FRONT SUSPENSION WHILE DRIVING THE VEHICLE

Bulletin No.: 02-003/24

Last Issued : 08/23/2024

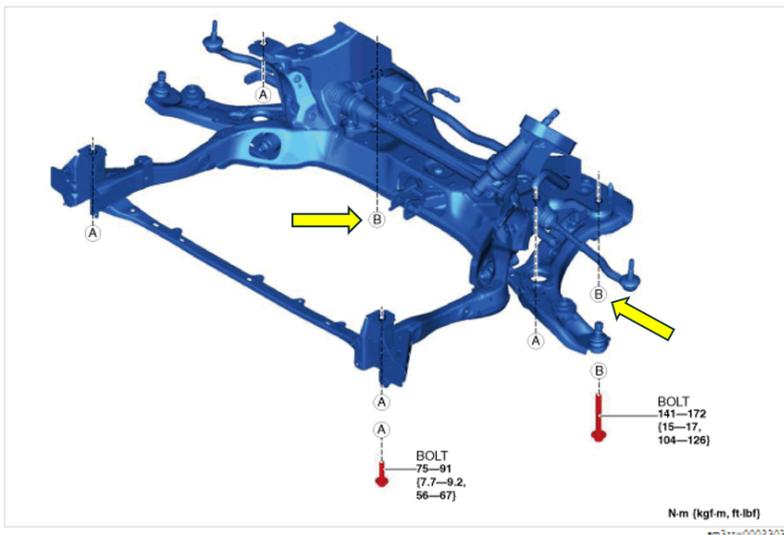
Some customers may experience a rattle noise coming from the front suspension while driving the vehicle, with no other driveability concerns. The rattle noise may be caused by a decrease in tightening torque of the two (2) front lower control arm bolts (B) shown in the image below.

The decrease in bolt tightening torque is due to corrosion formation at the bolt head. After the bolt head is weakened, it will most likely become separated from the rest of the bolt. However, this is not a safety concern as the other suspension bolts will remain intact. To eliminate this rattle noise concern, the bolt quality has been improved and a soft metal washer has been used to further prevent corrosion formation.
