**SERVICE BULLETIN**

**APPLICABILITY:** All Models with Gen 2 & Gen 3 Telematics  
Except Solterra

**NUMBER:** 15-251-19R

**SUBJECT:** DTC B2A16

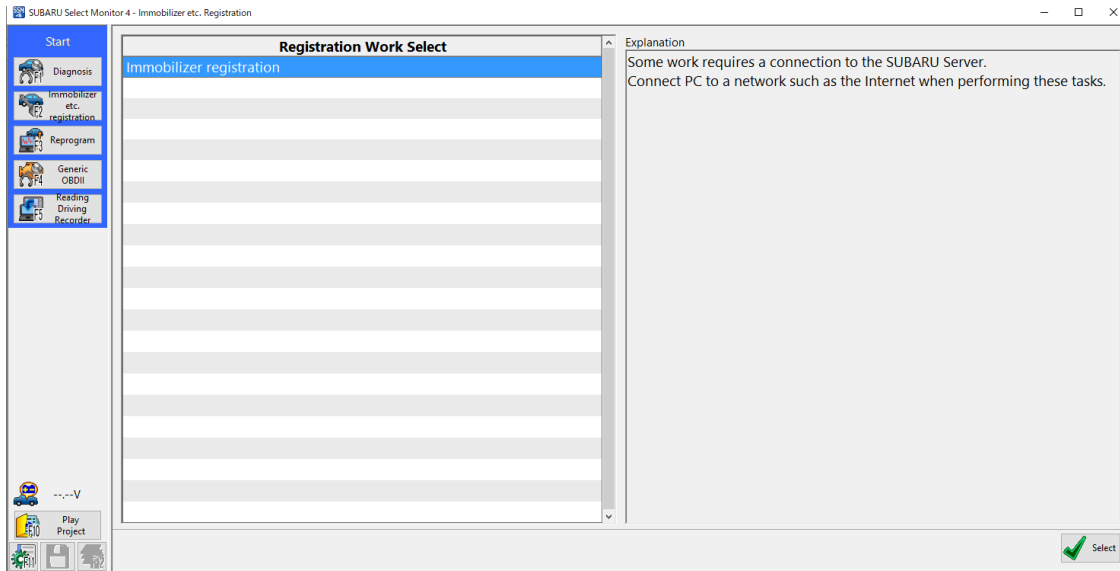
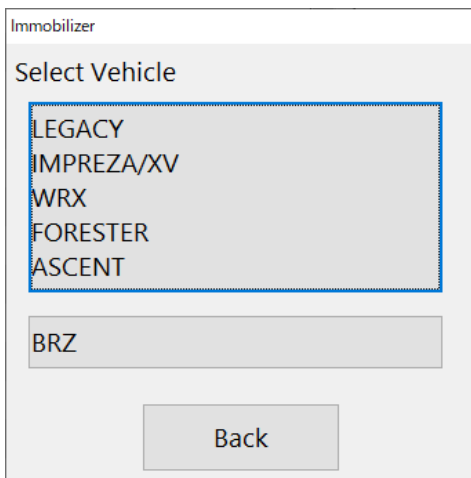
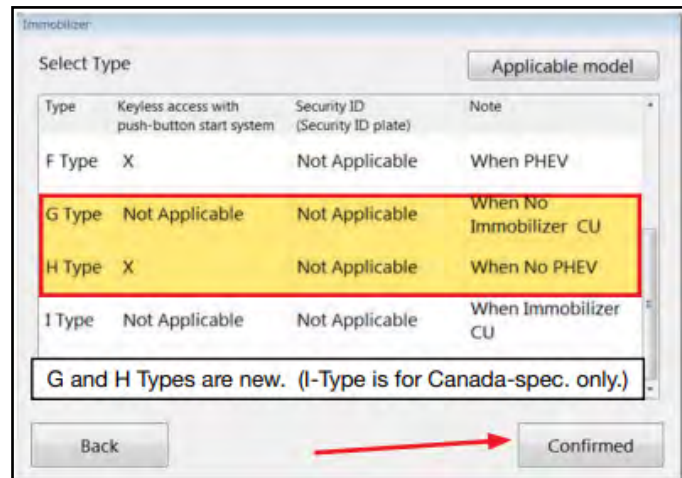
If DTC B2A16 is found in the DCM, start by registering the DCM with the vehicle immobilizer system to avoid a potentially unnecessary DCM replacement. Follow the instructions found in the applicable Immobilizer Registration Manual. See the basic SSM screenshots and additional information provided below for reference.

**NOTE:** When selecting G, H, or I Type, the latest SSM4 software (July 2019 version or later) is required along with a secure network connection. Refer to TSB 15-246-19 for additional details.

Once the DCM is registered, confirm the Telematics RES function operates. **NOTE:** The customer will need to help with this as it requires them to enter their PIN through either the MySubaru web page or the mobile MySubaru App.

If registering the DCM with the vehicle immobilizer system resolves the condition and STARLINK Telematics RES now operates normally, clear the DTC and release the vehicle.
