SERVICE INFORMATION BULLETIN

APPLICABILITY: All Telematics Equipped Models
Except Solterra

NUMBER: 15-308-23R

SUBJECT: Diagnostic Information - Testing Telematics Systems for Dark/Standby Current

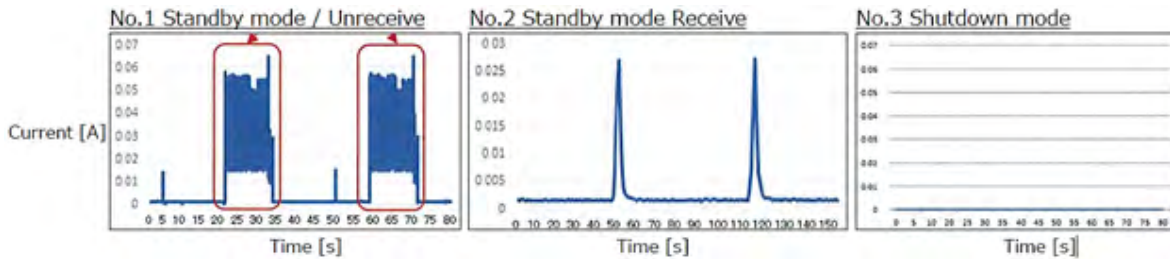
The DCM has six possible states of amperage current waveform patterns. The DCM will shut down after a 15-day time period without the ignition being turned on. During Factory Mode (*) the DCM will shut down after approximately 30 seconds. When the DCM cannot receive a radio wave signal, it will attempt to find a signal once a minute causing an increase in current draw (detailed in **red** below).

DCM		Radio wave	
Status	Mode	Receive	Unreceive
Factory	Standby	-	No.1*
	Shutdown	-	No.3
Unsubscribed	Standby	No.2	No.1
	Shutdown	No.3	No.3
Subscribed	Standby	No.2	No.1
	Shutdown	No.3	No.3
