# TECHNICAL SERVICE BULLETIN

Classification: AN22-007B	Reference: ITB22-017B	Date: August 15, 2024
------------------------------	--------------------------	--------------------------

## DTC B2E01-96 (INTERNAL BATTERY) STORED AS CURRENT IN IVC

**APPLIED VEHICLES:** 2020-2024 Q50 (V37)  
2020-2022 Q60 (CV37)  
2020-2024 QX50 (J55)  
2022-2024 QX55 (FJ55)  
2022-2024 QX60 (L51)  
2020-2024 QX80 (Z62)

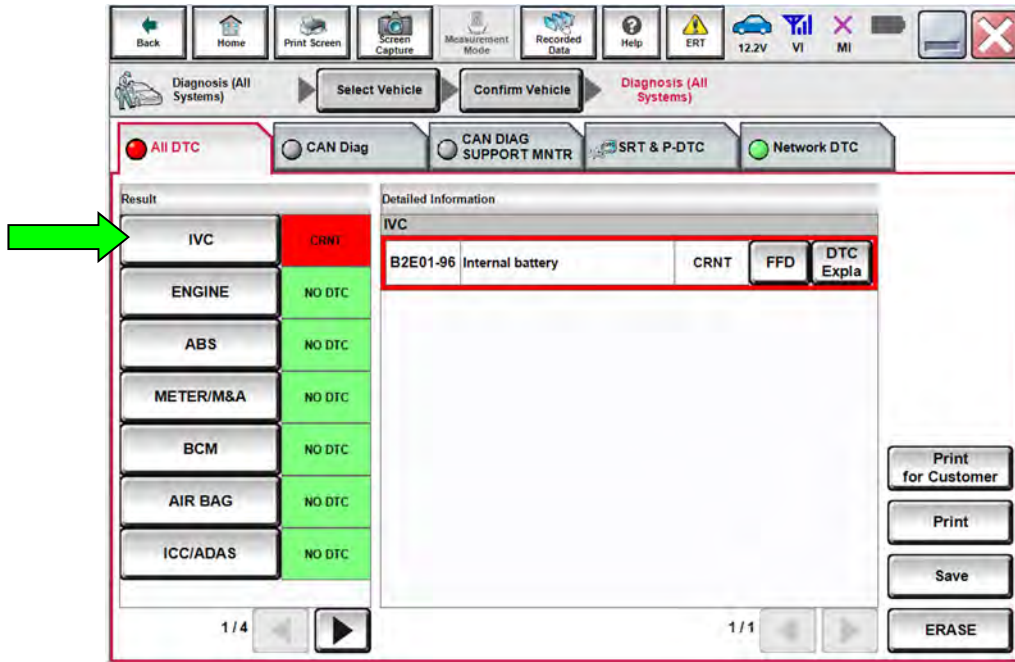
Figure 3

11. Confirm that DTC B2E01-96 for “Internal battery” is “CRNT” in the **IVC**.

- If only DTC B2E01-96 is present, select **IVC** (Figure 3) and then proceed to step 12.
- If additional DTCs, other than B2E01-96, are present in the **IVC**, refer to the ESM for further diagnostic information and repair first, and then proceed to step 12.
