# TECHNICAL SERVICE BULLETIN

Classification: AN23-005B	Reference: ITB22-020B	Date: August 15, 2024
------------------------------	--------------------------	--------------------------

## TELEMATICS CONTROL UNIT RESET AFTER AUTOMATIC COLLISION NOTIFICATION

**APPLIED VEHICLES:** 2020-2024 Q50 (V37)  
2020-2022 Q60 (CV37)  
2020-2024 QX50 (J55)  
2020-2024 QX80 (Z62)

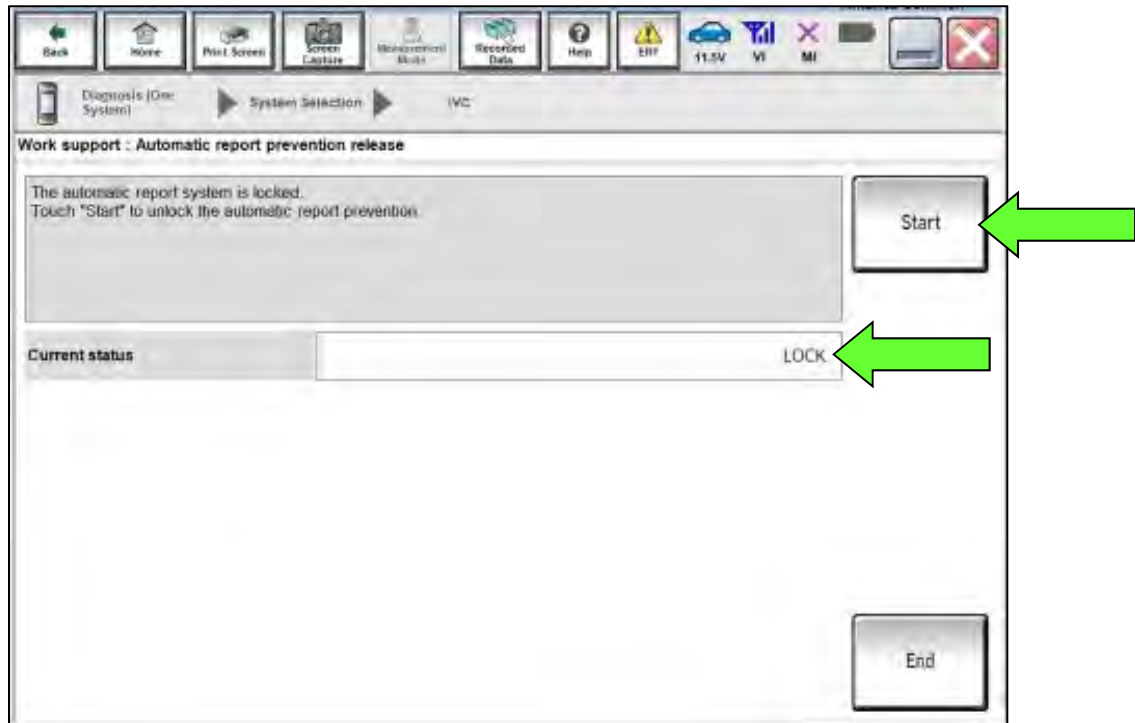
Figure 4

**HINT:** If “UNLOCK” is displayed next to **Current status**, the TCU does not need to be reset. Select **End**.

11. If “LOCK” is displayed next to **Current status**, select **Start**.
