TECHNICAL SERVICE BULLETIN

Classification: AN22-006B	Reference: NTB22-027B	Date: August 15, 2024
------------------------------	--------------------------	--------------------------

DTC B2E01-96 (INTERNAL BATTERY) STORED AS CURRENT IN IVC

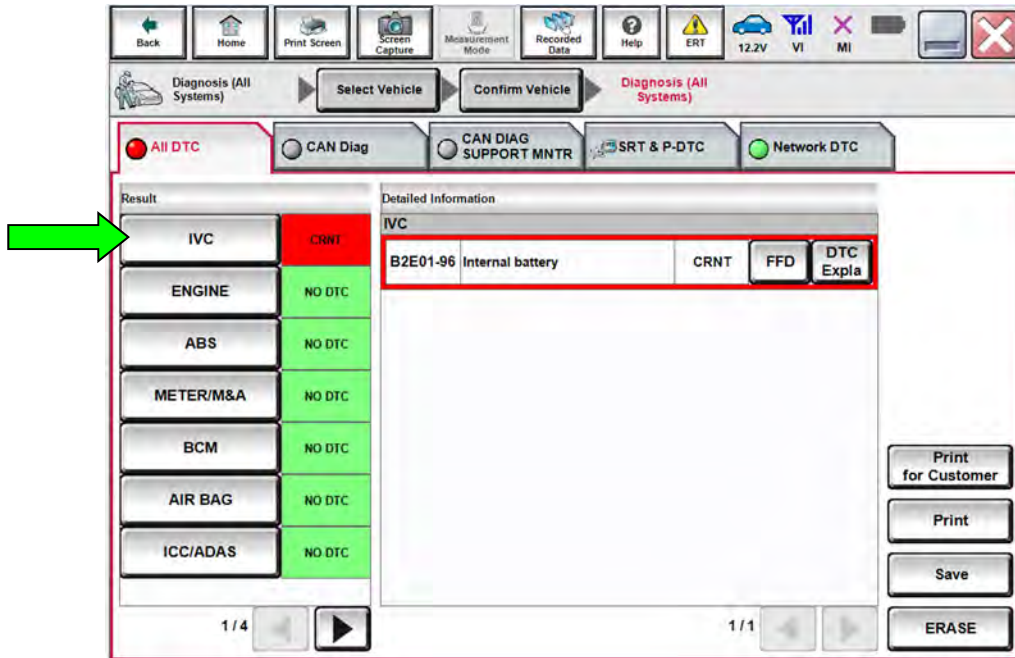
Figure 3

11. Confirm that DTC B2E01-96 for “Internal battery” is “CRNT” in the **IVC**.

- If only DTC B2E01-96 is present, select **IVC** (Figure 3) and then proceed to step 12.
- If additional DTCs, other than B2E01-96, are present in the **IVC**, refer to the ESM for further diagnostic information and repair first, and then proceed to step 12.
