TECHNICAL SERVICE BULLETIN

Classification: EM22-004B	Reference: NTB22-045B	Date: August 16, 2024
------------------------------	--------------------------	--------------------------

RATTLE OR KNOCK NOISE FROM FRONT WHEN DRIVING OVER BUMPS AND/OR TURNING

APPLIED VEHICLES: 2021-2024 Sentra (B18)
APPLIED DATES: Built from January 2, 2021 to April 11, 2024

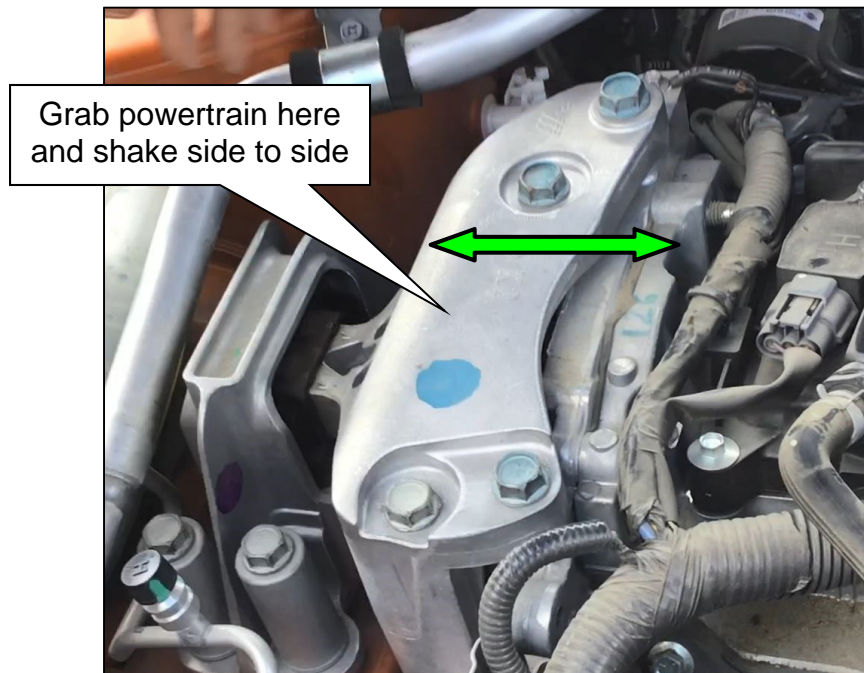
Figure 1

1. Confirm if the noise is coming from the Engine Mounting Insulator (RH).
 - a. Turn the engine OFF.
 - b. Open the hood.
 - c. Grab the Engine Mounting Insulator (RH) at the location shown in Figure 2, and shake the powertrain side to side.

- The required side to side shake force can be quite vigorous to simulate actual driving conditions (centrifugal force pulls the engine to one side when driving the vehicle in a corner, and then releases when the steering wheel is straightened).
- You may not hear the rattle or knock noise while outside of the vehicle, as it is structurally transferred to sheet metal and may be heard better inside the cabin.

YES: Replace the Engine Mounting Insulator (RH).
