TECHNICAL SERVICE BULLETIN

Classification: DA21-005B	Reference: NTB21-115B	Date: July 11, 2024
------------------------------	--------------------------	------------------------

FALSE ACTIVATION OF AEB OR FCW

APPLIED VEHICLES:	2021-2022 Altima (L34) 2022-2023 Frontier (D41) 2020-2022 Sentra (B18)
APPLIED DATES:	Altima: All Frontier: All Sentra: Built on or before March 10, 2022
APPLIED SYSTEMS:	Automatic Emergency Braking/Forward Collision Warning

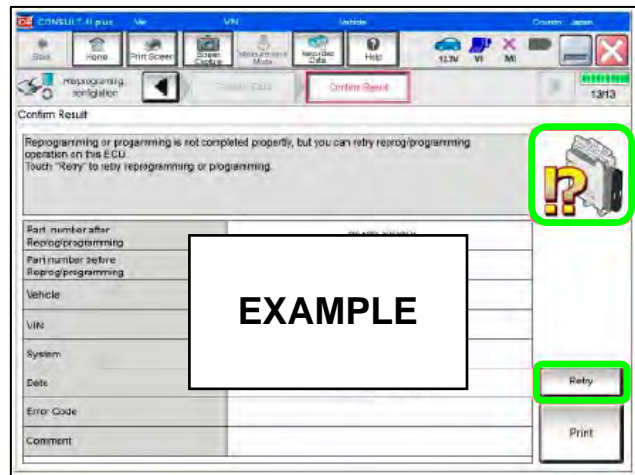
Figure 14

If reprogramming does not complete and the “!?” icon displays, as shown in Figure 14:

- Check battery voltage (12.0 - 13.5 V).
- Ignition is ON, engine OFF.
- External Bluetooth® devices are OFF.
- **All** electrical loads are OFF.
- Select **Retry** and follow the on screen instructions.
- Retry may not go through on first attempt and can be selected more than once.

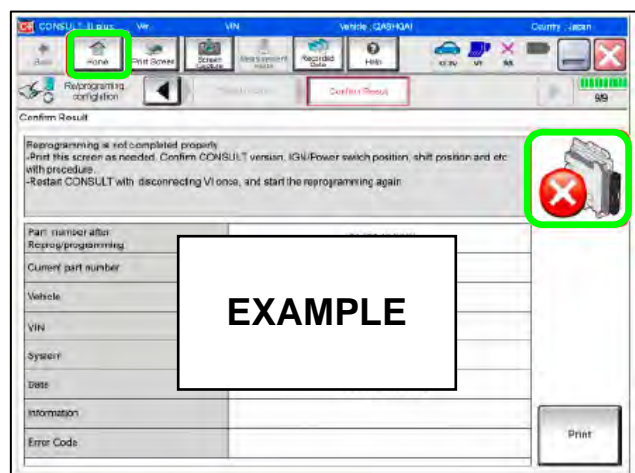
Figure 15

If reprogramming does not complete and the “X” icon displays, as shown in Figure 15:

- Check battery voltage (12.0 - 13.5 V).
- CONSULT A/C adapter is plugged in.
- Ignition is ON, engine OFF.
- Transmission is in Park.
- All CONSULT VI cables are securely connected.
- All C-III plus updates are installed.
- Select **Home**, and restart the reprogram procedure from the beginning.
