TECHNICAL SERVICE BULLETIN

Classification: DA24-002	Reference: NTB24-037	Date: July 17, 2024
-----------------------------	-------------------------	------------------------

FALSE ACTIVATION OF AEB OR FCW

APPLIED VEHICLES: 2019-2024 Murano (Z52)
APPLIED SYSTEMS: Automatic Emergency Braking/Forward Collision Warning

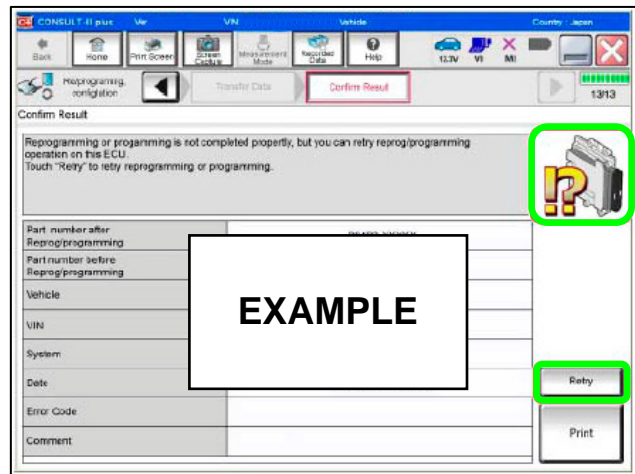
Figure 20

If reprogramming does not complete and the “!?” icon displays, as shown in Figure 20:

- Check battery voltage (12.0 - 13.5 V).
- Ignition is ON, engine OFF.
- External Bluetooth® devices are OFF.
- **All** electrical loads are OFF.
- Select **Retry** and follow the on screen instructions.
- **Retry may not go through on first attempt and can be selected more than once.**

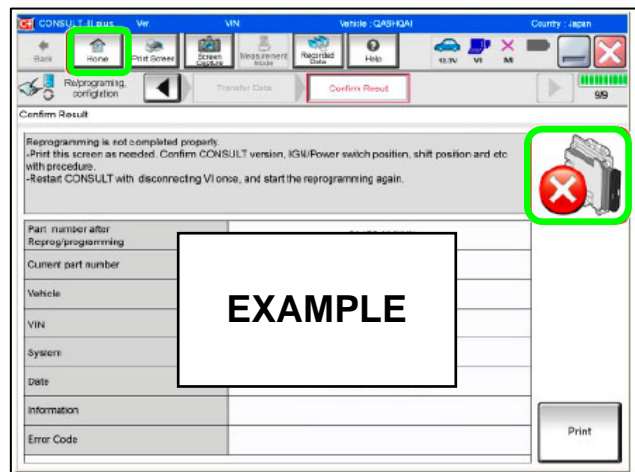
Figure 21

If reprogramming does not complete and the “X” icon displays, as shown in Figure 21:

- Check battery voltage (12.0 - 13.5 V).
- CONSULT A/C adapter is plugged in.
- Ignition is ON, engine OFF.
- Transmission is in Park.
- All CONSULT VI cables are securely connected.
- All C-III plus updates are installed.
- Select **Home**, and restart the reprogram procedure from the beginning.
