GENERAL MOTORS  
DCS6999  
URGENT - DISTRIBUTE IMMEDIATELY

Subject: N242435600 - Customer Satisfaction Program  
Multiple Module Reprogramming

Models: 2024 GMC HUMMER EV Pickup  
2024 GMC HUMMER EV SUV

## N242435600 Multiple Module Reprogramming

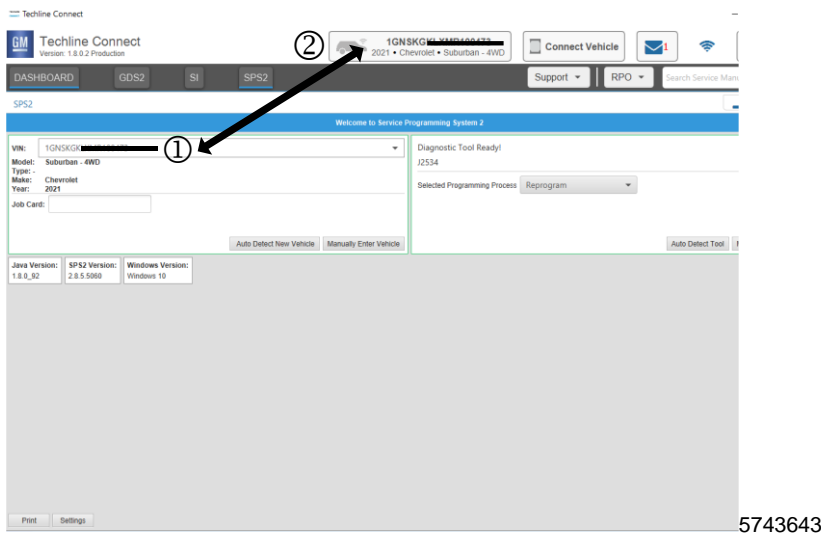
**Caution:** Be sure the VIN selected in the drop-down menu (1) is the same as the vehicle connected (2) before beginning programming.

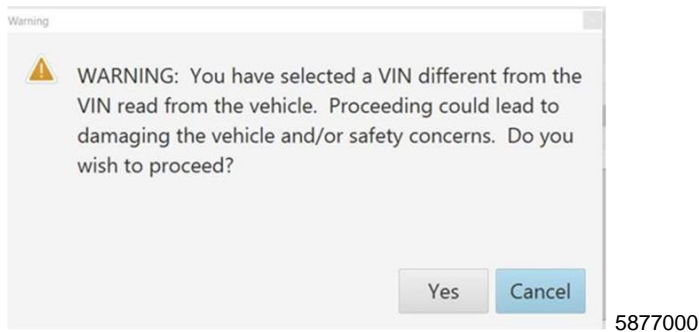
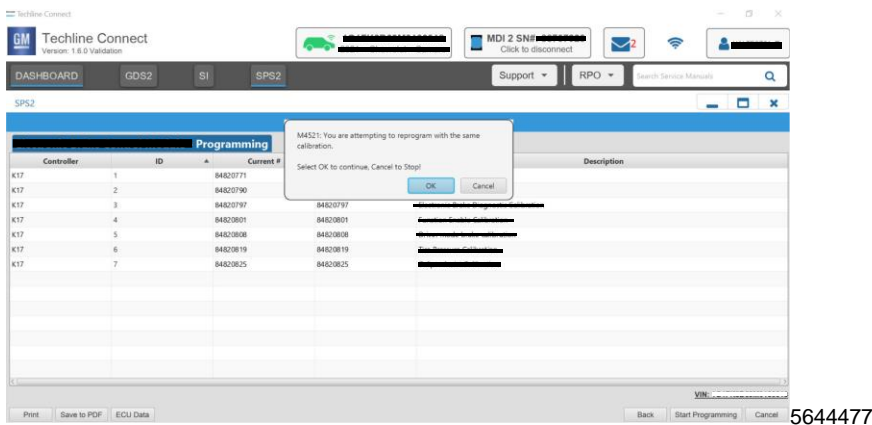
**Important:** If the vehicle VIN DOES NOT match, the message below will be shown.

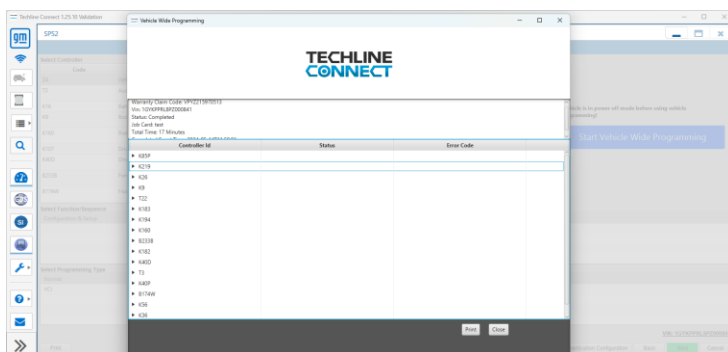
6693875

**Note:** The screenshot above is an example of Vehicle Wide Programming and may not be indicative of the specific modules that are being programmed. VIN information has been blacked out.

**Important:** To avoid warranty transaction rejections, you MUST record the Total Time provided on the Warranty Claim Code (WCC) screen shown above on the job card.
