Service Alert

Subject: ELECTRICAL CONCERN AND/OR MULTIPLE DTC'S DUE TO AFTERMARKET DEVICE	Service Alert No.: SA-057/24
	Last Issued : 08/15/2024

2007-2025 Mazda3	2007-2015 Mazda5	2013-2025 CX-5	2023-2025 CX-50
2007-2021 Mazda6	2007-2012 CX-7	2016-2023 CX-3	2025 CX-70
2007-2024 MX-5	2007-2023 CX-9	2020-2025 CX-30	2024-2025 CX-90
2007-2011 RX-8	2011-2023 Mazda2	2022-2023 MX-30

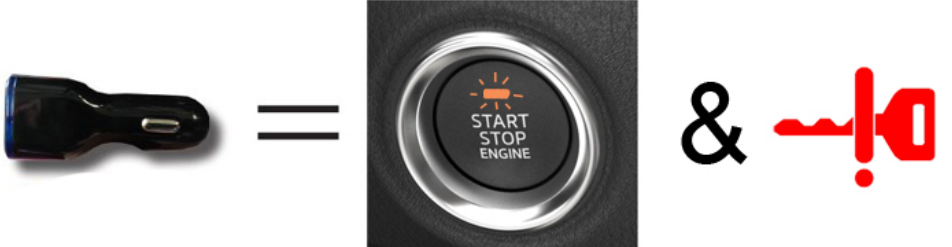
Some aftermarket cell phone chargers, accessories connected to the 12V outlet or key fob proximity to a cell phone may cause issues with the START/STOP button or rear view camera.

- Intermittent engine no start or unable to turn off
- Instrument cluster red security indicator light ON
- Engine Start/Start Button Amber indicator light flashing
- Battery discharge
- Electrical relay buzzing noise
- DTC B13D3:94 stored (Communication error with remote transmitter)
- DTC P1260:00 stored (Immobilizer system problem)
- Rear View Monitor Display is Blurry

Aftermarket Cell Phone Charger/Accessory connected to 12V outlet	Engine Start/Stop Button Amber Indicator Light Flashing	Key Warning Light (red)

For concerns where the vehicle power supply cannot be controlled adequately, such as an engine no start condition or the engine cannot be turned off, explain to the customer as follows: Due to the reverse power supply from electronic devices with internal batteries connected through the vehicle's accessory socket, the vehicle system may not be able to determine the vehicle electronic status. As a result, the vehicle power supply control fails. To overcome this situation, remove the electronic device with internal batteries from the accessory socket.

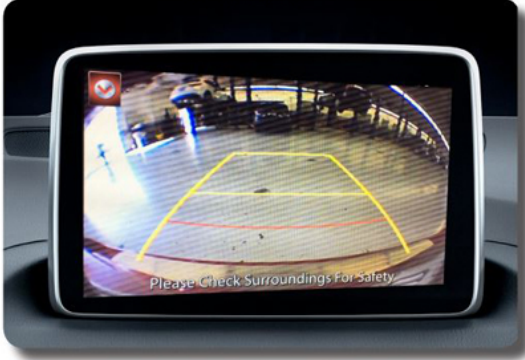
Blurry Display

With aftermarket cell phone charger connected to 12V outlet

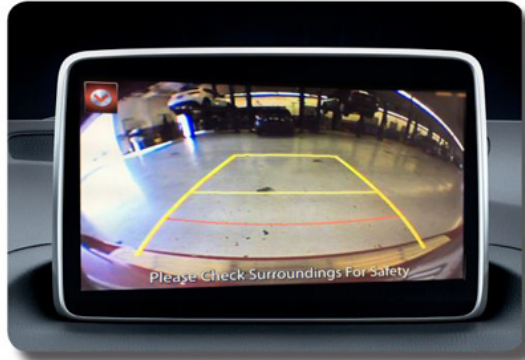
OK

Without aftermarket cell phone charger

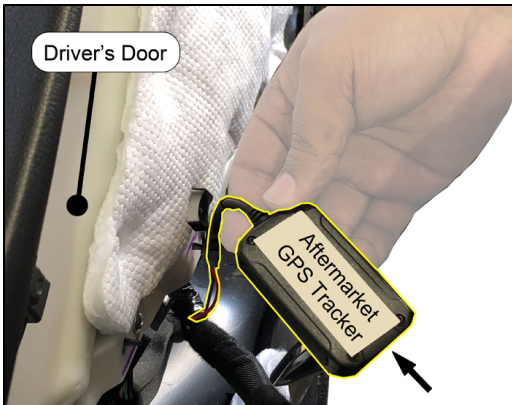
Below are examples of concerns due to an aftermarket GPS tracking device wired to the power window main switch:

- Engine no start
- Battery discharge
- Main relay buzzing

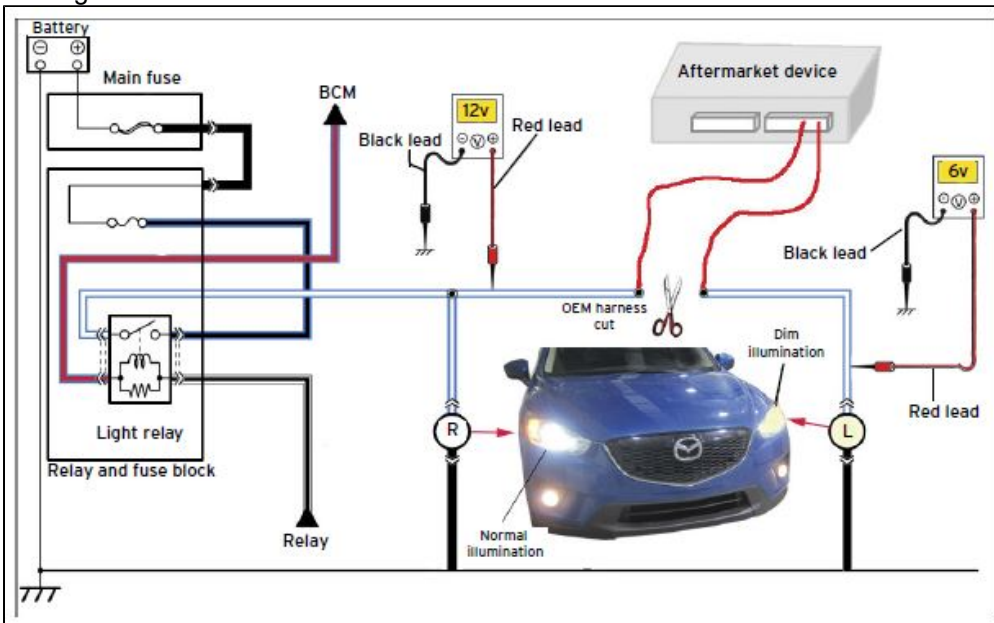
Below is an example of a dim headlight. The aftermarket device changed the headlight circuit resistance, causing a dim headlight.
