WPS1 - Checking Pressure Sensors and Replacing them if Necessary (Workshop Campaign)

Model Year: As of 2020 up to 2023

Vehicle Type: Cayenne E-Hybrid (9YA / 9YB) / Cayenne S E-Hybrid (9YA / 9YB)

Concerns: Air conditioning system pressure sensors

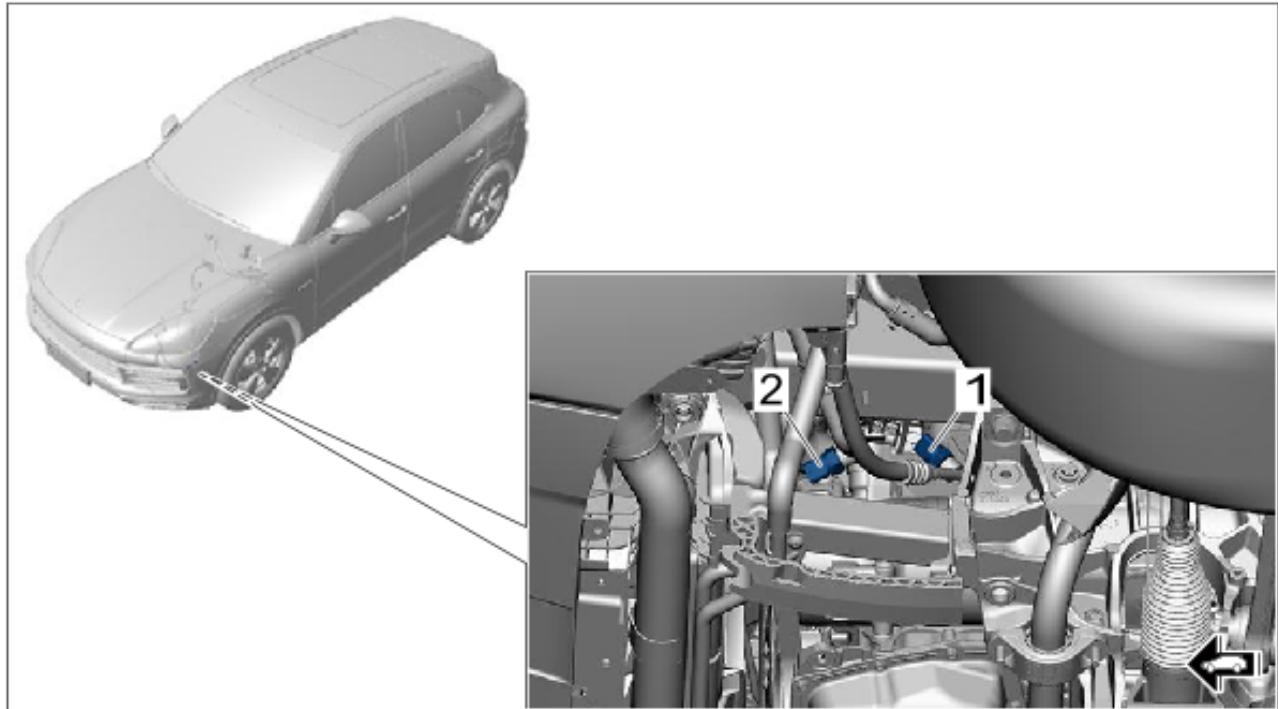
Installation position of pressure sensors

- 1 – Pressure sensor (PT1) on high-pressure side (**check and replace if necessary**)
- 2 – Pressure sensor (PT2) on low-pressure side (**check and replace if necessary**)

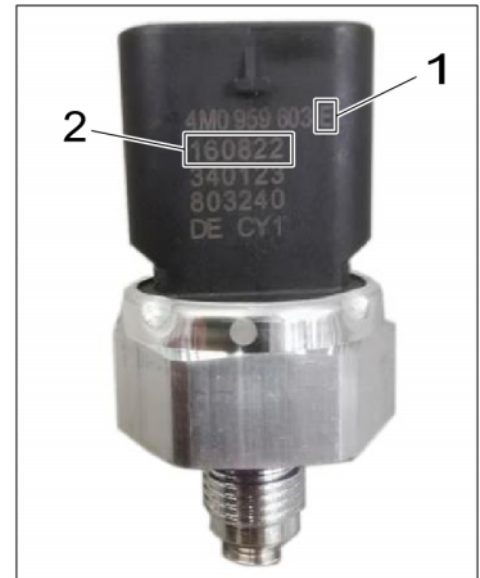
New type of pressure sensor

Pressure sensors with spare part number 4M0.959.603.**E** and applied production date:

- **up to** _41921 are **not OK** and must be replaced.
- **from** _42921 are **OK** and do **not** need to be replaced.

- 1 – Spare part index
- 2 – Production date from _42921 (S / D / CW / YY - Shift / Weekday / Calendar Week / Year). Shown in the image: 1st place not relevant / weekday 6 / calendar week 08 / year2022

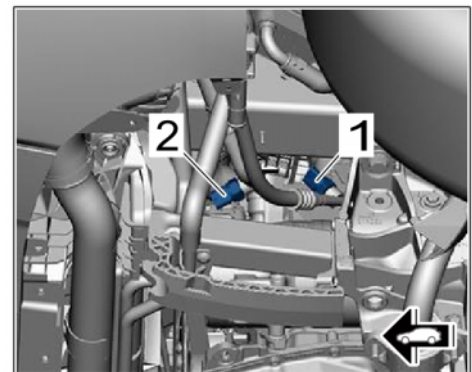
Checking pressure sensor PT1 and pressure sensor PT2

Assessment		Action
(X)	Pressure sensor with spare part number 4M0.959.603.C	Pressure sensors with spare part index C are not OK and must be replaced. Replace the relevant pressure sensors. ⇒ Continue with Step 2 ⇒ [Scope 3 to Scope 5]
(X)	Pressure sensor with spare part number 4M0.959.603.E and production date up to_41921	Pressure sensor is not OK due to production date (up to _41921) and must be replaced. Replace the relevant pressure sensors. ⇒ Continue with Step 2 ⇒ [Scope 3 to Scope 5]
(✓)	Pressure sensor with spare part number 4M0.959.603.E and production date from _42921	Pressure sensor is OK due to spare part index E and production date (from _42921) and does not have to be replaced. End of action. Continue with ⇒ <i>Technical Information '505619 follow-up actions'</i> [Scope 1]

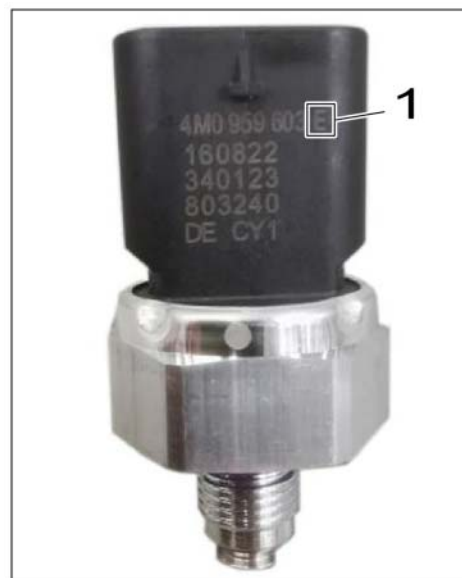
When replacing pressure sensors, it is essential to ensure that the pressure sensors have the same spare part index. If one of the pressure sensors has a different spare part index, the corresponding pressure sensor must also be replaced. The spare part index is visible on the pressure sensor. (Example 4M0.959.603.E)

- 1 – Spare part index for pressure sensor
- 2 Replace pressure sensors **with old component status**.
For procedure, see:
⇒ *Workshop Manual '878319 Installing and removing refrigerant circuit pressure sensor (PT1 and PT2)'*
