WPS1 - Checking Pressure Sensors and Replacing them if Necessary (Workshop Campaign)

Vehicle Type: Cayenne Turbo S E-Hybrid (9YA / 9YB)

Concerns: Air conditioning system pressure sensors

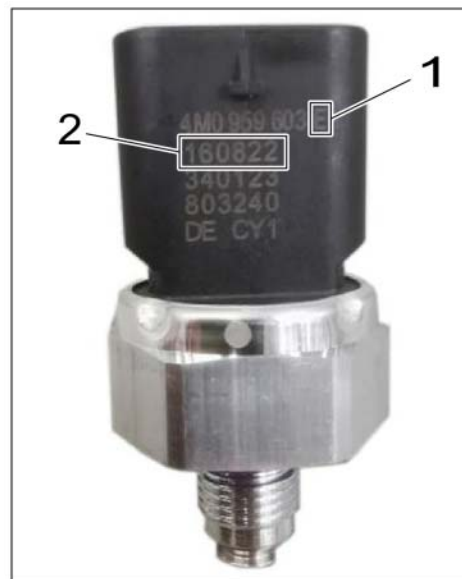
New type of pressure sensor

- **up to** _41921 are **not OK** and must be replaced.
- **from** _42921 are **OK** and do **not** need to be replaced.

- 1 – Spare part index
- 2 – Production date from _42921 (S / D / CW / YY · Shift / Weekday / Calendar Week / Year). Shown in the image: 1st place not relevant / weekday **6** / calendar week **08** / year**2022**

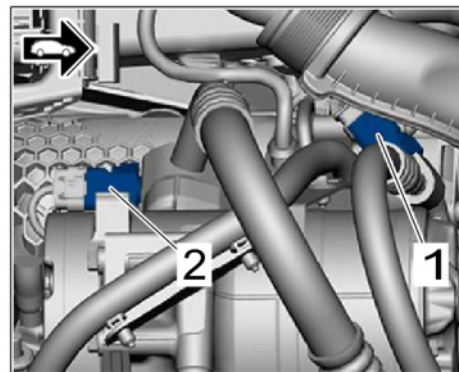
Checking pressure sensor PT1 and pressure sensor PT2

- 1 Check whether **pressure sensor PT1** ⇒ *Checking pressure sensor PT1 and pressure sensor PT2 -1-* and **pressure sensor PT2** correspond to ⇒ *Checking pressure sensor PT1 and pressure sensor PT2 -2-* the new component status.

Assessment	Action
(X)	Pressure sensor with spare part number 4M0.959.603.C	Pressure sensors with spare part index C are not OK and must be replaced. Replace the relevant pressure sensors. ⇒ Continue with Step 2 ⇒ [Scope 6 to Scope 8]
(X)	Pressure sensor with spare part number 4M0.959.603.E and production date up to _41921	Pressure sensor is not OK due to production date (up to _41921) and must be replaced. Replace the relevant pressure sensors. ⇒ Continue with Step 2 ⇒ [Scope 6 to Scope 8]
(✓)	Pressure sensor with spare part number 4M0.959.603.E and production date from _42921	Pressure sensor is OK due to spare part index E and production date (from _42921) and does not have to be replaced. End of action. Continue with ⇒ <i>Technical Information '213919 follow-up actions'</i> [Scope 2]
