Pre-Authorization and Appeals Status

Dual Battery System Grounding Related to Open 150A Underhood PDC Fuse Array - MY 2025 RAM 1500 (DT)

Reverse Polarity Issue in IDCM, Updated Service Procedure for Reverse Polarity - MY 2023 - 2024 Alfa Romeo Tonale (GC) / Dodge Hornet (GG), Jeep Wrangler (JL), Jeep Grand Cherokee (WL), Jeep Renegade (BV) / Jeep Compass (MV) - All Models and Variants

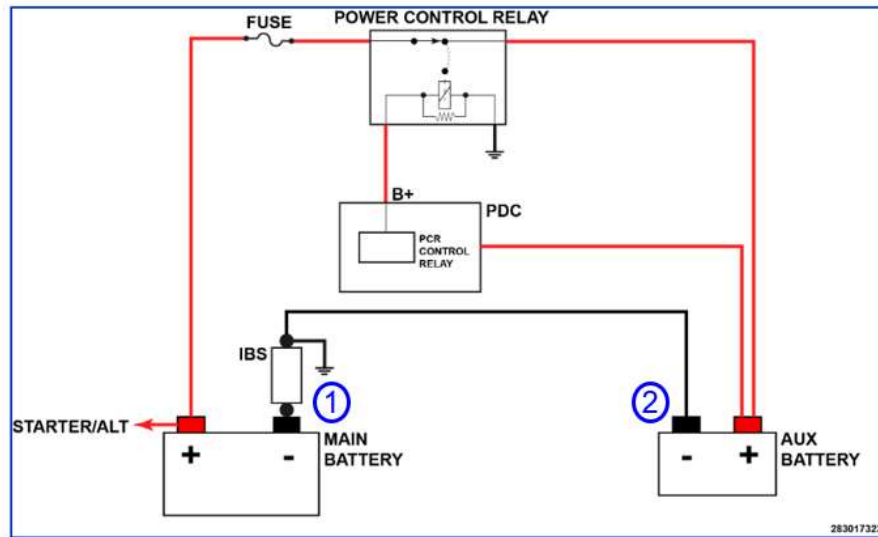
knowledge of how the dual batteries are interconnected. There are 2 grounds (one from each battery). See figure below:

From Fig. 1, note that if the ground from only Point #1 is removed, then the Aux Battery will still be feeding the system with 12V. The same is true if only the ground from Point #2 is removed; the Main battery will then continue to supply power. This is why it is very important to properly disconnect the battery grounds PRIOR to performing any Electrical repairs because any contact of the battery feed to ground in the vehicle will most likely blow the 150A fuse in the underhood PDC.

are 300 amps or more which is typically from a direct short to ground. Note that the maximum amperage seen on the complete DT system is only about 200. amps even with low state-of-charge batteries.

The 150A fuse is designed to only blow around 200% of its rating in order to protect the wiring; therefore, this fuse will not blow unless there

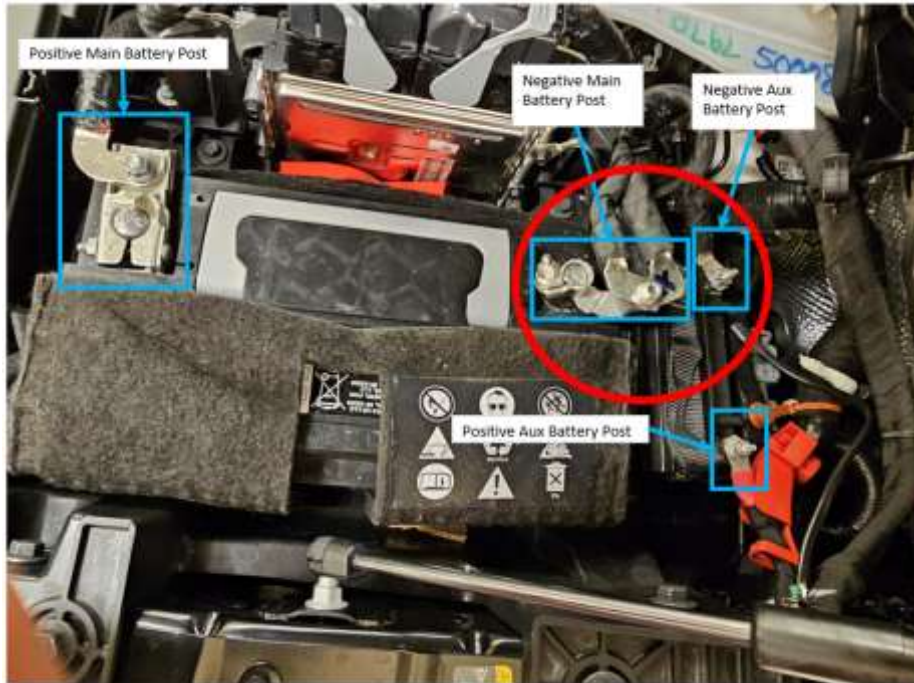
Below is a picture of an actual DT underhood showing where the batteries are located in the vehicle. The service procedure requires that both grounds be disconnected at the Main and Aux batteries and protect them from touching any vehicle metal in order to fully disconnect any battery power from the entire vehicle prior to performing Electrical service. (See inside RED circle)

If the 150A fuse is open during service and the batteries are fully charged, no issue will appear immediately. However, if the vehicle is started and operated for a short time with several loads turned on and then the vehicle is shut off,

the vehicle may not start again, or the main battery may be drained enough to set a P2AF5 DTC alerting the technician that the main battery is low and most likely the 150A fuse is open.

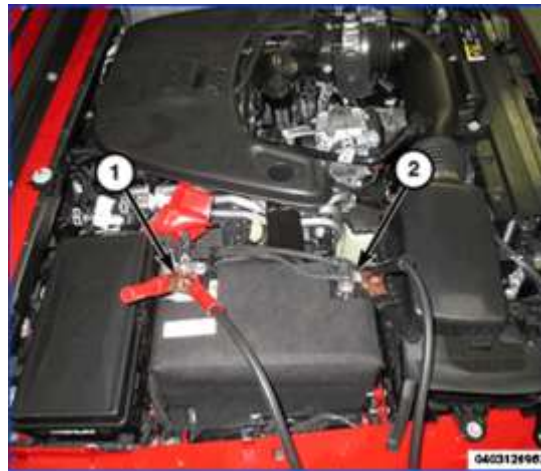
Please note that in the event of a Reverse Polarity trigger coming on, this condition may be due to the following causes:

1. Jump Starting the 12V Battery in the reverse connection, resulting in reverse polarity situation.

The issue will be eliminated with following a thorough service procedure since this is not a warrantable issue. Not following the updated service procedure will result in an IDCM failure, which will induce and IDCM replacement.

During the Jump-Starting procedure, make sure the B+ terminal of the battery is connected correctly to positive clamp, and the GND is connected to the negative clamp.

Please follow the Jump-Starting Standard Procedure (JUMP STARTING), present in the Link-E-Entry system.

Please refer to the picture below (Red is positive, black is negative):
