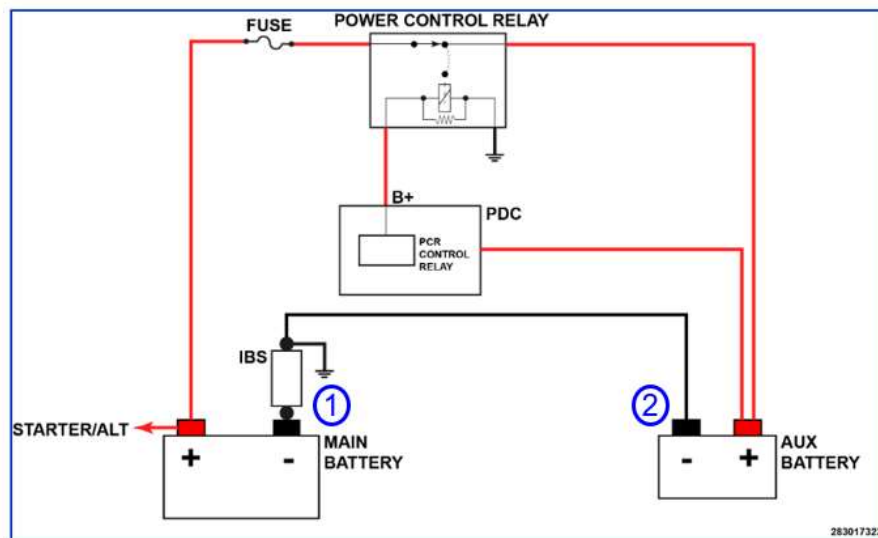
knowledge of how the dual batteries are interconnected. There are 2 grounds (one from each battery). See figure below:

From Fig. 1, note that if the ground from only Point #1 is removed, then the Aux Battery will still be feeding the system with 12V. The same is true if only the ground from Point #2 is removed; the Main battery will then continue to supply power. This is why it is very important to properly disconnect the battery grounds PRIOR to performing any Electrical repairs because any contact of the battery feed to ground in the vehicle will most likely blow the 150A fuse in the underhood PDC.

The 150A fuse is designed to only blow around 200% of its rating in order to protect the wiring; therefore, this fuse will not blow unless there

are 300 amps or more which is typically from a direct short to ground. Note that the maximum amperage seen on the complete DT system is only about 200. amps even with low state-of-charge batteries.

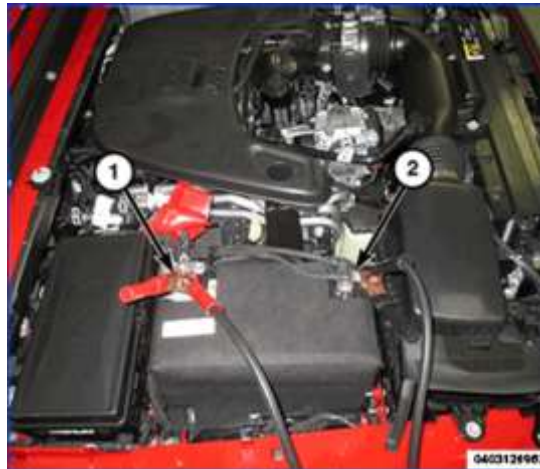
The issue will be eliminated with following a thorough service procedure since this is not a warrantable issue. Not following the updated service procedure will result in an IDCM failure, which will induce and IDCM replacement.

Please refer to the picture below (Red is positive, black is negative):

During the Jump-Starting procedure, make sure the B+ terminal of the battery is connected correctly to positive clamp, and the GND is connected to the negative clamp.
