**ARB2 - Replacing Upper Trailing Arm on the Front Axle (Recall Campaign)**

Revision: This bulletin replaces bulletin Group 4 122/24 ARB2, dated August 14, 2024.

Model Line: **Cayenne (9YA / 9YB)**

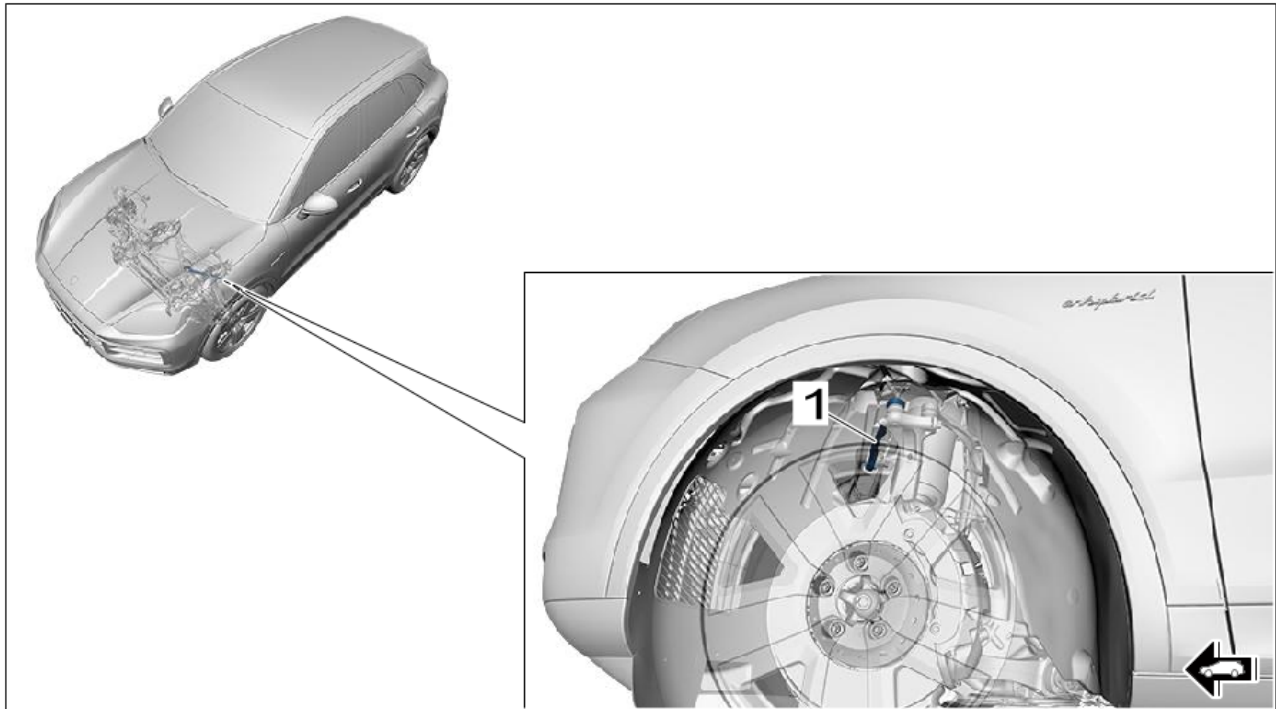
Cause: **There is a possibility that trailing arms on the front axle (top front left) on affected vehicles do not meet the required specifications.**

*Installation position of front trailing arm upper left*

1 – Front trailing arm upper left

Action: Replace upper trailing arm (front left) on the front axle.
