9YA, 9YB PHEV- HV Battery Actual Values Not Plausible

Models	Model Year	Model Type	VIN Range	Vehicle-Specific Equipment
Cayenne	As of 2024 up to 2025	9YA, 9YB	N/A	PHEV

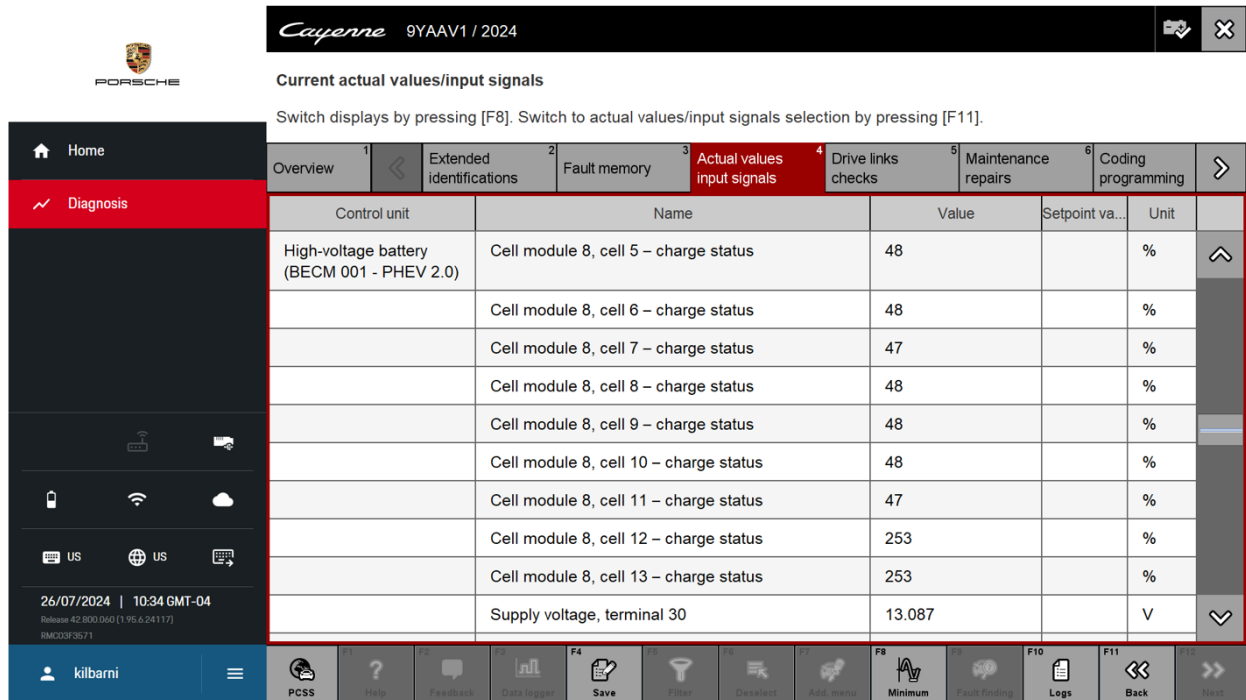
The workshop finds implausible actual values in HV battery module 8 cells 12 and 13 for both charge and voltage readings. The normal readings for charge and voltage are shown in figures 1 and 2 respectively.

Figure 1: Implausible charge status for module 8 cells 12 and 13

The actual values for each battery cell listed in the PIWIS Tester do not correspond to the modules in the latest generation HV battery due to a change in module design. An in-depth overview and description of the new HV system is available in the [SIT Cayenne 24](#) starting on page 90. The table below summarizes the cell distribution break-down between generations for quick reference.

This behavior of HV battery cell actual values is currently a known defect in the PIWIS Tester software. When performing diagnosis of any faults in the PHEV 2.0 HV battery, these last two values of module 8 should not be taken into consideration as they do not physically exist.

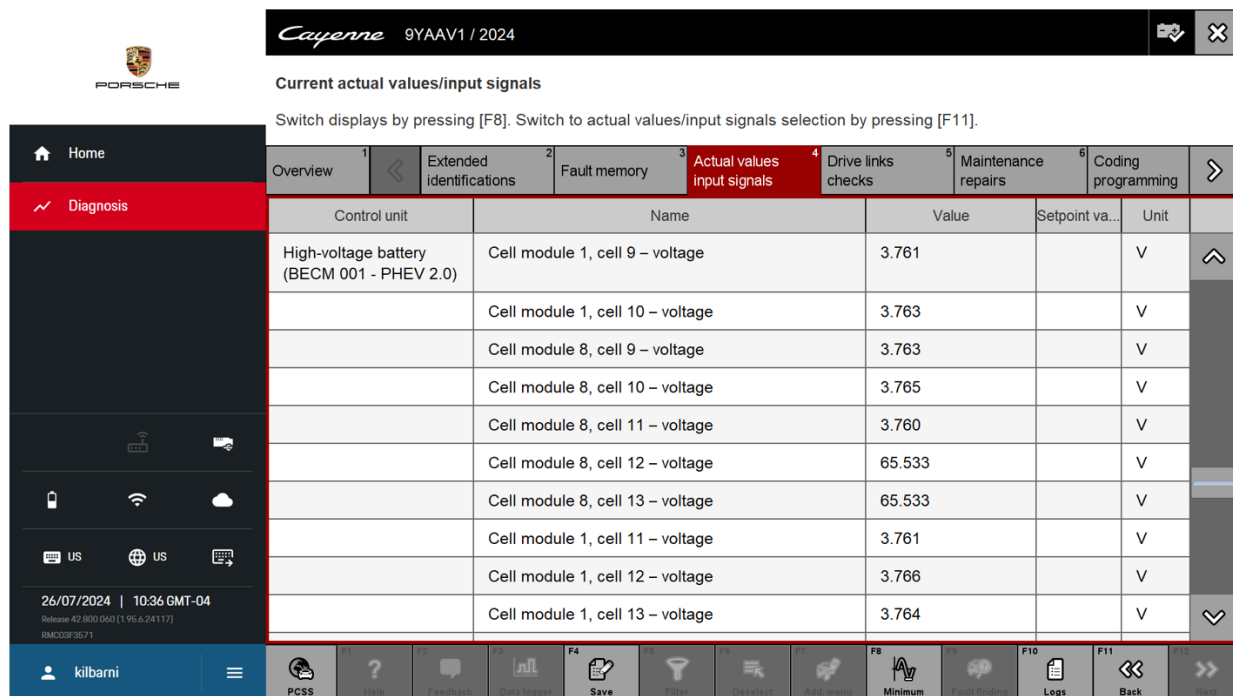
Figure 2: Implausible voltage values for module 8 cells 12 and 13
