**Surround Camera Intermittent Operation**

**Vehicles Affected**

Models	Model Year	Model Type	VIN Range	Vehicle-Specific Equipment
Cayenne	As of 2019 up to 2025	9YA, 9YB	N/A	KA6

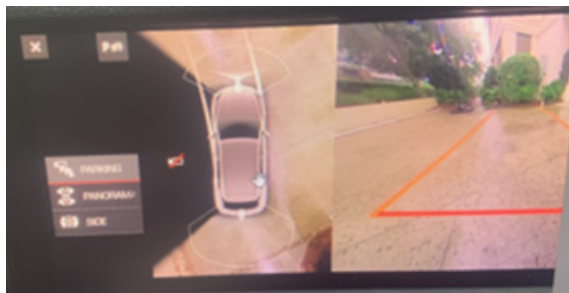
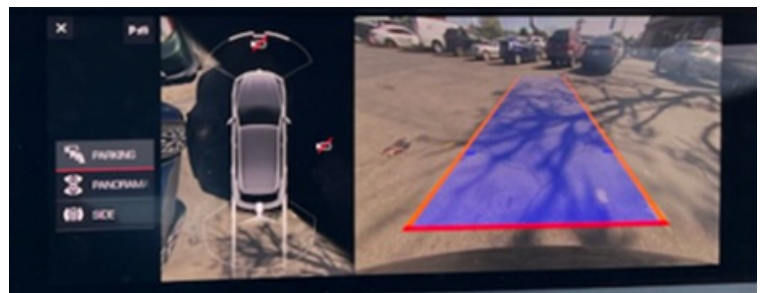
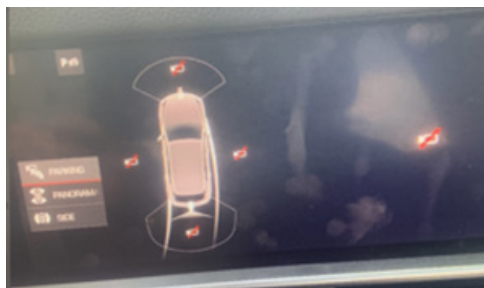
Customer complains of intermittent operation for one or multiple surround view cameras while appearing blank with a crossed-out camera icon for each failed camera.
