**Surround View Camera Intermittent Operation**

Models	Model Year	Model Type	VIN Range	Vehicle-Specific Equipment
911	As of 2020 up to 2023	992	N/A	KA6

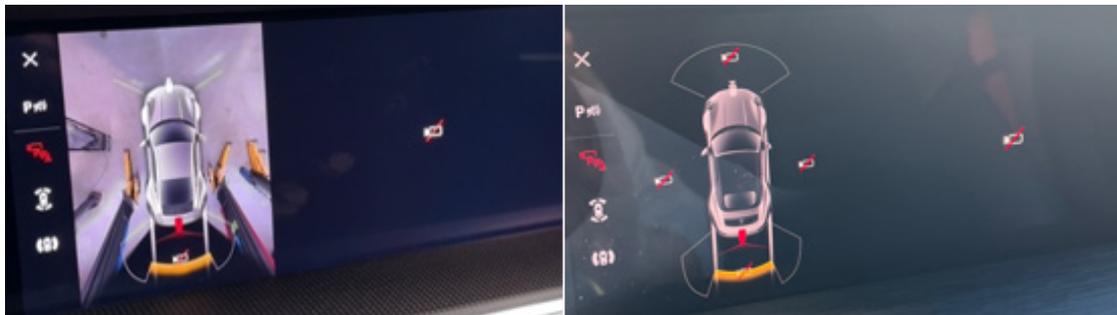
Figure 1

Customer complains of intermittent operation for one or multiple surround view cameras. Failed surround camera(s) appear blank with a crossed-out camera icon.

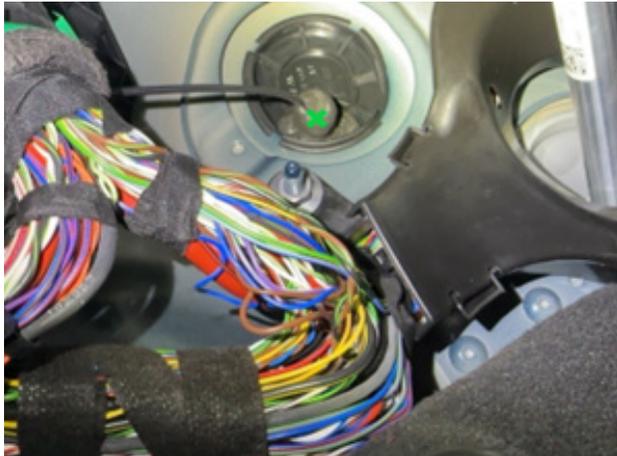
**Figure 4**  
Cabin Side - Clutch Master Cylinder Grommet

**IMPORTANT:** Ensure no material is removed from any grommet when piercing and do **NOT** drill any holes. Avoid damaging wires by pointing insertion tool **AWAY** from wires while penetrating.

- Pictures above are of driver side camera overlay to zFAS control unit from A-pillar connector. Grommet of use is for the missing clutch master cylinder.
- If the vehicle is a manual, refer to the pictures below to be used for driver side camera overlay. Passenger footwell grommet is to also be used for rear and passenger camera overlays. When overlaying wires, ensure wires are secured to existing harnesses and area of piercing is properly sealed.
- Recommended points of piercing are designated by green X's.

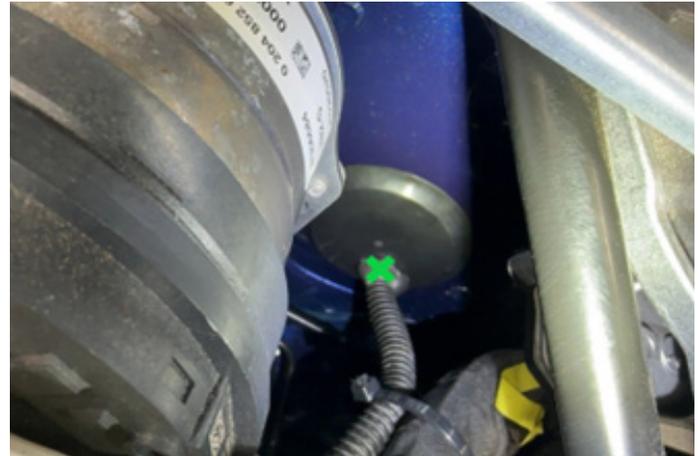
**Figure 5**  
Exterior Side - Clutch Master Cylinder Grommet

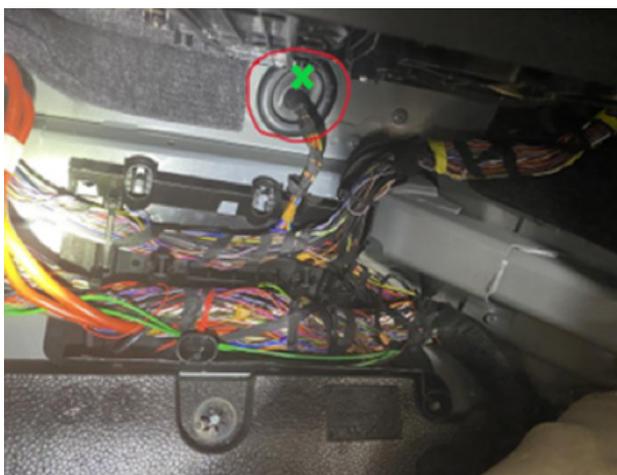
**Figure 6**  
Cabin Side - Passenger Footwell Grommet

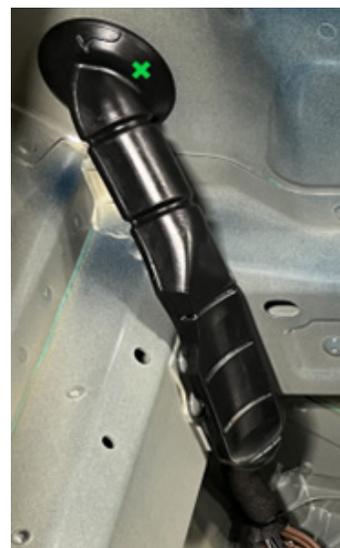
**Figure 7**  
Tub Side - Passenger Side Grommet

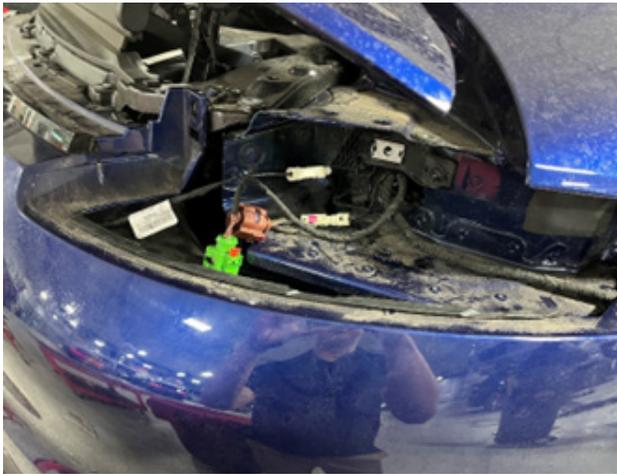
**Figure 8**  
Rear Camera Connection Point (Right Rear Taillight)

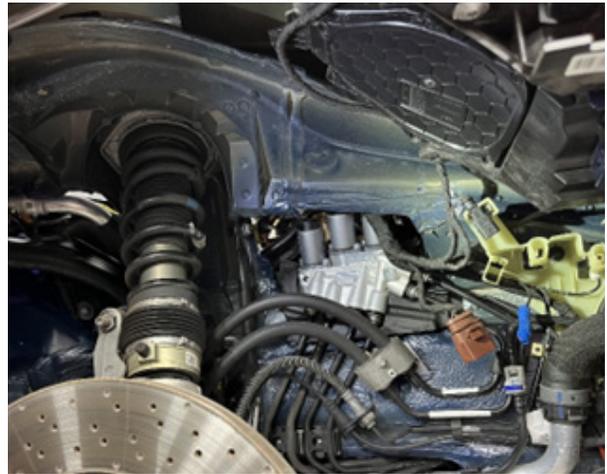
**Figure 9**  
Front Camera Connection Point  
(Front Right Wheel Well)

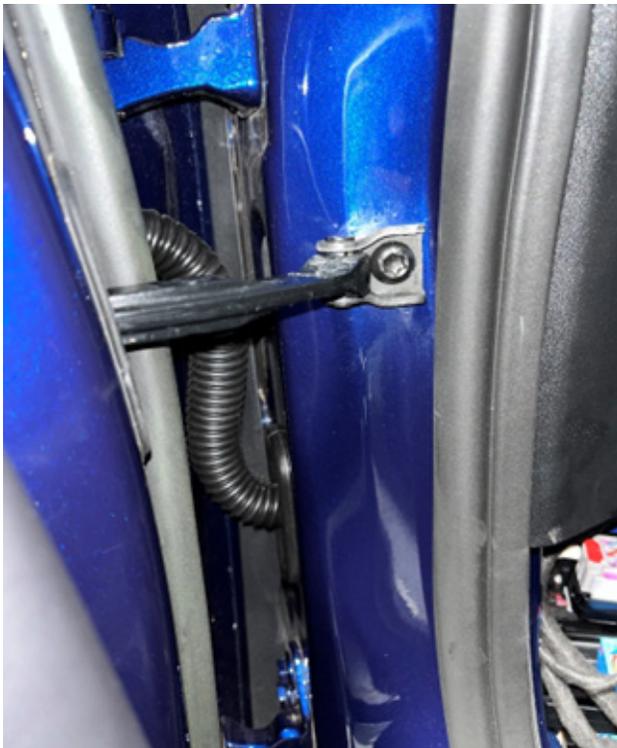
**Figure 10**  
Door Harness Connection Point (1)

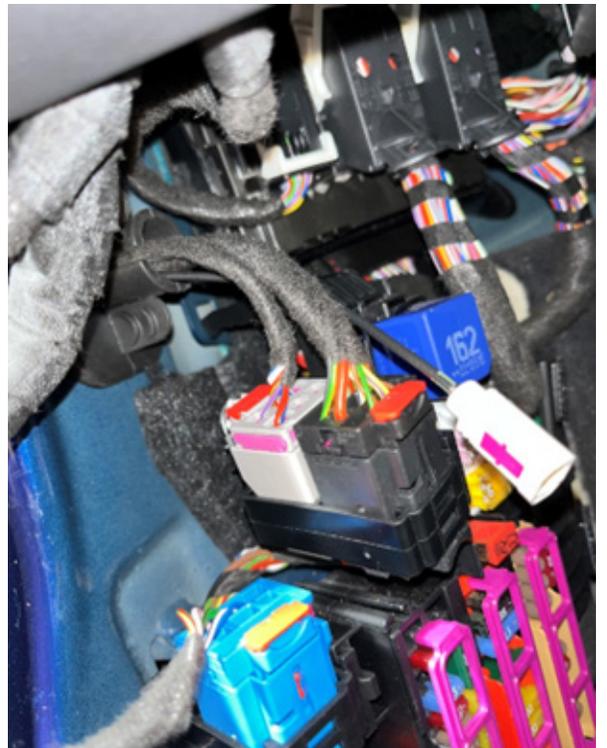
**Figure 11**  
Door Harness Connection Point (2)
