Service Bulletin

Bulletin No.: 22-NA-128

Subject: Malfunction Indicator Lamp (MIL) Illuminated - DTC P0172, P026D, P2459, and/or P2A00 Set

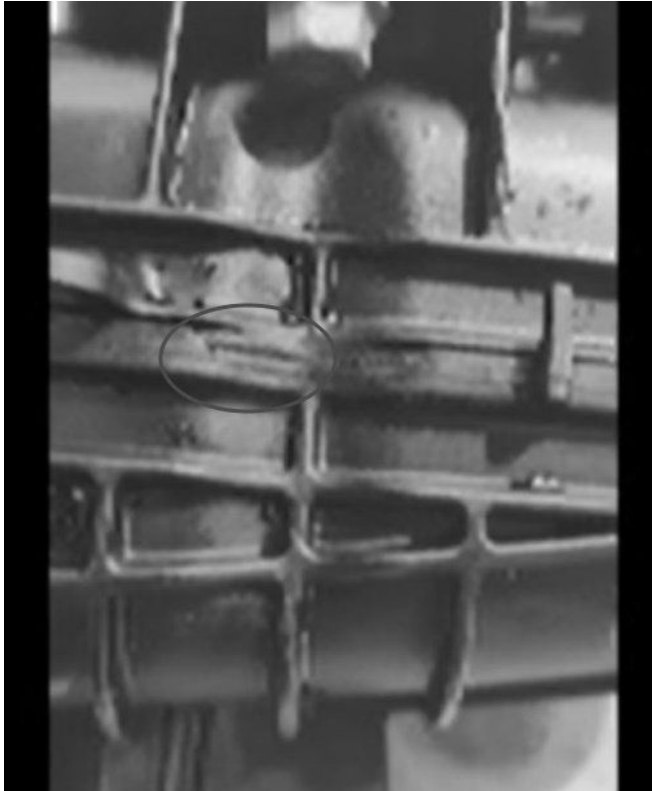
<p>This condition may be caused by a leak at the intake manifold. 6102369</p>
<p>Correction</p>	<p>The technician can find this leak by testing using the <i>Component/System Leak Test in SI</i> or bulletin PIP5684. If a leak is found in the intake manifold, replace the intake manifold.</p>

Refer to *Intake Manifold Replacement in SI*.
