Service Bulletin

Bulletin No.: 23-NA-141

Subject: Information on Engine Block Cracked at Head Bolt Hole Locations

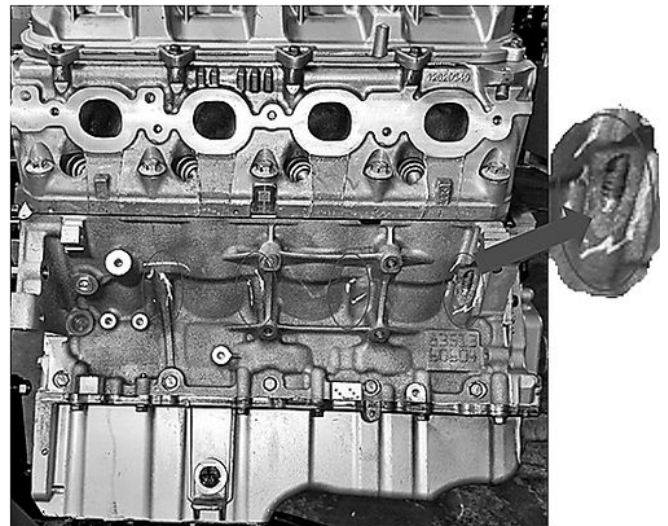
6407761

Engine Block Damage caused by Foreign Debris, Dirt, or Coolant Left in the Cylinder Head Bolt Holes

The engine block may be cracked or damaged if debris, dirt, or coolant is left in the cylinder bolt holes of the block, or if the threads are damaged when installing the head bolts during any service repair that requires removal, installation, or replacement of the cylinder head. (See GenV engine photo above as example). The head bolt holes in the block are being damaged due to coolant, dirt, or debris being present in head bolt

holes during cylinder head installation during a repair, or when re-assembling the engine for core return. If coolant, dirt, or debris is present in the bolt holes during assembly, the foreign material will create a hydro-lock condition that will over-pressurize the casting column of the threaded hole in the block, causing the casting to break as shown in the graphic above.

Follow steps below prior to performing any service repair involving cylinder head installation, or replacement.

- Clean all dirt, debris, and coolant from the engine block cylinder head bolt holes. Failure to remove all foreign material may result in damaged threads, improperly tightened fasteners, cause damage to engine block, or other components.

- Clean bolt holes using spray solvent, and compressed air.
- Inspect/repair threads of head bolt holes per SI repair procedures.
