Technical product information

Topic	Fatigue warning is not visible within the Infotainment screen menu after the Data bus control unit (J533) was replaced
Market area	United States E05 Bentley USA and rest America (6E05)
Brand	Bentley
Transaction No.	2074860/1
Level	EH
Status	Draft
Release date

Fatigue warning is not visible within the Infotainment screen menu after the Data bus control unit (J533) was replaced

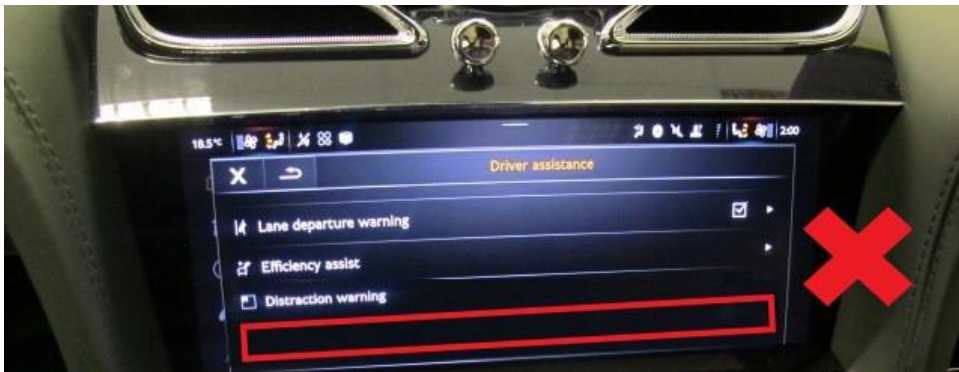
Fatigue warning is not visible (Figure 1) within the Infotainment screen menu after replacement of the Data bus control unit (J533)

When initialising and calibrating the replacement Data bus control unit (J533) one of the adaption channels may not have been written correctly. As a result, the menu entry for the fatigue warning in the Infotainment screen is missing. Should the described issue be evident please conduct the instructions within the Measure section of this TPI

- Check the latest ODIS version is installed on your diagnostic machine
- After initialising the Data bus control unit (J533) the operative must perform the configuration again as follows:
- Connect a suitable 12 volt battery charger to the vehicle before proceeding - Refer to Rep.Gr 27
 - Select Guided functions from 0019 Data Bus OBD interface (Gateway) Control module (Figure 3)

- Once the procedure is complete check the infotainment screen to confirm if the "Fatigue warning" menu entry is displayed and can be selected under the Driver assistance menu as Figure 1

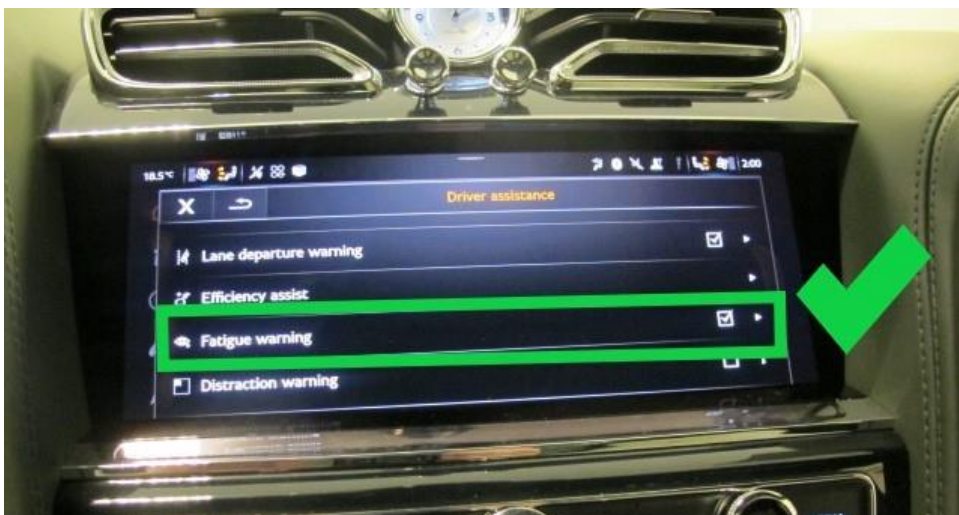
Figure 2 shows the Fatigue warning (Correct status)
