McLaren 750S Spider - Door Sensor Reseal and Door Control Unit Inspection

Bulletin type:	Service Campaign
Reference number:	N/A
Campaign reference:	SCB 28 A 001
Attention:	Retailer Aftersales Managers, Retailer Service Managers, Retailer Service Advisors, Retailer Technicians, Retailer Parts Managers
Affected vehicles:	McLaren 750S Spider
Situation:	Resealing of the door sensor and inspection of the door control unit
Procedure:	Action affected vehicles on first opportunity (immediately if already on site or during next Retailer visit if not already on site). Please refer to the information outlined in this document to complete the required work
Date:	23 August 2024

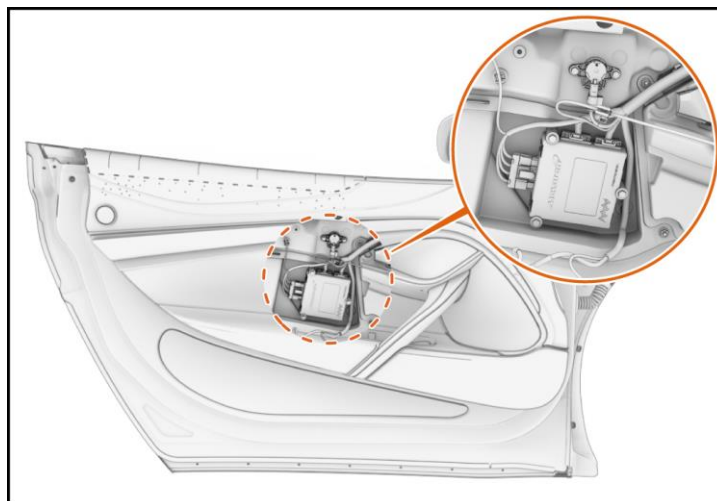
Image 1 Rework and Inspection Area

Through continuous product quality monitoring, McLaren Automotive has identified that on certain McLaren 750S Spider vehicles, the internal door panel to the peripheral pressure sensor housing interface requires resealing in the area behind the door card. In the same area behind the door card, the door control unit requires inspection for contamination.

To inspect the door control unit, follow ‘P28 Spider Door Sensor Reseal and Door Control Unit Inspection’ work instruction attached with this Service Campaign bulletin. To perform the required work to reseal the door sensor housing to the door inner, follow McLaren Service Portal (MSP) D051050 ‘Occupant Restraint Control (ORC) Peripheral Pressure Sensor’ work instruction.
