GENERAL MOTORS  
DCS7001  
URGENT - DISTRIBUTE IMMEDIATELY

Subject: N242435602 - Customer Satisfaction Program  
Multiple Module Reprogramming

Models: 2024 GMC HUMMER EV Pickup  
2024 GMC HUMMER EV SUV

## N242435602 Multiple Module Reprogramming

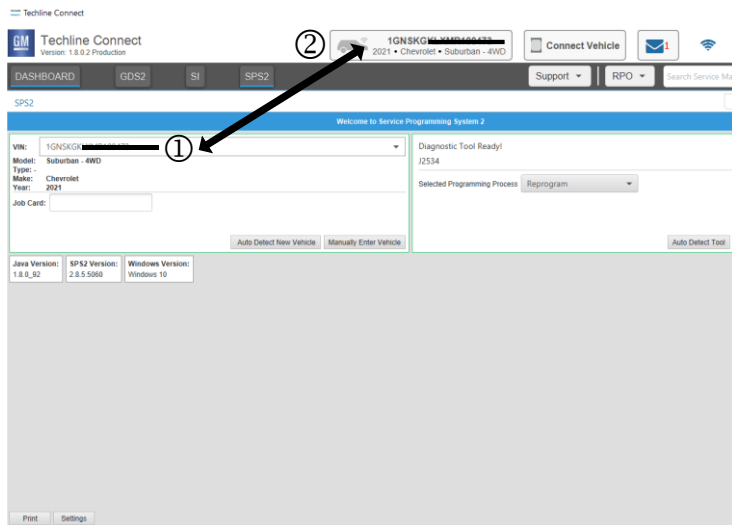
5743643

**Caution:** Be sure the VIN selected in the drop-down menu (1) is the same as the vehicle connected (2) before beginning programming.

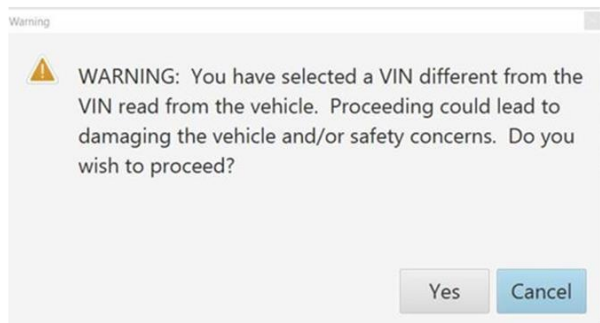
5877000

**Important:** If the vehicle VIN DOES NOT match, the message below will be shown.

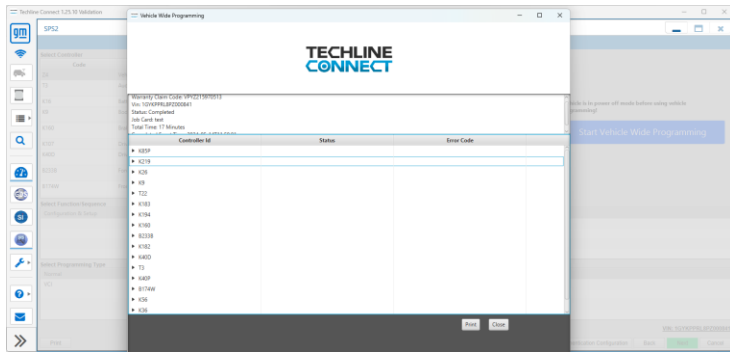
6693875

**Note:** The screenshot above is an example of Vehicle Wide Programming and may not be indicative of the specific modules that are being programmed. VIN information has been blacked out.

**Important:** To avoid warranty transaction rejections, you **MUST** record the Total Time provided on the Warranty Claim Code (WCC) screen shown above on the job card.

- Print a copy of the Warranty Claim Code screen and attach to the repair order. It is critical to record the total time in order to close out the field action.
