STAR ONLINE PUBLICATION

Case Number: S2423000027 Rev. B

Symptom/Vehicle Issue: Horn Sound Is Weak, Off Tone, Or Inoperative.

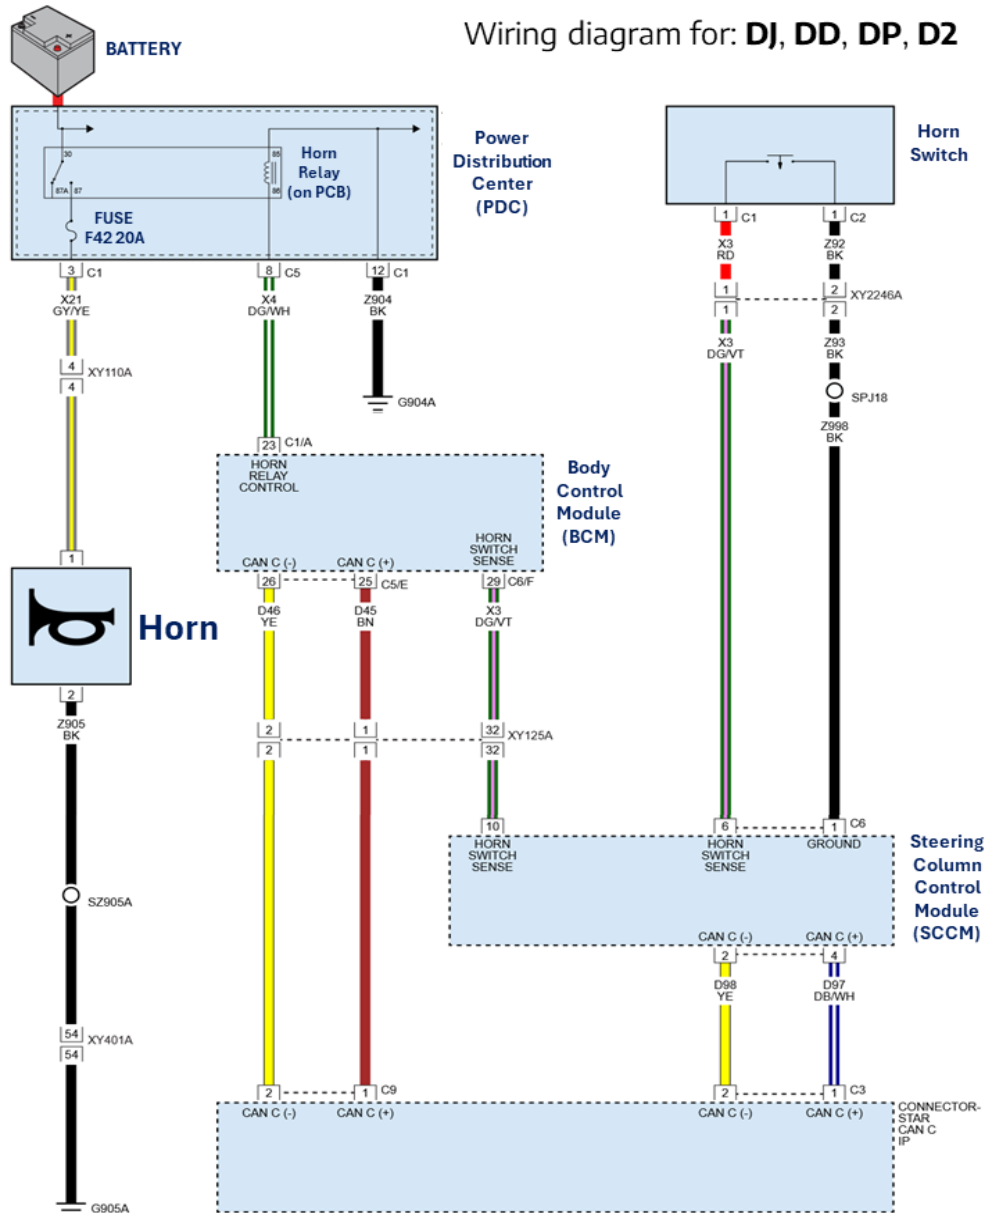
horn. Likewise test for ground at the BCM low current relay coil side harness connectors. Continue through the system until the cause is found.
