**KEYSTONE**  
RV COMPANY

**SERVICE ADVISORY 24-457**

## SERVICE ADVISORY # 24-457

### Inverter Battery Cable

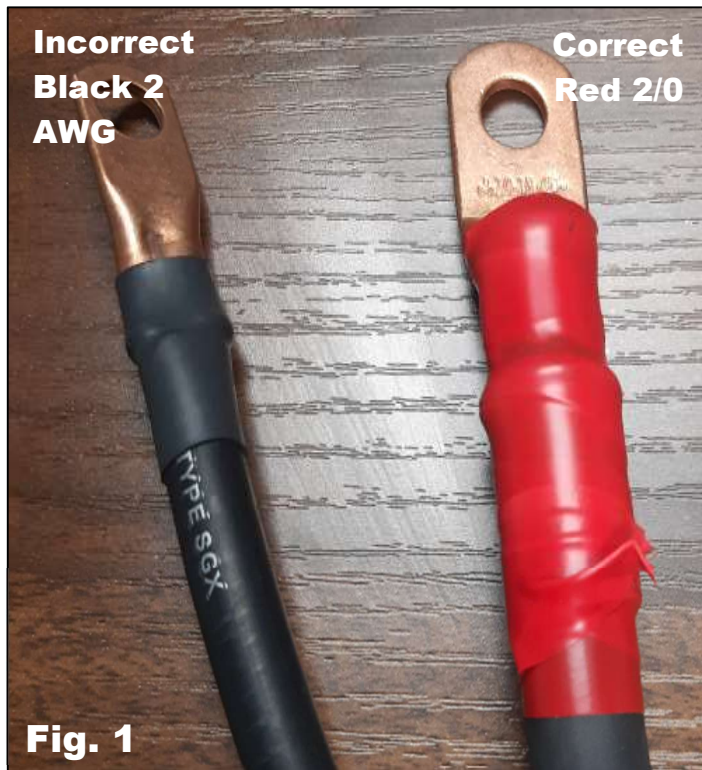
The remedy is to inspect the positive battery cable that leads to the inverter disconnect. Inspect to see if it is a 2 AWG 105 C positive battery cable and replace it with the 2/0 positive battery cable. See Figure 1 as an example of the incorrect and correct positive battery cables. A clear picture of the correct positive battery cable is required for the claim.

It has been determined that the incorrect gauge positive battery cable may have been used from the battery to the inverter disconnect. The correct battery cable needs to be installed. The remedy is to inspect the positive battery cable that leads to the inverter disconnect. Inspect to see if it is a 2 AWG 105 C positive battery cable and replace it with the 2/0 positive battery cable.
