Technical Service Bulletin

19 loss of coolant from coolant pump - V6 TFSI

19 24 65 2070349/4 August 30, 2024. Supersedes Technical Service Bulletin Group 19 number 23-46 dated December 12, 2023 for reasons listed below.

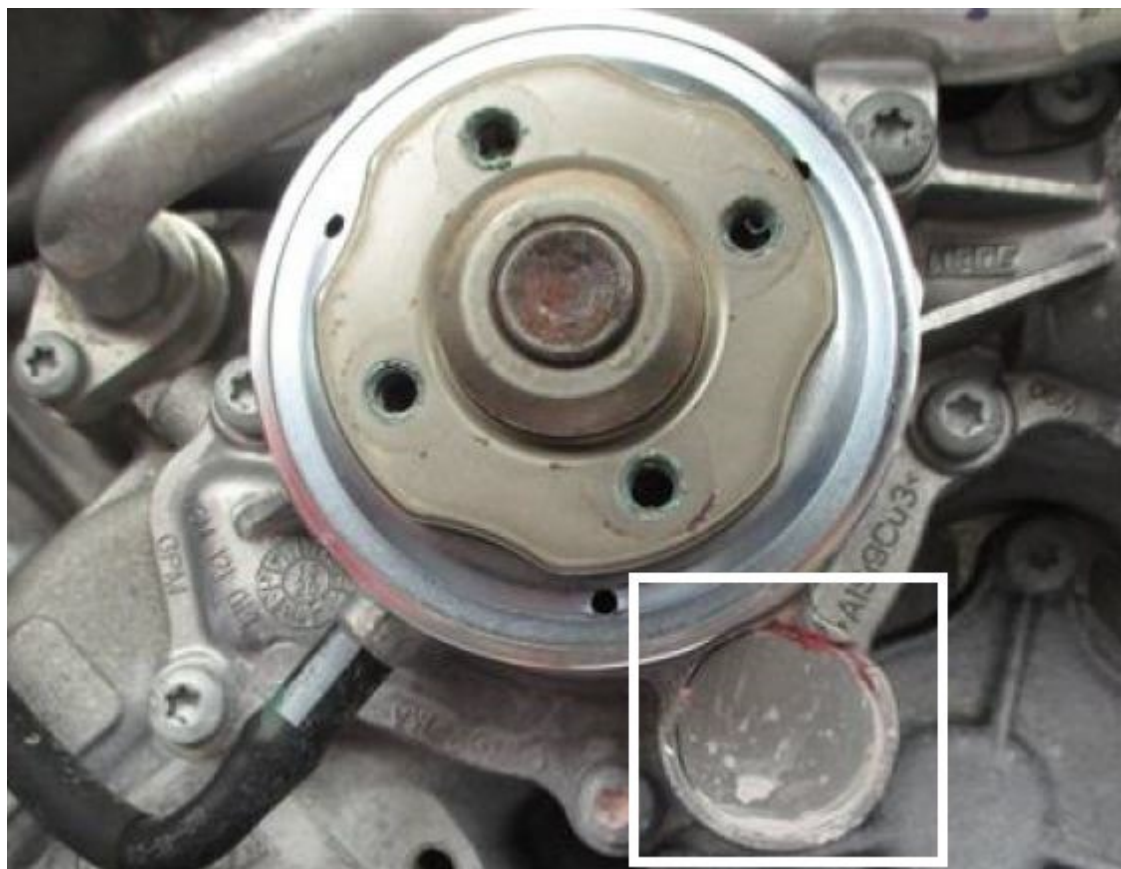
1) Traces of coolant (small quantity) on drip cup (refer to figure 1).

Due to lubrication/cooling of the seal, up to 3 ml may escape over the course of 100 hours of operation. This is quite normal and does not constitute a reason for a complaint.

Figure 1: Traces of coolant on the drip cup.

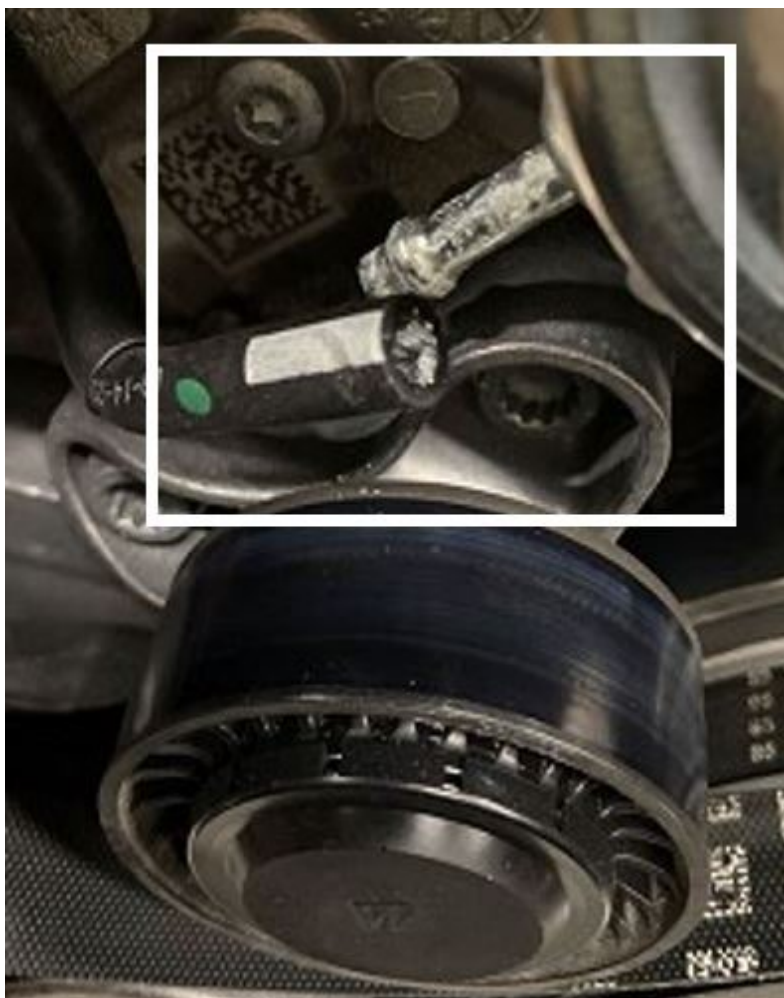
2) Dried deposits on vacuum connection are **not** a clear indication of a leak (see Figure 2).

Figure 2: Dried deposits on vacuum connection.

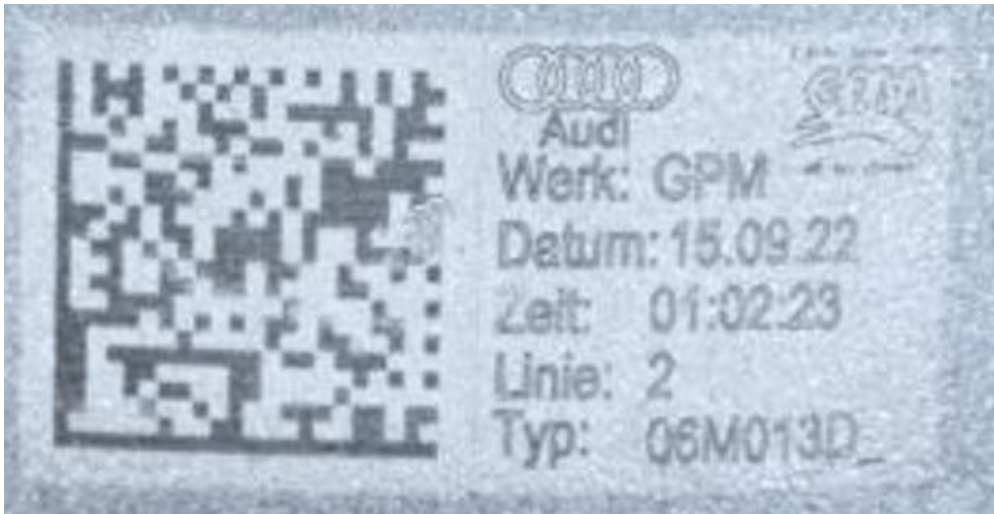
Figure 3: Example of coolant pump production date.

3. Perform visual check; assess whether there may be a leak at idling speed and at higher engine speeds of up to approx. 2500 rpm.
4. Check the cooling system for leaks according to the Workshop Manual.
5. Reassess the suspected leak:
 - **No** further coolant leak can be detected: **continue to observe without replacing any parts.**
 - Coolant leak can be detected again, **replace the component(s) causing the leaks and document leaks with photos/video. If the coolant pump is found to be leaking, also photograph the production date (refer to image 3 for an example).**
