# Technical Service Bulletin

## 55 Guide to finding water ingress on the rear lid structure

55 24 01 2073283/2 August 30, 2024. Supersedes Technical Service Bulletin Group 55 number 24-93 dated March 5, 2024 for reasons listed below.

Model(s)	Year	VIN Range	Vehicle-Specific Equipment
Q4 e-tron, and Q4 Sportback e-tron	2022 - 2025	All	Not Applicable

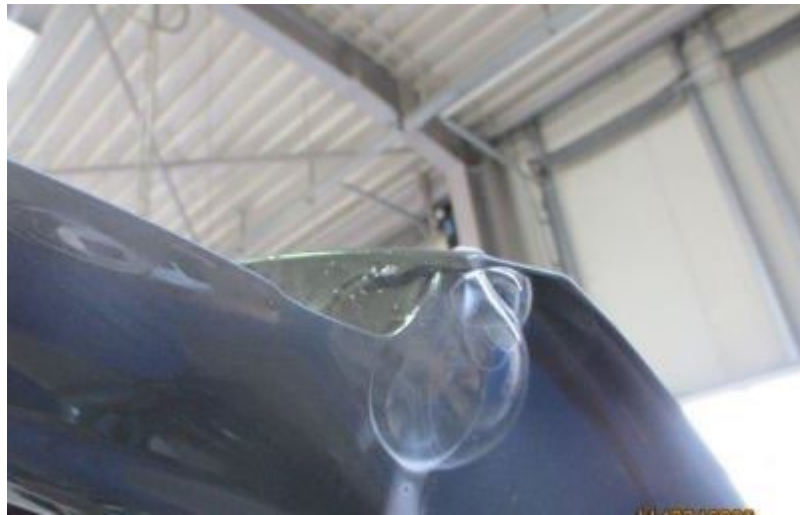
1. Remove the rear lid trim and perform a leak test on the rear lid. With the lid trim removed visual and physical access to the rear lid structure can be gained. Mix a solution of dish detergent and water and add to a spray bottle. Spray the solution on the area shown in Figures 1, 2 and 3 while blowing compressed air from the inside of the rear lid structure and watch for bubble formation.

**Figure 1.** Bubble formation with compressed air applied internally.

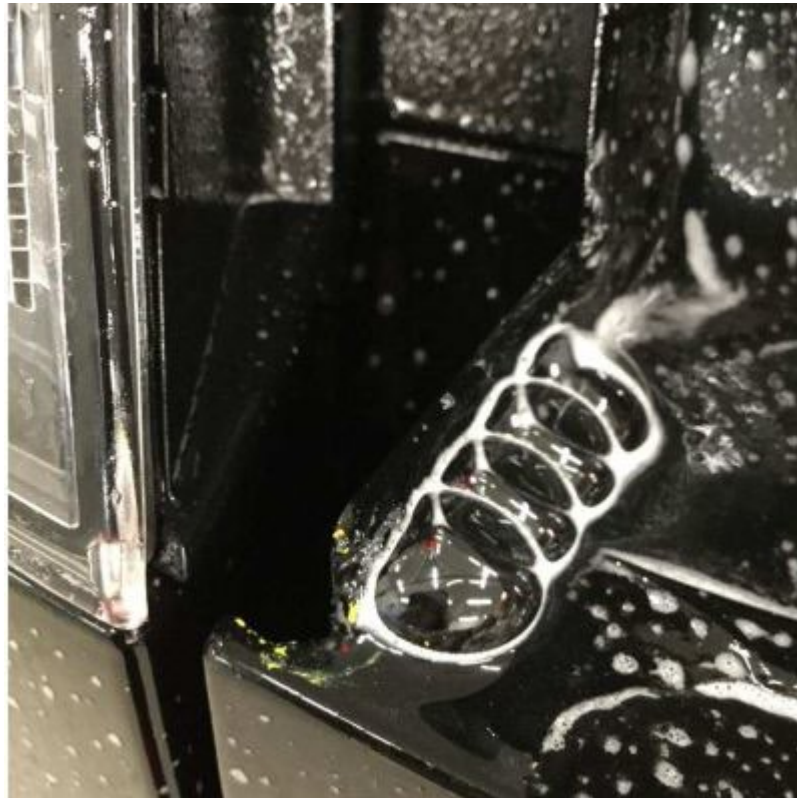
*Figure 2. Bubble formation with compressed air applied internally.*

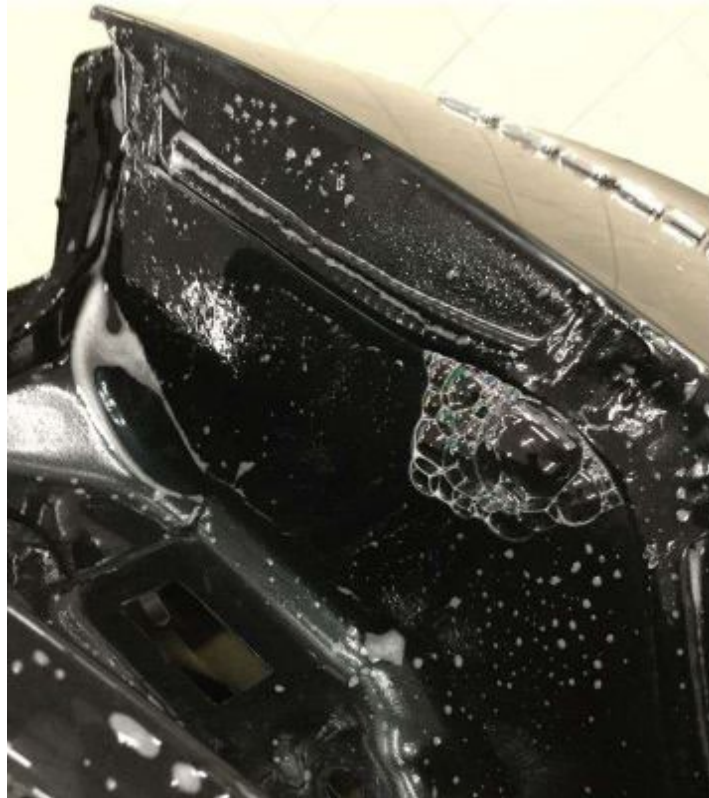
*Figure 3. Bubble formation with compressed air applied internally.*

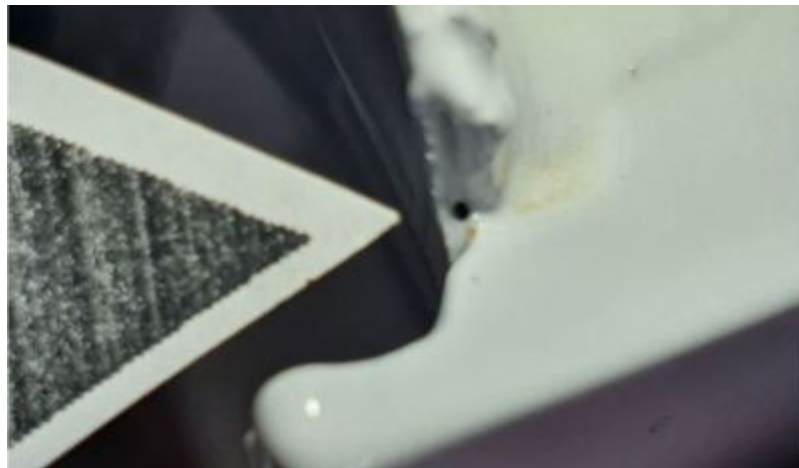
The seam sealer used to seal adjoining panels may have a flaw causing a small opening that can allow water to enter the rear lid shell. This TSB shows areas of the rear lid shell where sealer flaws may exist.

4. Figure 4 shows a possible location of insufficient sealant.

*Figure 4. Area where sealant may be missing.*

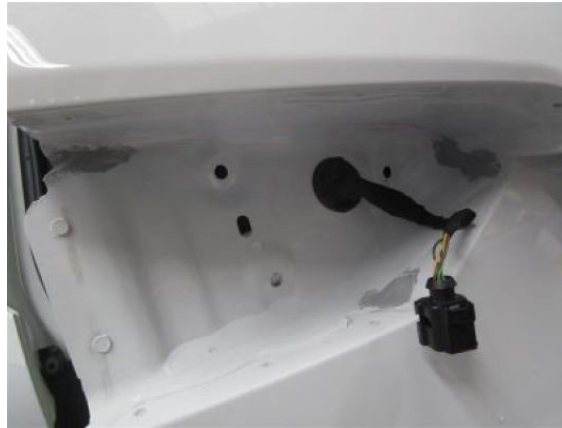
**Figure 5.** Concealed areas repaired with D 476KD1M2 or D 476KD1M3 sealant.

5. In cases where the sealer flaw is in a concealed area (e.g., behind a tail lamp) the openings can be repaired by applying D 476KD1M2 or D 476KD1M3 sealant to the openings with a brush. To the corresponding area on the inside of the rear lid shell apply D 321M16M2 cavity preservative using a brush. Ensure the application area is thoroughly clean and allow the sealant to cure as instructed. Touch up painted surfaces as necessary.
