Technical Service Bulletin

91 Parking aid sensor bracket(s) separates from rear bumper

91 24 46 2068573/3 August 30, 2024. Supersedes Technical Service Bulletin Group 91 number 23-05 dated June 12, 2023 for reasons listed below.

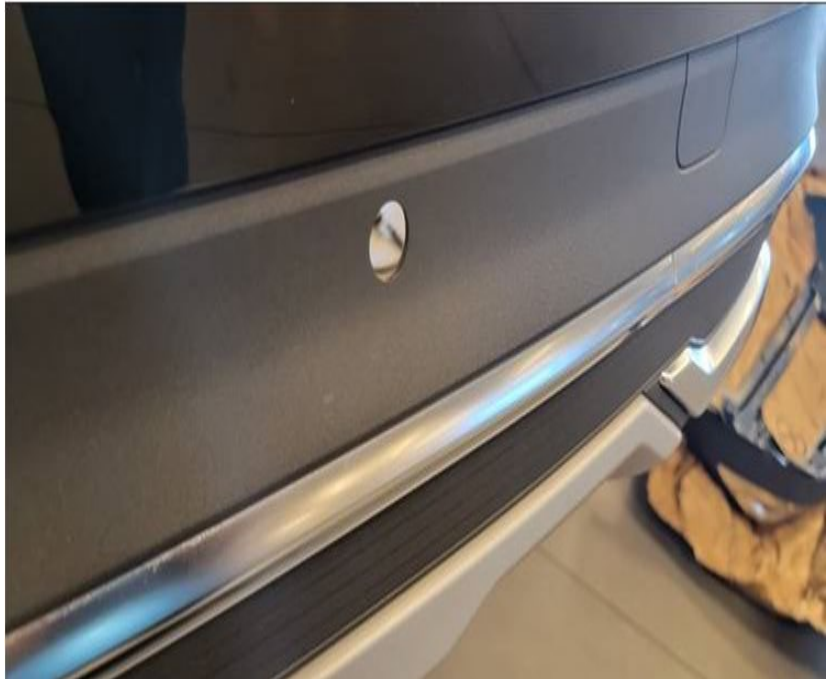
The adhesive strength of the parking aid bracket is not sufficient.

Over time, one or more of the sensor mounts may separate from the rear apron.

Figure 1: The parking aid mount has come loose.

It is possible for the parking aid sensor(s) to issue false warnings when the mounts start to separate.

If one or more of the sensor brackets has come loose from the rear bumper, use the steps below to re-attach the mounts.

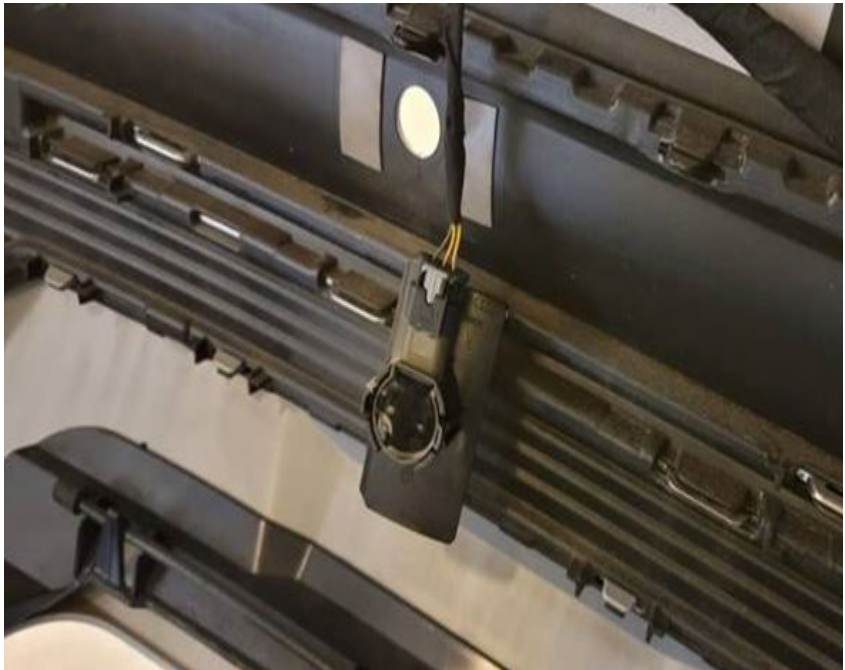
Figure 2: The parking aid mount has come loose.

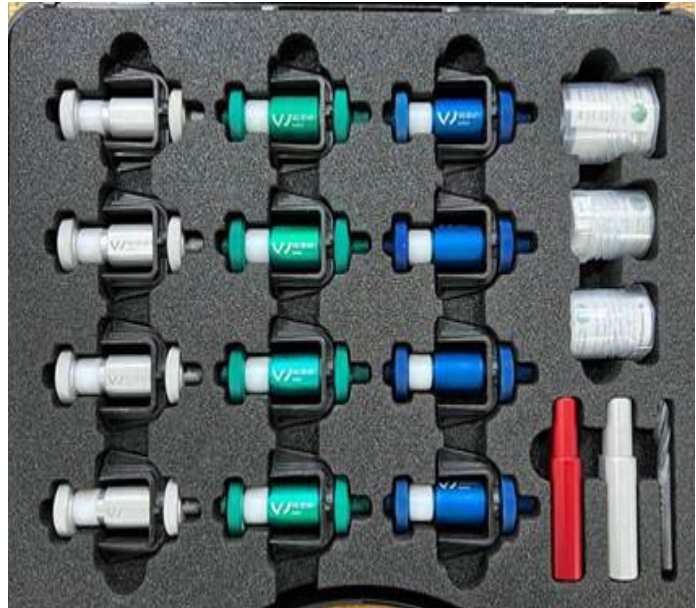
Figure 3: VAS 6614/C contents.

- Special tool **VAS 6614/C** will be used to complete this repair.
- Inside there are 3 sets of holders in various diameters to accommodate different size PDC sensors.
- Use the appropriately sized holder to center and clamp the mounts.

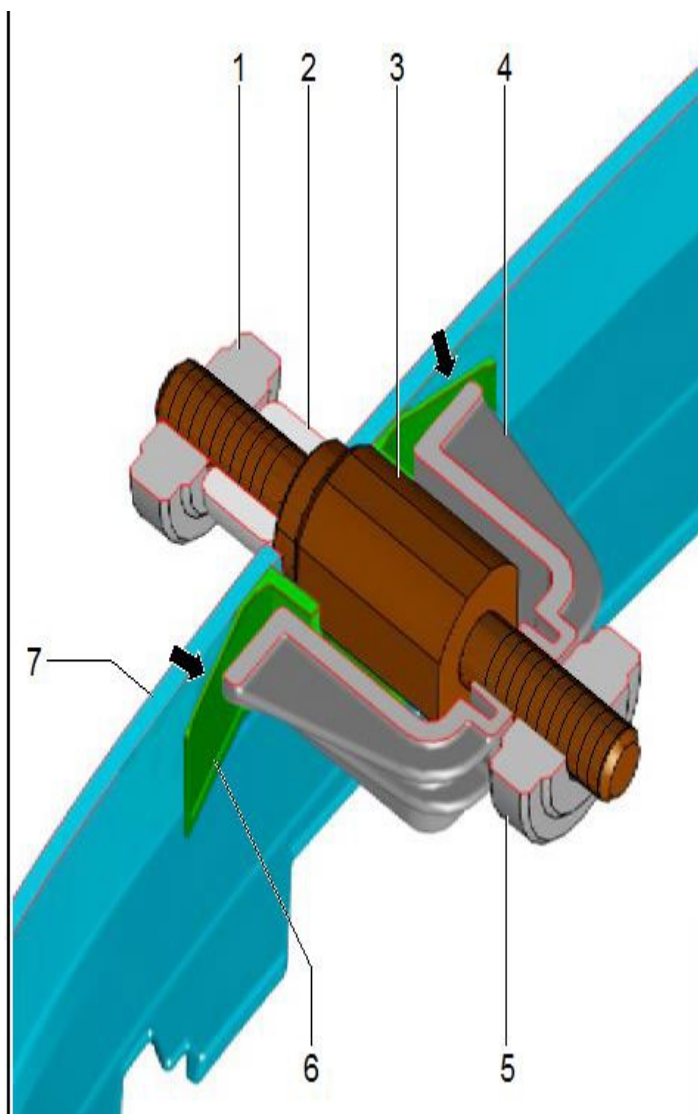
Figure 4: VAS 6614 assembled with PDC mount on rear apron.

- Slide parking aid bracket -6- onto centering pin -3- (VAS 6614) and push through rear apron -7- as seen in Figure 4.
- Slide on counter hold tool -2- from outside and tighten knurled nut slightly.
- Align bracket -6- in correct position and according to markings on rear apron.
- Slide on clamp -4- and screw in knurled nut -5- but do not tighten yet.

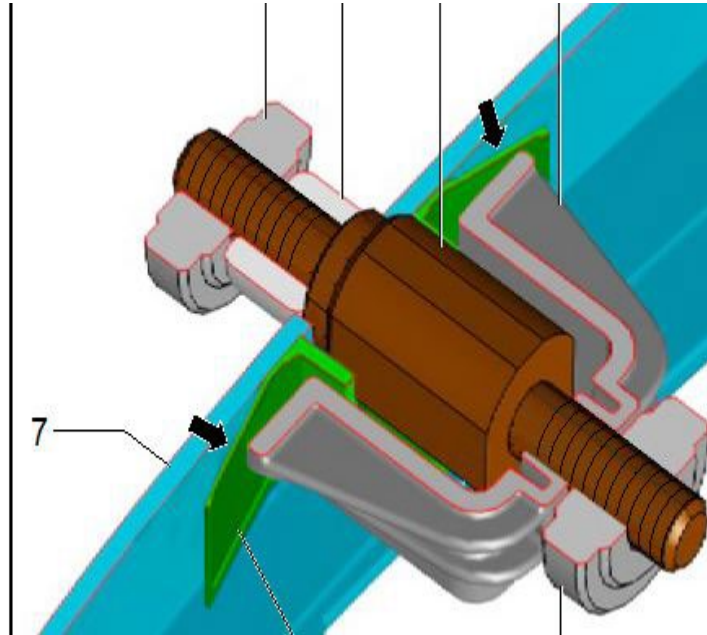
Figure 5: Arrows mark location for adhesive.

Apply plastic adhesive **D 180 KU2 A1** to areas marked by arrows between the parking aid bracket and rear apron (Figure 5).

- The first 3-5 cm of adhesive from the mixing nozzle may not be properly mixed and must therefore be discarded.

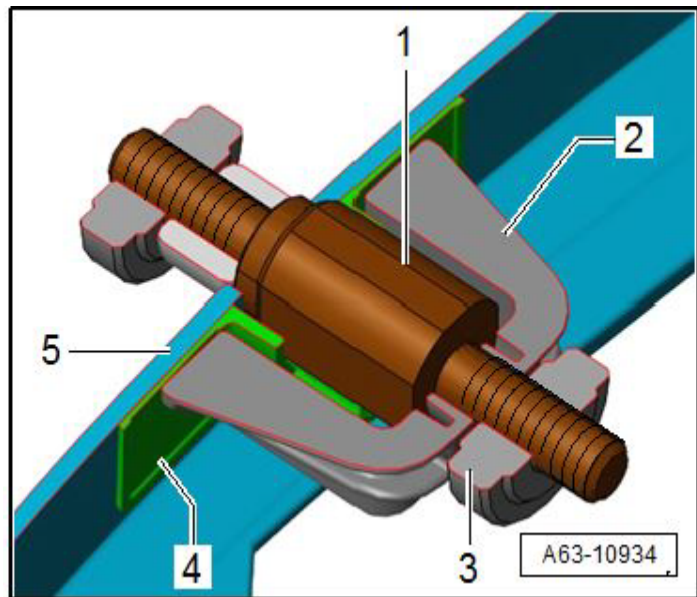
Figure 6: Mounts compressed to spoiler.

- Tighten knurled nut -3-.
- This results in clamp -2- pushing tabs of bracket -4- flat onto rear apron/spoiler -5-.
- Perform this step for all affected brackets.

- Allow a minimum drying time of 30 minutes before removing the jig.
- The rear apron must be left undisturbed during this period and must not be moved.
- Re-Install the rear bumper cover and confirm system operation.
