Technical Service Bulletin

60 Panoramic sunroof: checking seal due to wind noises or leaks

60 24 73 2063187/6 August 27, 2024. Supersedes Technical Service Bulletin Group 60 number 24-70 dated April 11, 2024 for reasons listed below.

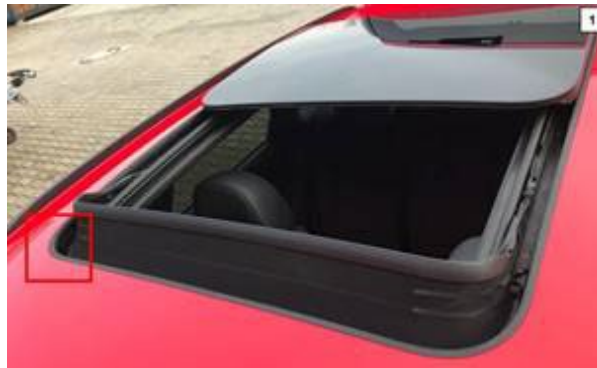
Figure 1. Front sunroof panel open.

1. Begin the inspection of the sunroof opening perimeter seal adhesion by fully opening the front sunroof glass panel (Figure 1).

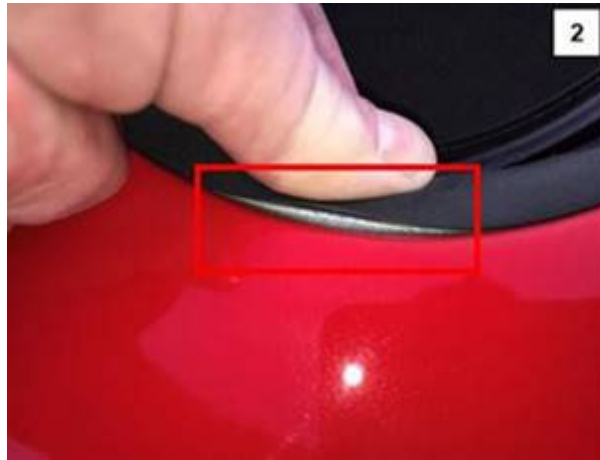
2. Press the seal downwards and inwards with your fingers until the adhesive tape for the seal is visible (Figure 2). The foam adhesive tape may be stretched but it must not be loose or detached from the roof panel to any degree.

Figure 2. Checking the adhesion quality.

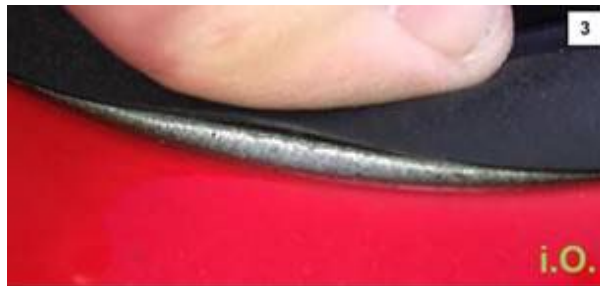
3. Figure 3 shows a properly adhered adhesive band.

Figure 3. A properly adhered perimeter seal.

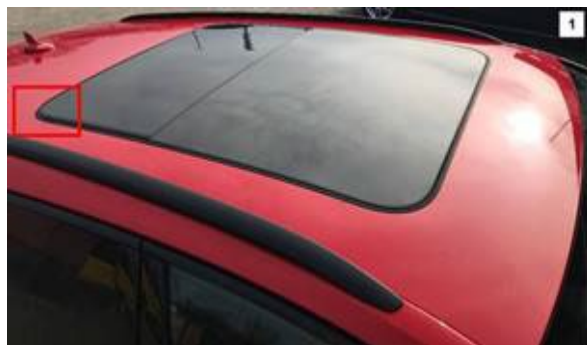
4. Repeat this procedure centimeter by centimeter over the entire length of the front sunroof opening. When this is completed, close the front sunroof panel.
5. Using the same inspection principle used in the inspection of the front portion of the sunroof opening perimeter seal check the seal adhesion in the rear portion of the sunroof opening (Figure 4).

Figure 4. Begin inspection of the rear portion of the perimeter seal.

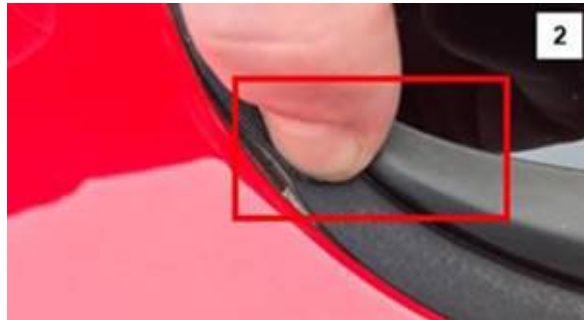
6. Figures 5 - 8 clearly show that the adhesive tape has come loose from the vehicle body. The obvious color and shape difference at the point of contact revealing the gaps is evidence of detachment.

Figure 5. Clear evidence of adhesive detachment.

7. A gap in the attachment is revealed in the examples in Figures 5 - 8.

8. The locations where the adhesion is compromised or has failed is a possible entry point for water into the cabin. The area directly below these openings is outside the area of the sunroof drainage. If any adhesion is found to be compromised or failed to any extent replace the sunroof opening perimeter seal. Follow the procedure in ElsaPro explicitly to ensure proper seal adhesion paying particularly close attention to the adhesion surface preparation.
9. Please take photos of the customers' concern and upload them into DOC-IT with the repair order. Photos should
 - Have a date stamp and VIN reference.
 - Be taken in focus and with sufficient light.

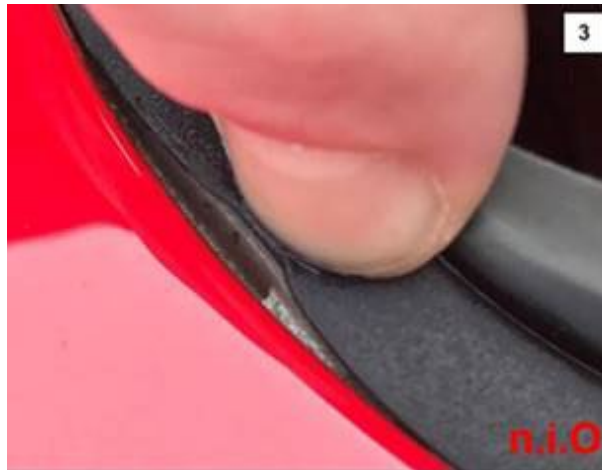
Figure 6. Seal adhesive band detachment revealed.

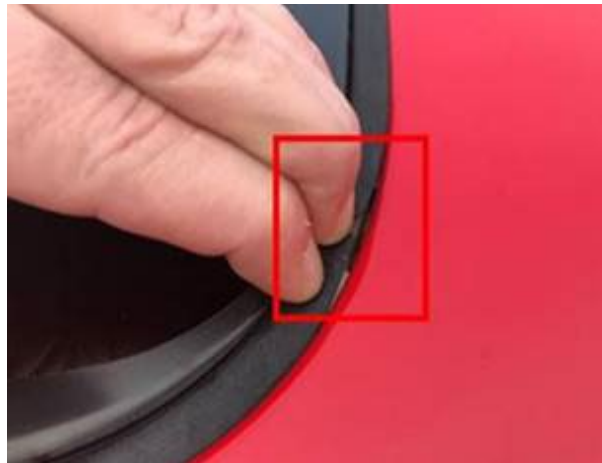
Figure 7. Adhesive band detachment.

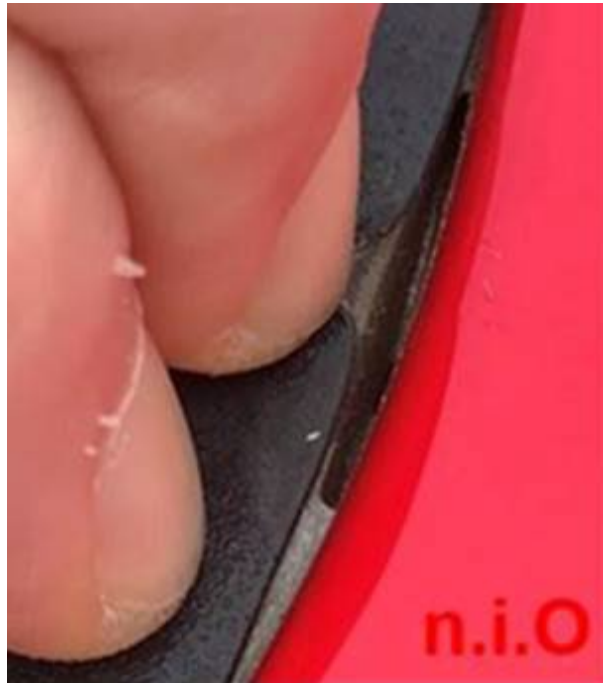
Figure 8. Close-up view of the detachment area from Figure 7.
