Technical Service Bulletin

92 Headlight washer jet does not retract

92 24 39 2065982/3 August 27, 2024. Supersedes Technical Service Bulletin Group 92 number 23-34 dated March 3, 2023 for reasons listed below.

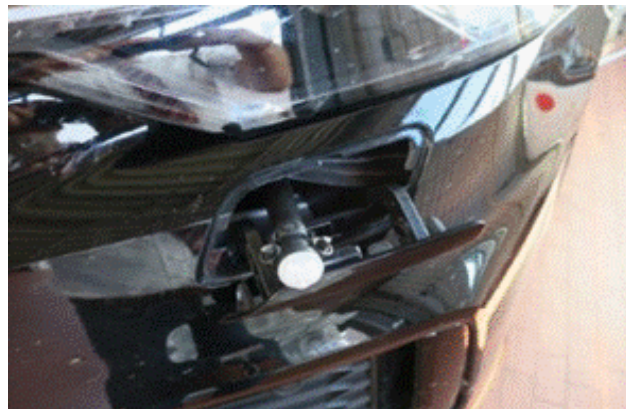
The headlamp washer nozzle/pressure cylinder does not retract automatically after a wash cycle (Figure 1).

Figure 1. The headlamp washer nozzle jammed in the extended position.

The headlamp washer nozzle/pressure cylinder binds against the headlamp washer system nozzle cover and does not retract automatically after a wash cycle.

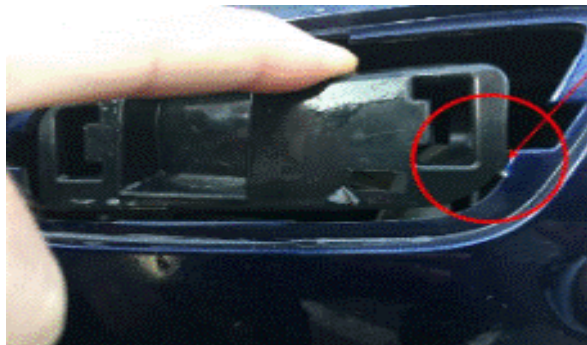
- A precise tolerance between the headlamp washer system nozzle cover and the bumper cover aperture may prevent full closure in the presence of dirt and debris in the area.
- The headlamp washer system nozzle cover return spring exerts too great a force preventing the nozzle from retracting.
- There is physical interference between the headlamp washer system nozzle cover and the bumper cover due to inadequate positioning of the headlamp washer nozzle/pressure cylinder.

Figure 2. Interference between the headlamp washer system nozzle cover and the bumper cover.

1. Remove the headlamp washer outer cover and inspect for possible interference with the cover mechanism and the bumper cover as shown in Figure 2. Using a cutting instrument carefully trim the area of interference on the cover mechanism just enough to provide appropriate clearance to allow free movement.

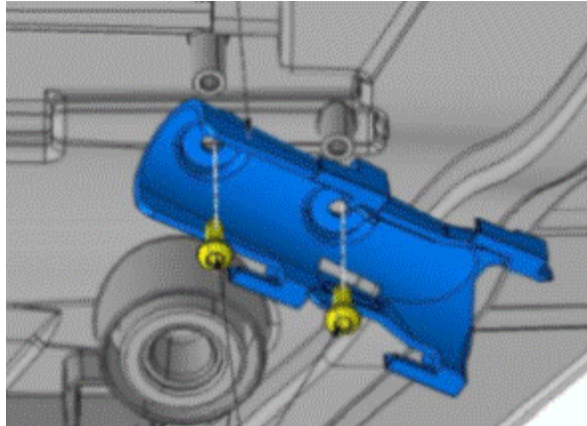
Figure 3. Headlamp washer cylinder mounting bracket screws.

2. Additionally, a small adjustment can be made to the position of the headlamp washer cylinder by loosening the two washer cylinder mounting bracket screws (Figure 3) and rotating it such that the nozzle end is rotated away from the center line of the vehicle toward the turn signal lamp on the respective side being serviced (Figure 4). Tighten the screws in the adjusted position.

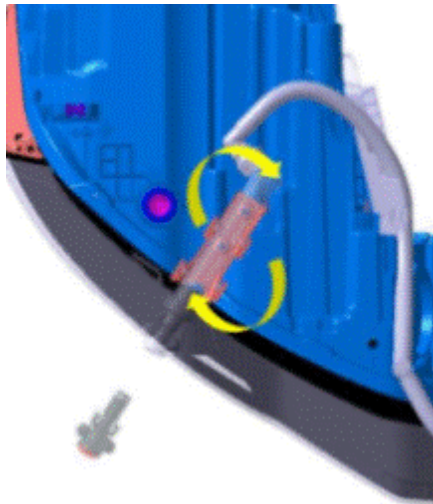
Figure 4. Desired angle of rotation of the washer cylinder.

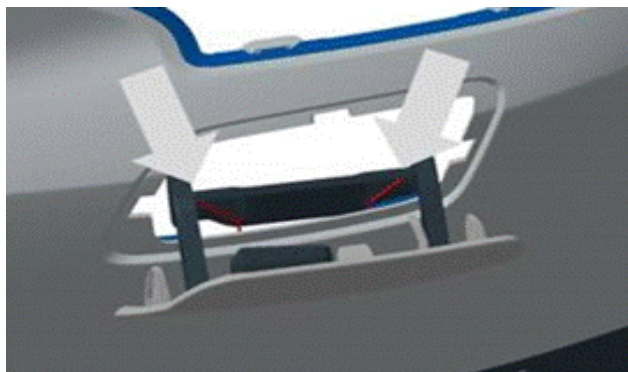
4. Make an attempt to relieve the pressure exerted on the headlamp washer system nozzle cover with your finger. If the nozzle retracts on its own check the cover spring clip version. Figure 5 shows the old version which has been found to exert excessive pressure and prevent smooth nozzle retraction.

Figure 5. Old version cover spring clip.

6. If the old spring clip version is installed and the nozzle retracts on its own after relieving the cover pressure, replacing the spring clip may solve the problem. Replace the spring clips for both the left and right sides in this case. Only the improved version spring clip is available.
7. If the nozzle does not retract after relieving the cover pressure and/or the spring version installed is of the improved type and all other inspections, adjustments, and repairs have been performed, continue root cause diagnosis as the solution specified in this TSB will not aid in solving the problem. Do not replace the headlamp washer cylinders as a replacement will not remedy this problem.

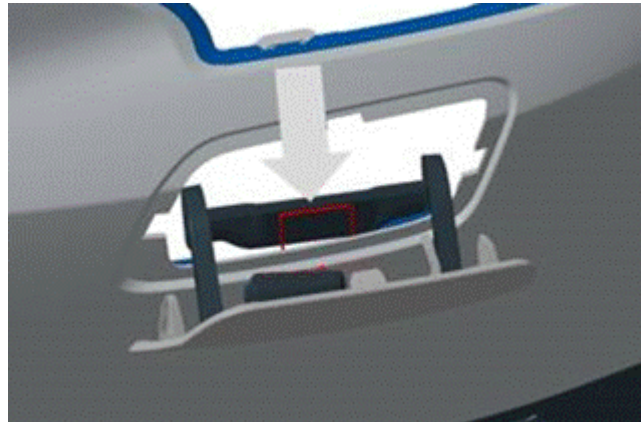
5. Figure 6 shows the improved spring clip with reduced tension.

Figure 6. Improved version cover spring clip.
