Applicable Vehicles

Model(s)	Year	Eng. Code	Trans. Code	VIN Range From	VIN Range To
Atlas Atlas Cross Sport	2024	2.0T (DRKB)	All	All	All

15-24-02TT - Cylinder Head Cover Oil Leak

Release date: 8/22/2024

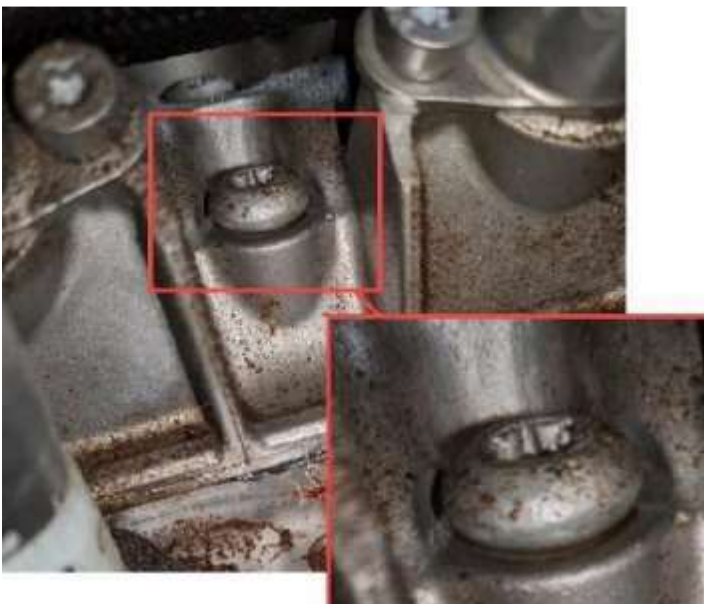
Figure 1.

Burrs on the cylinder head cover fasteners can cause the bolts to become loose, resulting in an oil leak from the cylinder head cover area.

See Figure 1 below for an example.

Visually inspect the cylinder head cover fasteners for any signs of the fastener being loose. If any loose fasteners are found, replace the affected fastener(s) and tighten to 8Nm +90 degrees. Please ensure that replacing the fastener(s) remedies the oil leak.

It is NOT necessary to perform a reseal of the cylinder head cover, or replace the entire cylinder head for this concern, unless the above remedy is not successful.
