**91-24-05 - Car Net® 2.0 - Emergency Call Module and Communication Unit -J949- Green Light Does Not Illuminate**

Release date: 8/20/2024

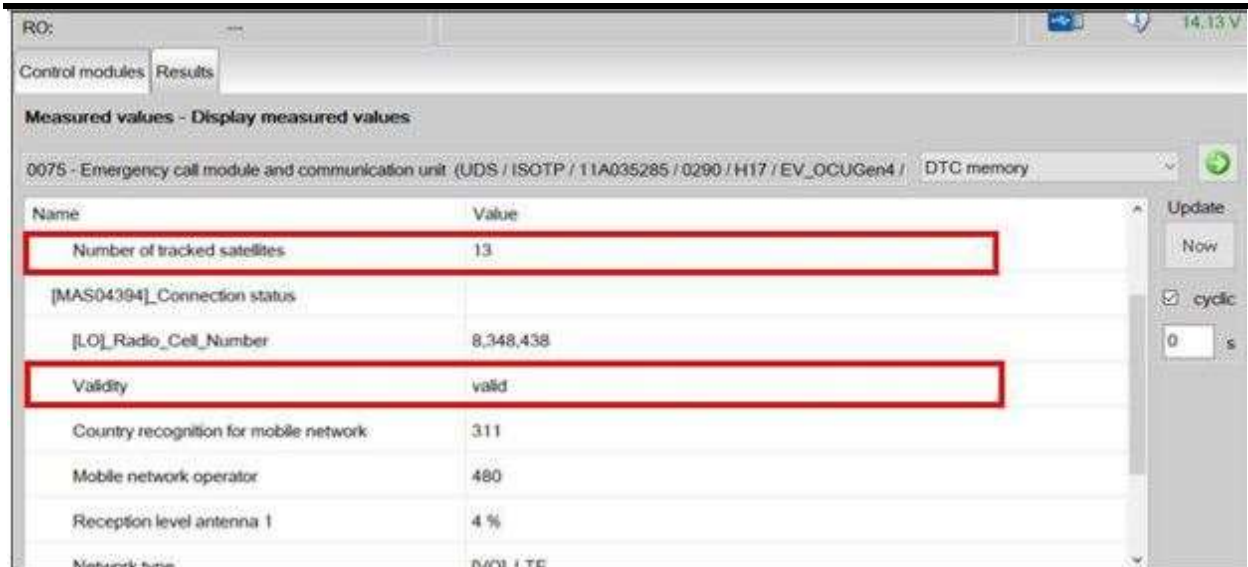
Figure 2.

If there is no change in the condition, check the measured value in Address 0075 via “Read measuring values” and search for “Status GPS Reception” and “Connection status”.

Status GPS Reception should show a minimum value of 3 satellites. Connection status Validity should read “Valid”.

If there is still no change in the condition, proceed to step Part 2.
