TECHNICAL INSTRUCTIONS
FOR
LIMITED-SERVICE CAMPAIGN 24TD04

DATA COMMUNICATION MODULE (DCM) UPDATE

CERTAIN 2020 - 2023 SUPRA

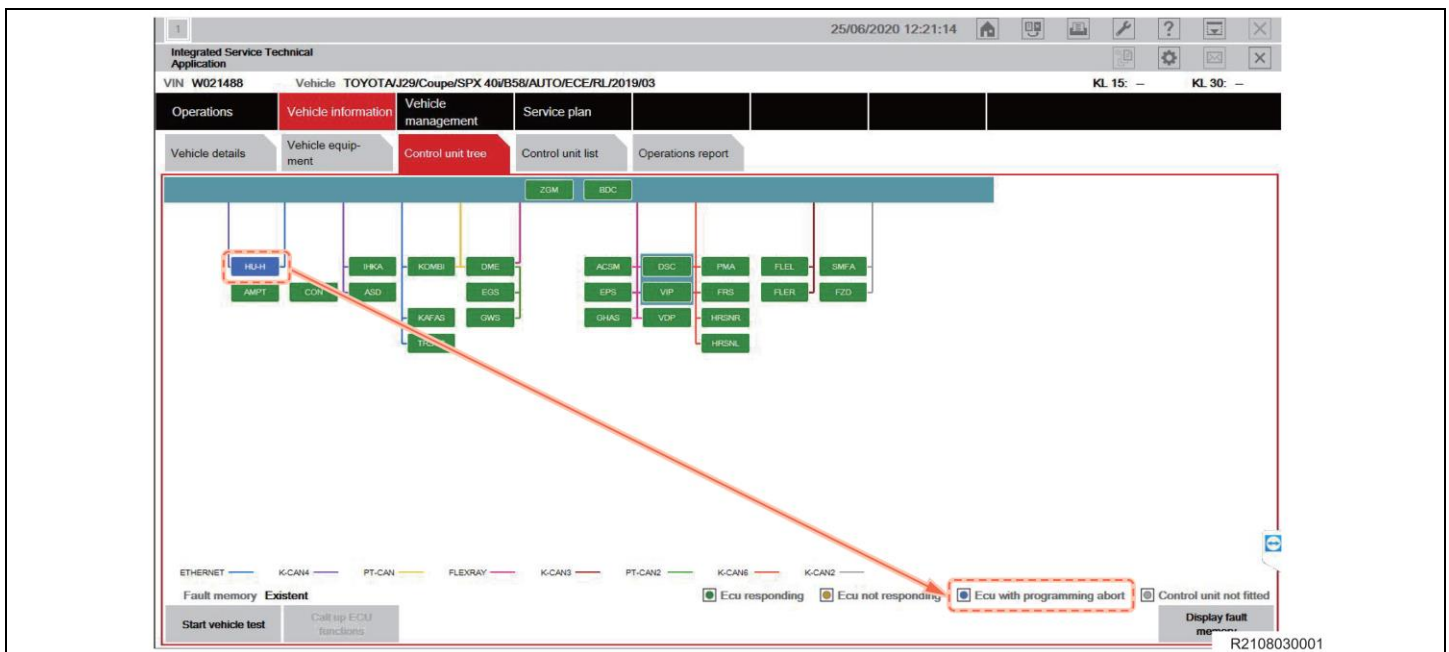
- In this print screen the HU-H is colored in Blue. This corresponds to the state of an ECU with programming abort.
- On the vehicle itself this can be recognized by the fact the screen of the navigation will display a Blue screen.

2. ABL FOR RECOVERING HU-H WITH ABORTED REPROGRAMMING

The new function becomes active only after a failed reprogramming.
(failed reprogramming > go to the indicated location during the same session and launch this function).
If the failed reprogramming session was closed, perform the reprogramming once again to make ISTA recognize the “HU-H reprogramming abort” and then go to the indicated location below.
