**TECH TALK - VOLUME 281
JULY/AUGUST 2024**

TECHNICAL INFORMATION

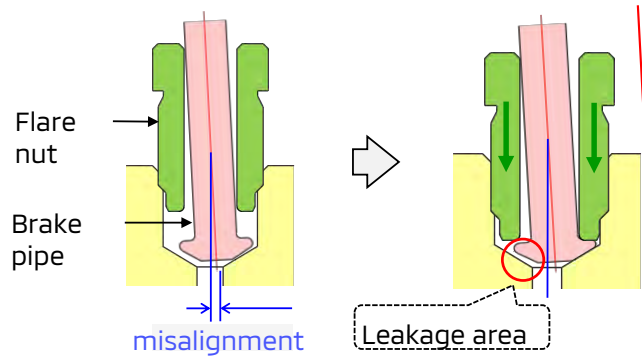
Incorrect Tightening Procedure

If the flare nut is tightened when the brake pipe is misaligned, the tip of the brake pipe may not be sealed properly, resulting in brake fluid leakage. This article introduces the proper tightening procedure for the brake pipe flare nut.

The flare nut tightening with the brake pipe misaligned.

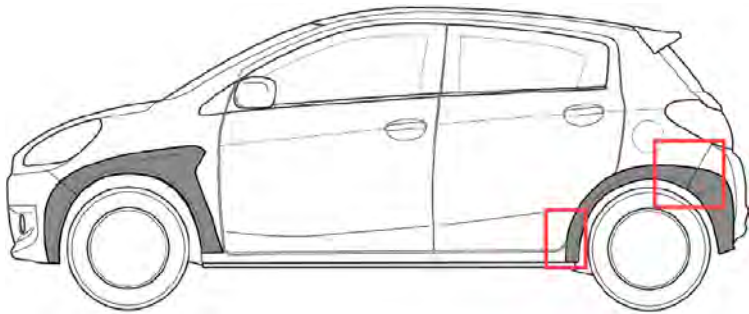
Mirage Fender Effects are separating from the vehicle along the rearward section of the quarter panels. When repairing or installing the fender effects, please take note of the key points below.

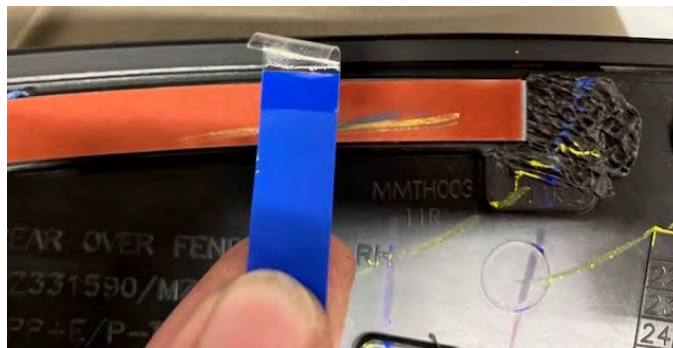
1) This accessory comes with blue "starting" tape to assist in peeling off the tape's red release paper. At times when pulled, this blue section will separate before peeling up part of the red release paper. If an installer does not notice the red release paper did not peel off the tape, that section will not adhere proper to the vehicle.

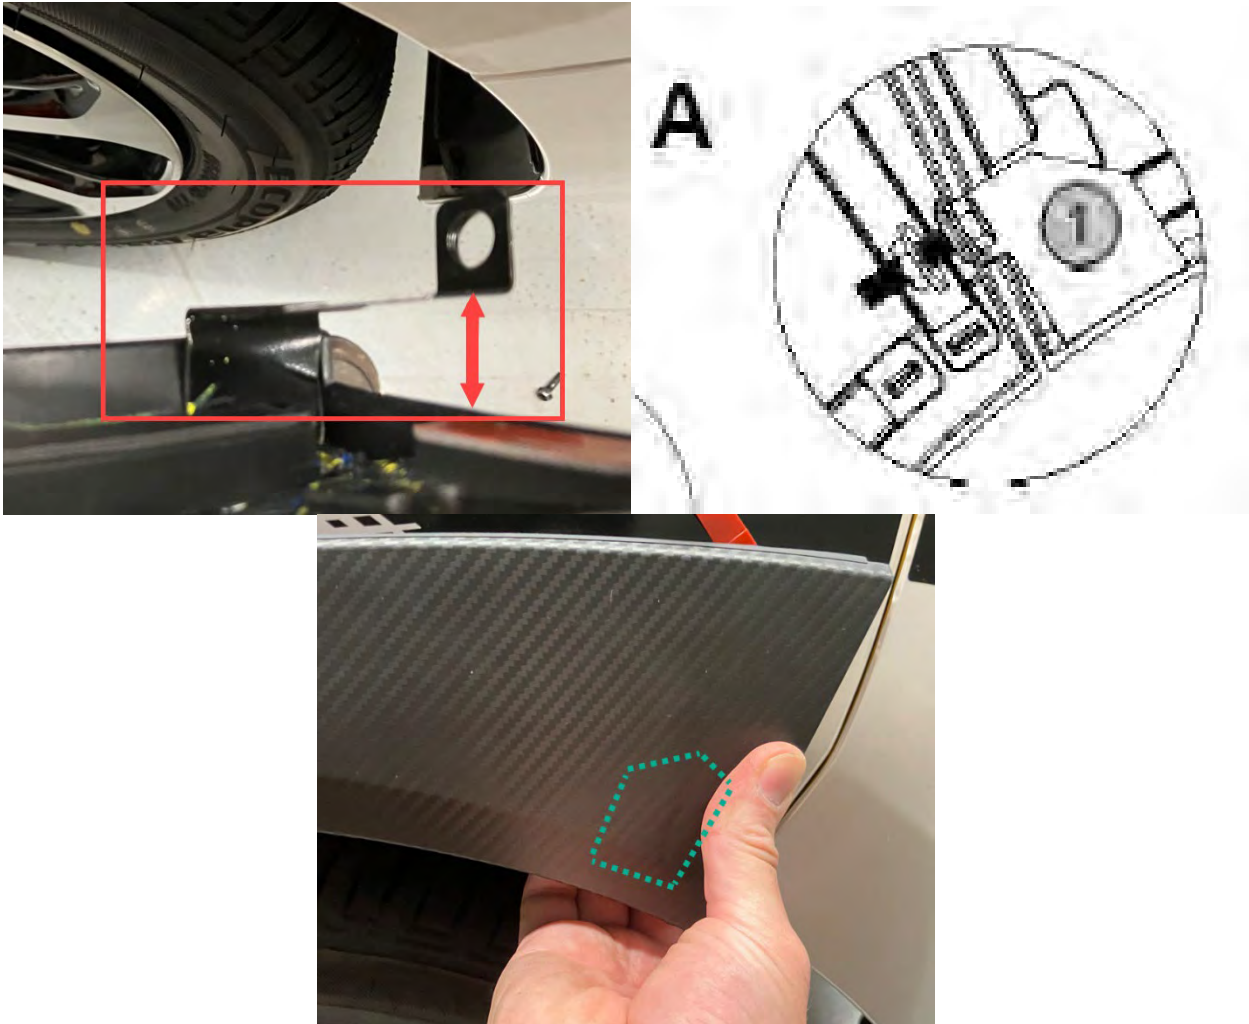
2) When positioning the quarter panel effect into the wheel well, it is possible to flex and deform the bracket. If not corrected, the enlarged gap can cause the quarter panel effect to separate from the vehicle. To realign the bracket, gently squeeze the bracket, quarter panel, and quarter panel effect together before securing bolt.

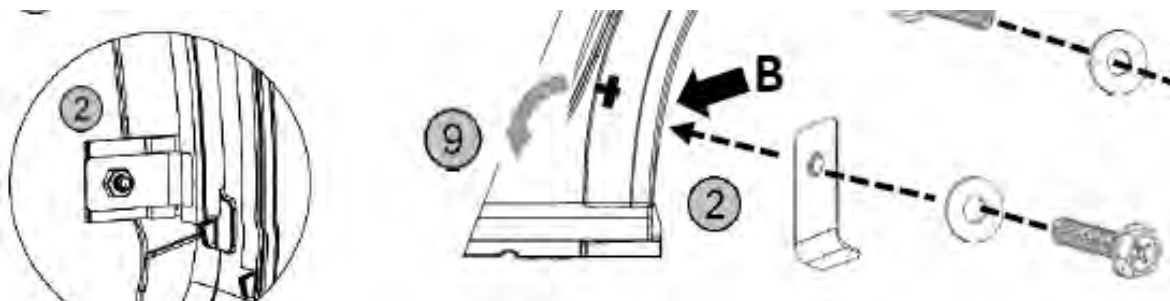
3) When tightening the front bracket on the quarter panel effect, do not over torque the bolt. Over torquing will be deform and misalign the bracket. This deformation pulls the quarter panel effect and separates it from the vehicle. Ensure the bracket is properly aligned and torqued to the 3 Nm, per the IM.

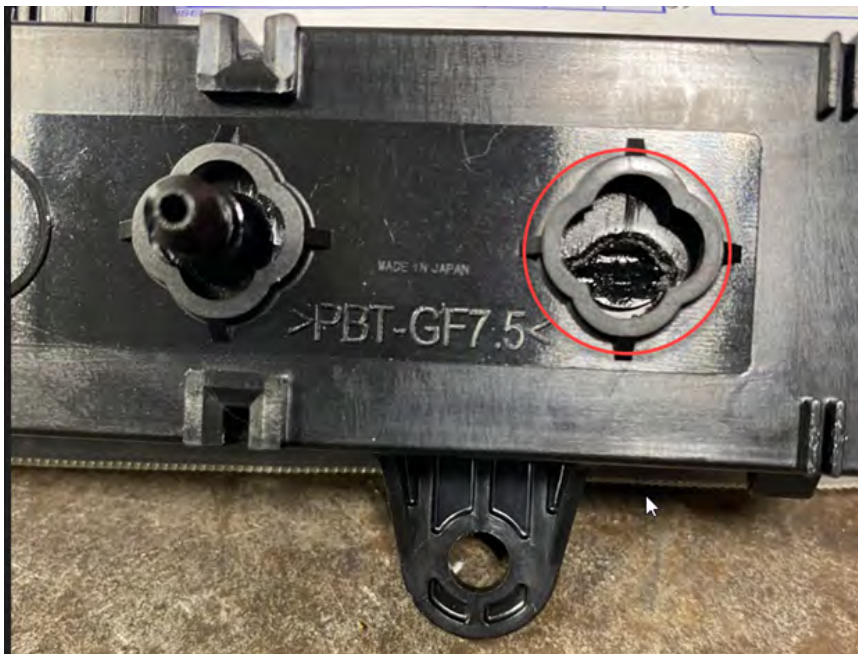
Vehicle is determined to have a discharged 12V accessory battery. After either charging or replacing the 12V battery, the battery quickly discharges and the technician identifies an abnormal draw on the battery.

The technician should disconnect the front passenger seat model and recheck. If the draw diminishes, then inspect the passenger seat switch (refer to image below).

The passenger seat switch may get stuck causing a draw to the 12V system. The solution recommended is to replace PN-6922A242 which should resolve the draw on the battery.

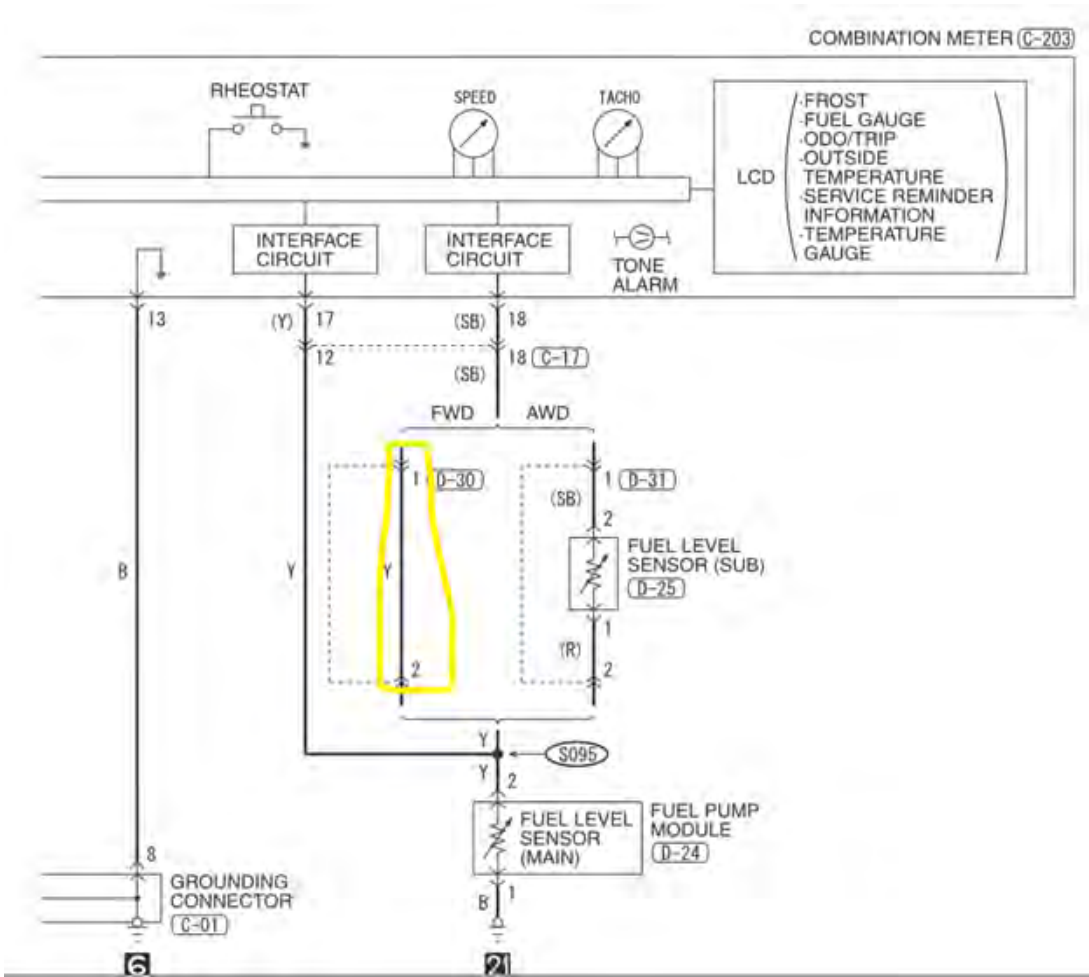
The Outlander Sport has two separate circuits for the Fuel Level Sensors. If one has been compromised by rodent damage, the gauge will not operate properly.

The FWD model has a jumper in place of the sender that is used on the AWD models (see diagram below). Rodents may get to the connector, chew the wires, causing the gauge failure.

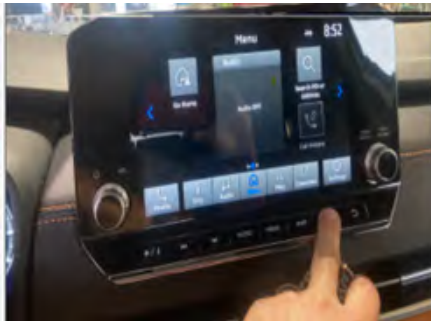
Customers may complain that the Multi Around View camera on 2022-2024 Outlander is inoperable. The technician should:

- Duplicate the concern
- If duplicated, press the camera button on the IVI until to check all cameras
- Once concern is verified and all DTC scan has been performed, the technician may find no related DTCs and may also find "**Non-equipped System or Communication error**" when viewing printed all DTC list (shown below).
- A "**NC**" may also be seen when viewing the system list
- After duplication and DTC scan, technician should proceed to the service manual and follow the Symptom Diagnosis found on **page 321** of the **AUDIO, VISUAL & NAVIGATION SYSTEM** in the applicable Service and Owners Publications.
- The technician can also reference **page 319** for the Multi Around Monitor Control Unit **POWER SUPPLY AND GROUND CIRCUIT**.
