SS 3146 - FTL M2, 108SD, 114SD - Unable to Program Replacement Bulkhead Module - Certain Model Years

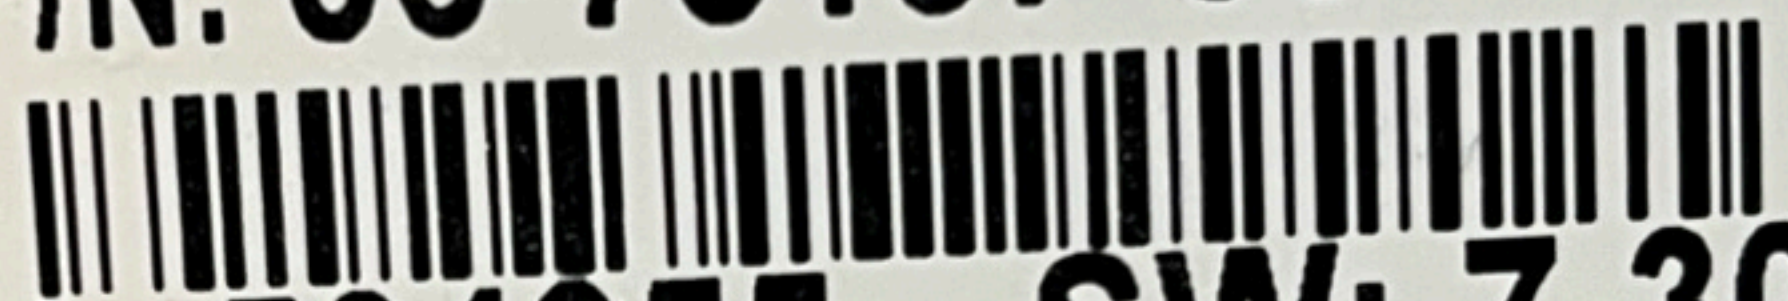
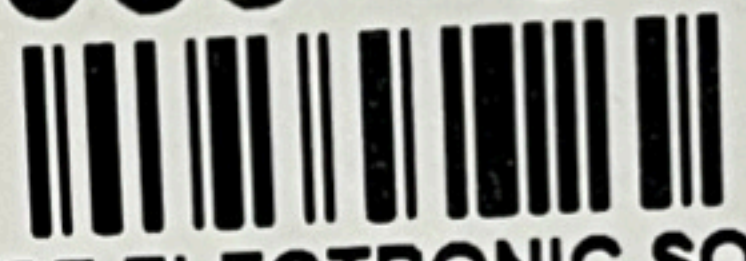
The software version may be visible on the part number label of the BHM installed in the vehicle (see picture for an example).

S/N: 504055 SW: 7.30

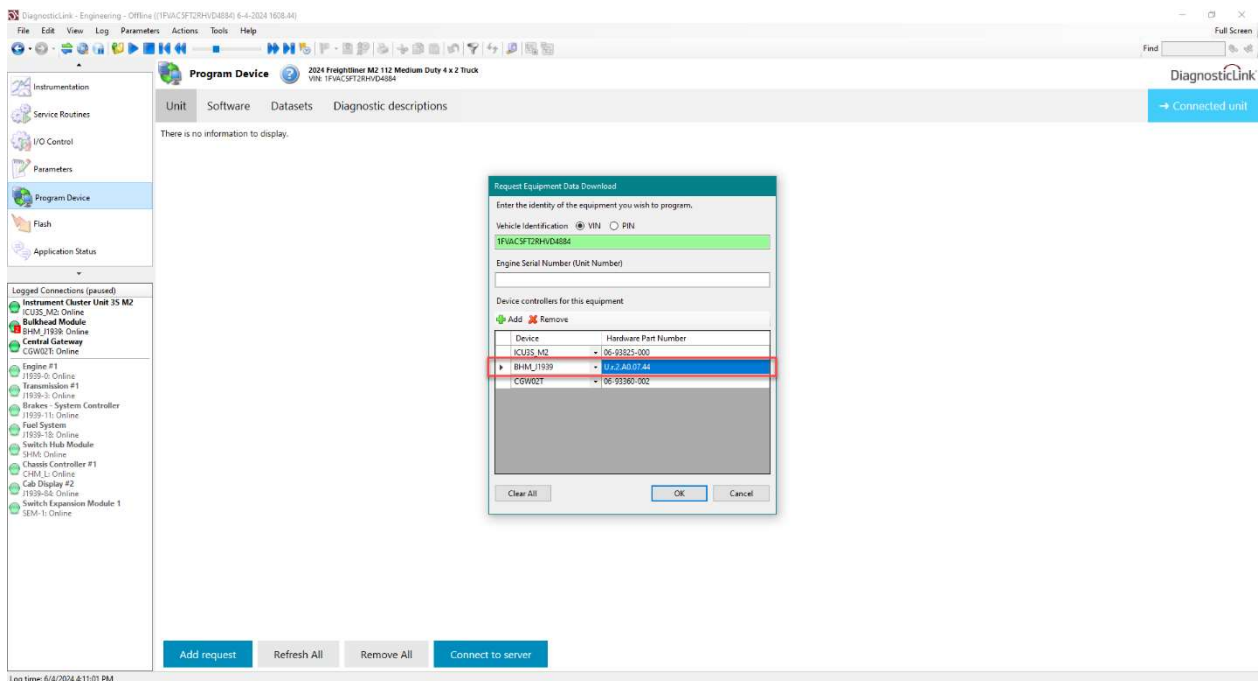
- 1- The first screen shot is showing the add request screen when connected to the vehicle, this will auto populate the ecu list below for current connected hardware and software combinations. The tech would click on the BHM after confirming the hardware software combination is what they want to request from the server. Then when ok is selected, connect to server, this will trigger the migration and provide the newest file. Don't pay attention to the actual numbers in the screen shot it is just a reference, for the legacy migration it should be to the U.r.2.A0.07.30 as in screen shot 2.

- 2- The same migration can be requested offline as well, the tech would put the VIN in, then click the drop down for device. Select BHM_1939, then in the hardware part number type in the new number for the hardware change requested, U.r.2.A0.07.30 in this case. Click ok and connect to server, this will trigger the migration with the hardware change.

If they just download by VIN, they will receive the current files available, legacy, which do not match the current hardware hence the same error will be displayed, hardware required 'X'.
