35–039 Detroit New Final Drive Standard Performance Forward Carrier Change to Top Performance Passive Lube Management

TSB-35-039-FTL

Creation Date:2023-01-26

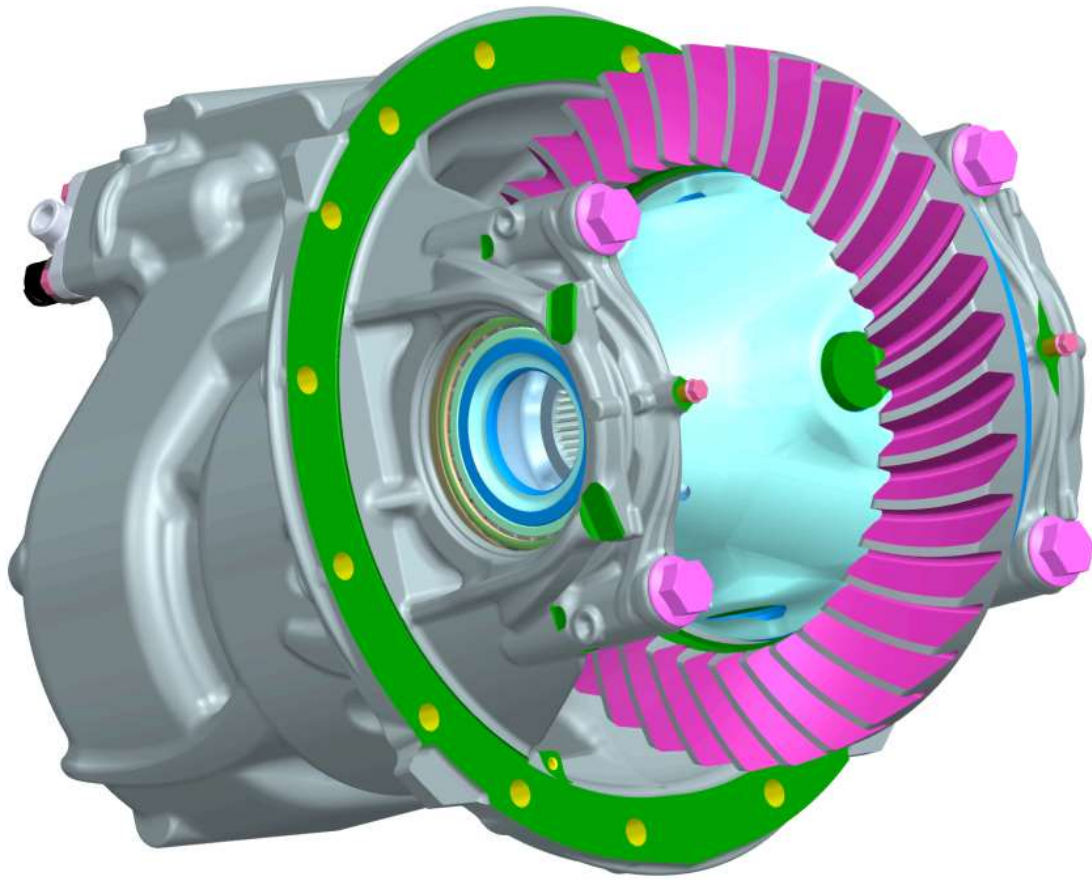
Fig. 1, Original Standard Performance Carrier without a Lube Management System

Detroit New Final Drive Standard Performance Axles will have a change to the lube management system. Initially launched without a lubrication management system, the forward rear axle will change to a passive management system. This will be the same passive lube management system as the New Final Drive Top Performance Axle with passive lube management.

The parts will supersede in Excelerator. This change is happening to the forward-rear carrier only. See Fig. [1](#), Fig. [2](#) and Fig. [3](#).

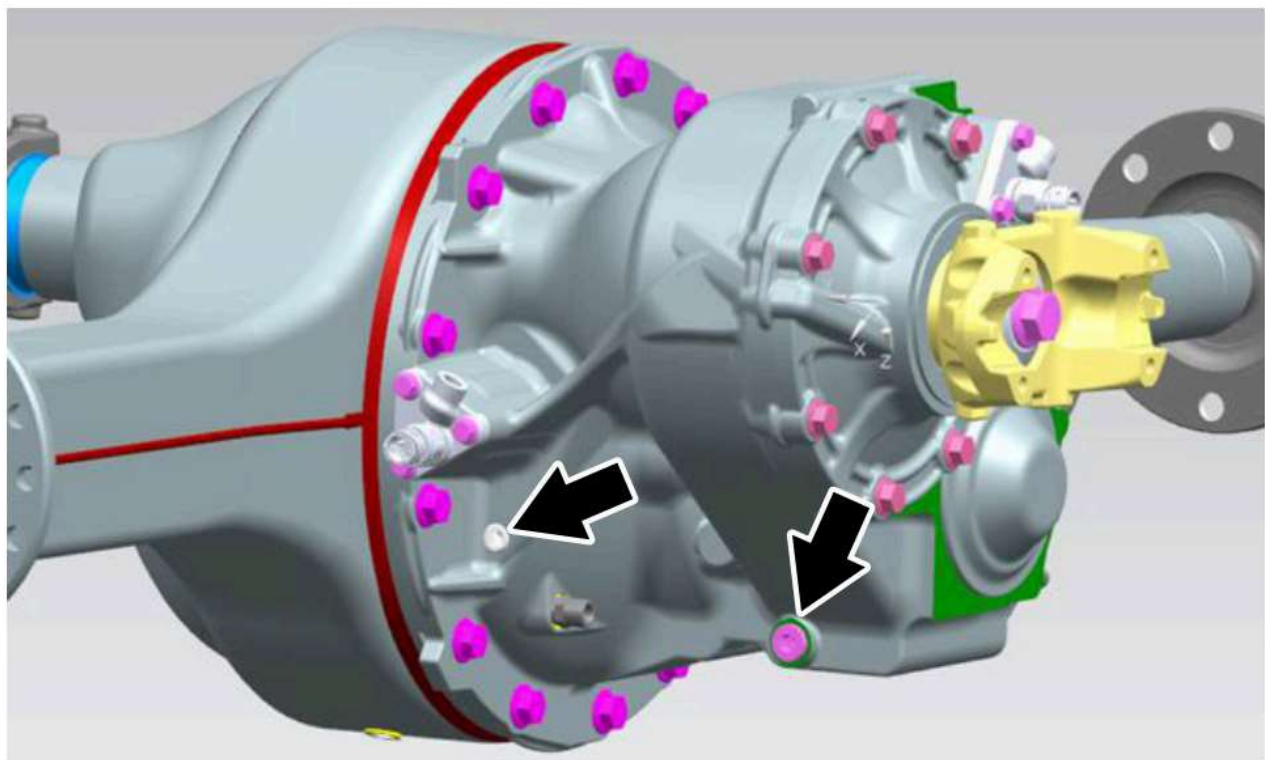
Fig. 4, New Fill Locations for New Final Drive with Passive Lube Management System

Oil fill locations will change to match the New Final Drive Top Performance locations. See Fig. [4](#). The type of approved oil is DFS93K219.01 only. The rear fill plug part number on the axle housing will change to a new part number (MBA 6809900117), and it will be installed from the inside, similar to the Top Performance carrier. See Fig. [5](#).
