Problem Details:

- Trucks equipped with Cab Load Disconnect Switch (CLDS)
- In extreme cold temperatures – below -20 degrees C
- If the CLDS is turned off overnight, the BCA contactor *may not* switch on when the CLDS switch is turned on in the morning

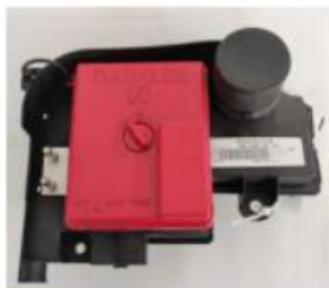
Problem: Vehicles with BCAs and a CLDS (cab load disconnect switch), are vulnerable to an issue when the vehicle is parked in very low temperatures (<-20C) with the switch left in the OFF position. When the BCA cools sufficiently, it will be unable to actuate back to a energized state when the CLDS is switched to the ON position. This leaves the truck totally unresponsive and unable to power on.

Affected models: P4,47X,49X,57X

- P66109: change resistor on circuit board, roll BCA part numbers
