Problem Details:

- Vehicles built with **Sales Code 3ZS-015- LYTX SF500 DRIVECAM SYSTEM, FACTORY/CTS INSTALLED**, in some cases, cables/wires do not get correctly secured resulting in wear/damage on the connector, looped and or twisted wires, that can result in pinched or damaged wiring.

Affected Models / Truck options:

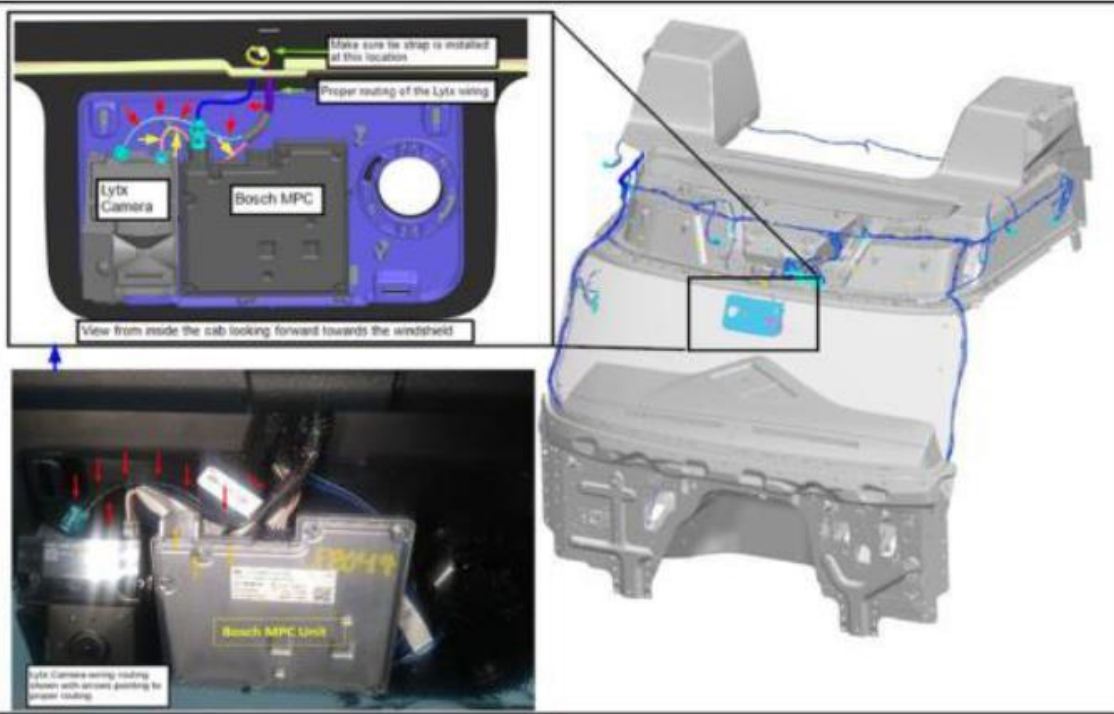
- P4 and Western Star X Series with Sales Code 3ZS-015 built from November 2022 through January 2024.

- Original cable routing was not consistent, with opportunities to be routed inconsistently.

- Service Freightliner and Western start Service Solutions **published 7/25/2024**.
 - **SS 3152-FTL New Cascadia Lytx SF500 intermittent video feed issues**
 - **SS 766-WST Western Star X-series Lytx SF500 intermittent video feed issues**
- **Lytx will communicate to customers, affected by intermittent loss of video feed, via a letter referencing the service solution.**

- Installation print **D66-31311-000** will be updated with the same information supplied in the Service Solutions with the release of **Revision C**.
