## Summary Overview of Work to be Performed

- **EV PDI** – Follow attached **WAR305 Pre-Delivery Inspection (PDI) Form: Freightliner – Electric Vehicles**
- Be sure to close out any open safety recalls. In addition, DTNA recommends performing the following work, to close out open service campaigns and service bulletins Complete all Open Campaigns and Recalls.
  - \*\*\*SF694 Ground Strap Modification <<<< Once it is published
  - \*\*\*SF708 Cooling system replace <<<< Once it is published
- Make sure TSB's and axle oil level have been addressed
  - TSB 20-089 Adjusting the Coolant Pipe Position
  - TSB 35-040 Fixing eAxle Oil Seepage at the Shift to Neutral Tool - Plug Location
- Perform other checks as noted in this document and repair as necessary.
  - Report back to Travis Ingram any other issues found while doing these tasks.

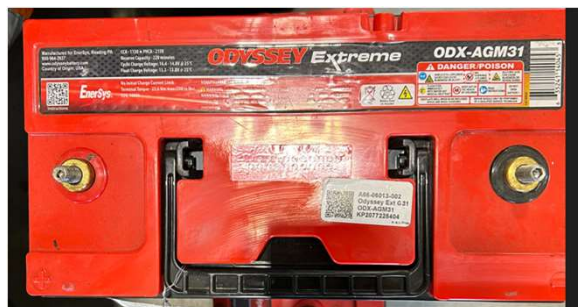
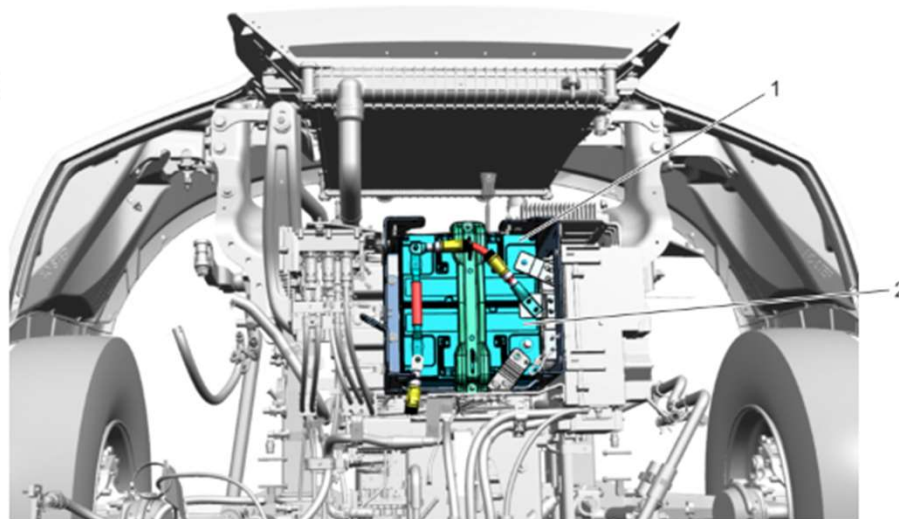
Fig. 1, Location of the Low Voltage Batteries

- Mod 4NJ, Section of 13.7 of the eCascadia Workshop: Inspect the Low Voltage (LV) Battery. If not factory battery, replace with DTNA spec'd battery and make sure hold downs are in place.
  - Spec'd Battery is **A66-06013-002** >>> Replaced by **ODX AGM31** which shows PDC inventory
- Mod 290: Make sure Battery Hold down bolts are still installed.

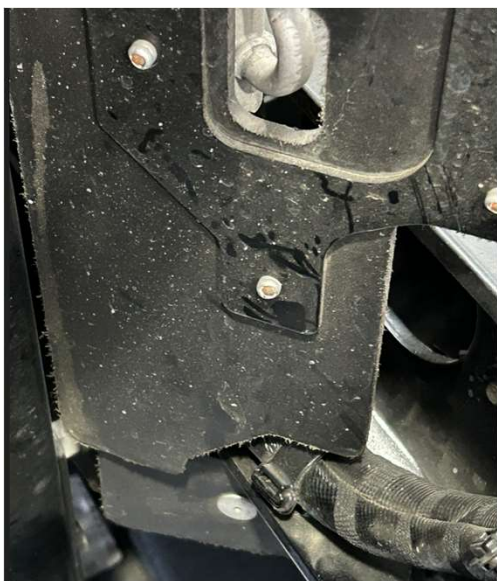
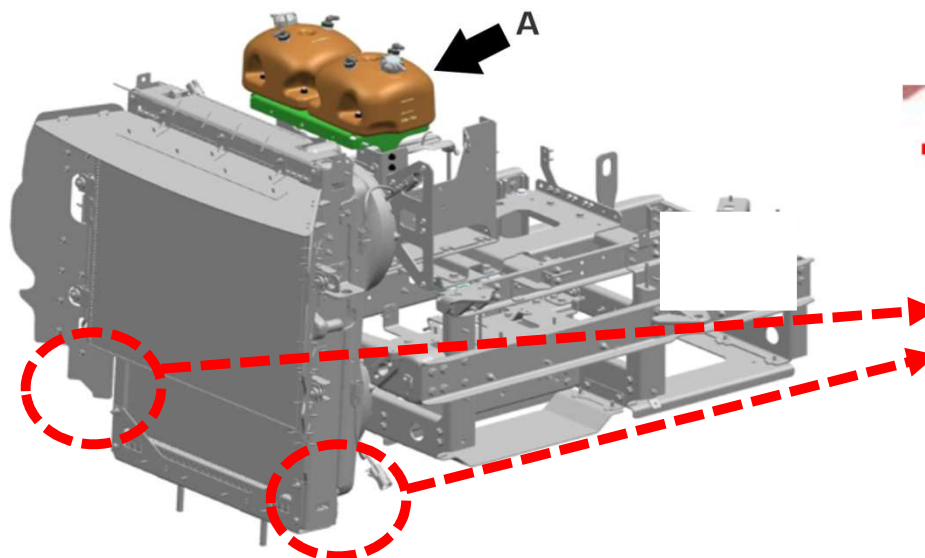
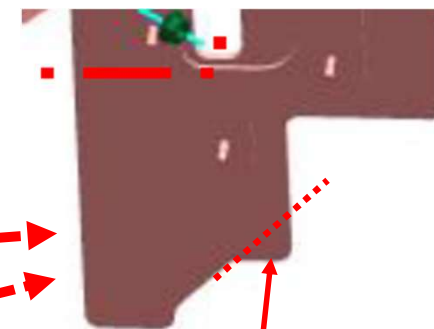
- Mod 278: Trim LH and RH Baffle on bottom of Fan Shroud to prevent it from rubbing on harness that routes around lower radiator

Continue existing  
angled cut to edge  
and remove corner

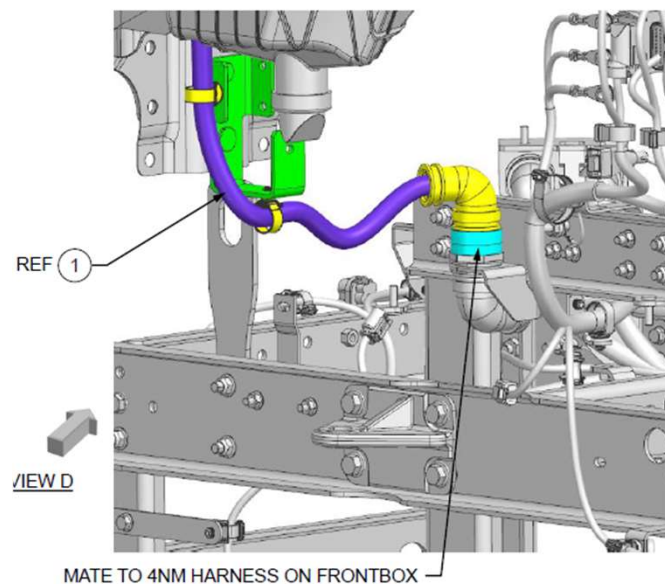
- Mod 321: Passenger side Firewall: Make sure there is a drip loop in harness going from firewall to Deutsch Connector

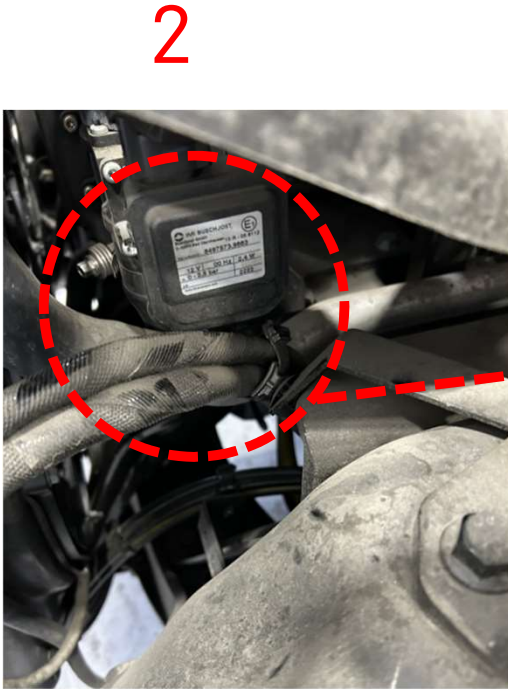
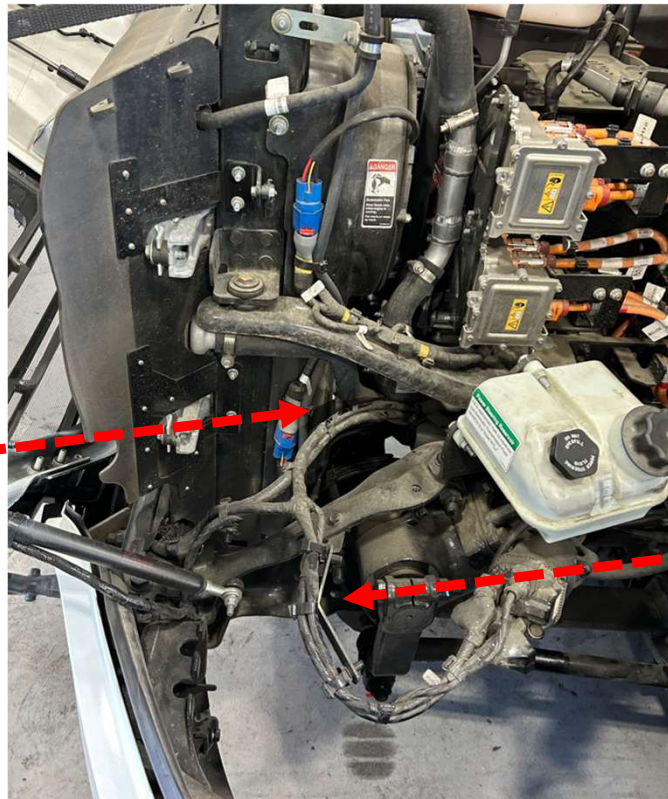
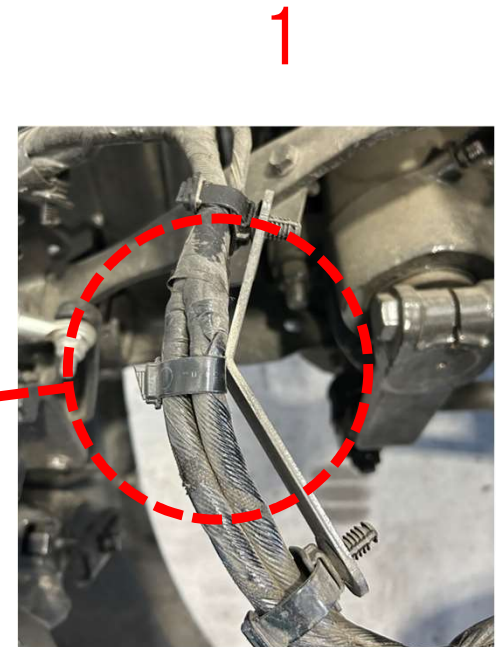
- Mod 475/288: 1) Add some slack to make sure power steering harness cannot rub on bracket by steering gear  
2) Make sure harness is not rubbing on 3/2 coolant valve

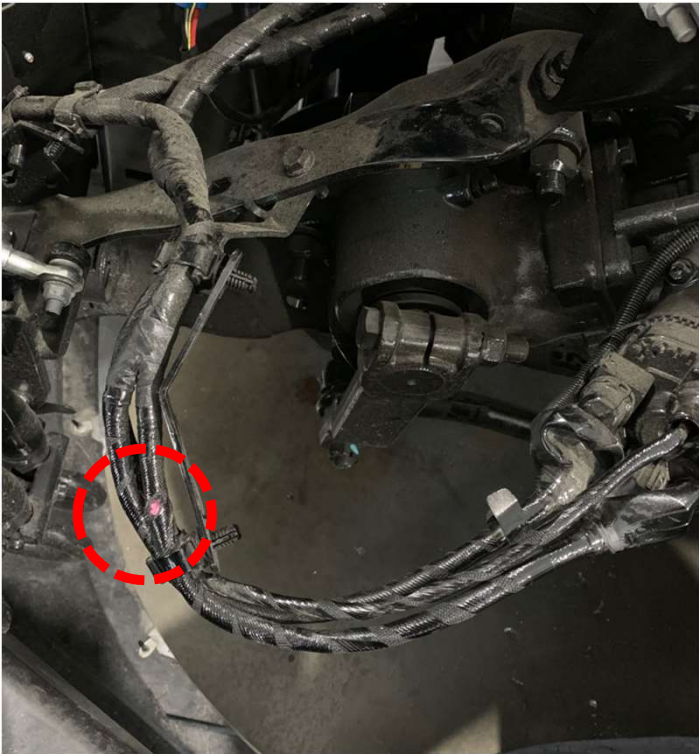
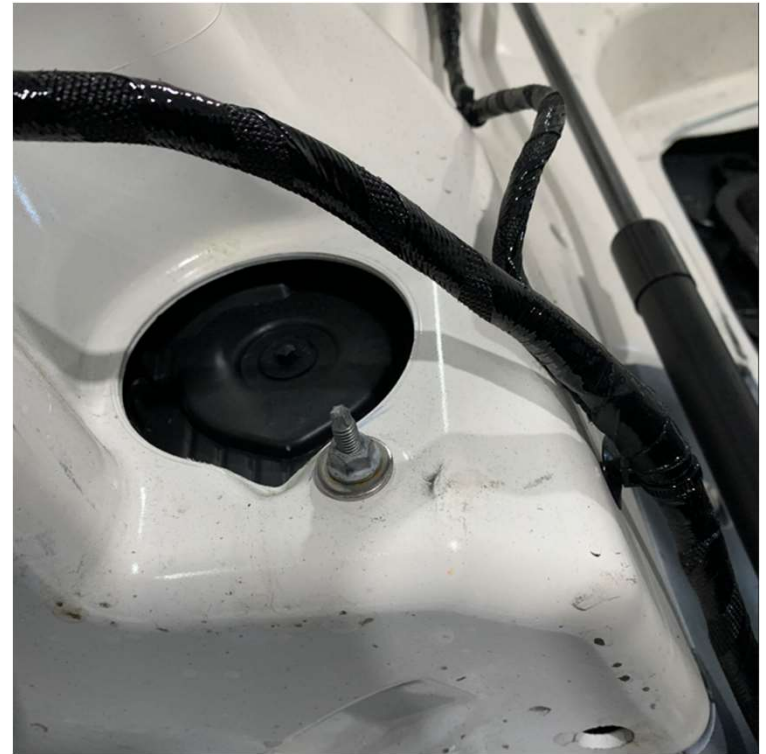
- Mod 475: Check for headlamp bolts rubbing on harness when hood is closed. Bracket can be bent so bolt doesn't hit harness or bracket.

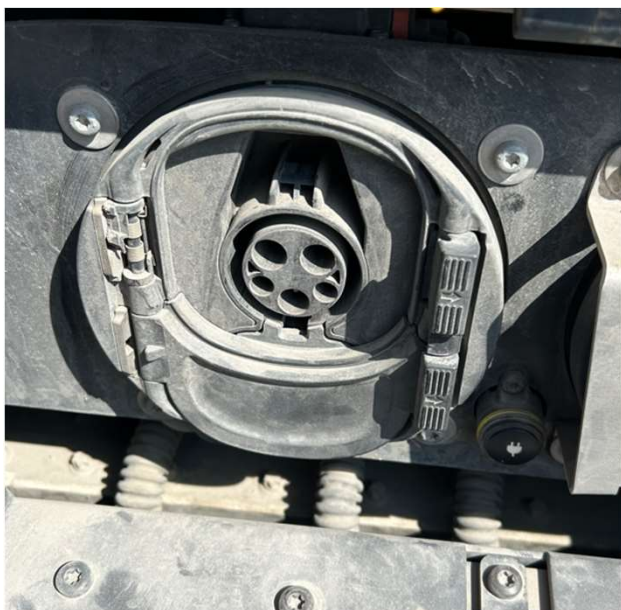
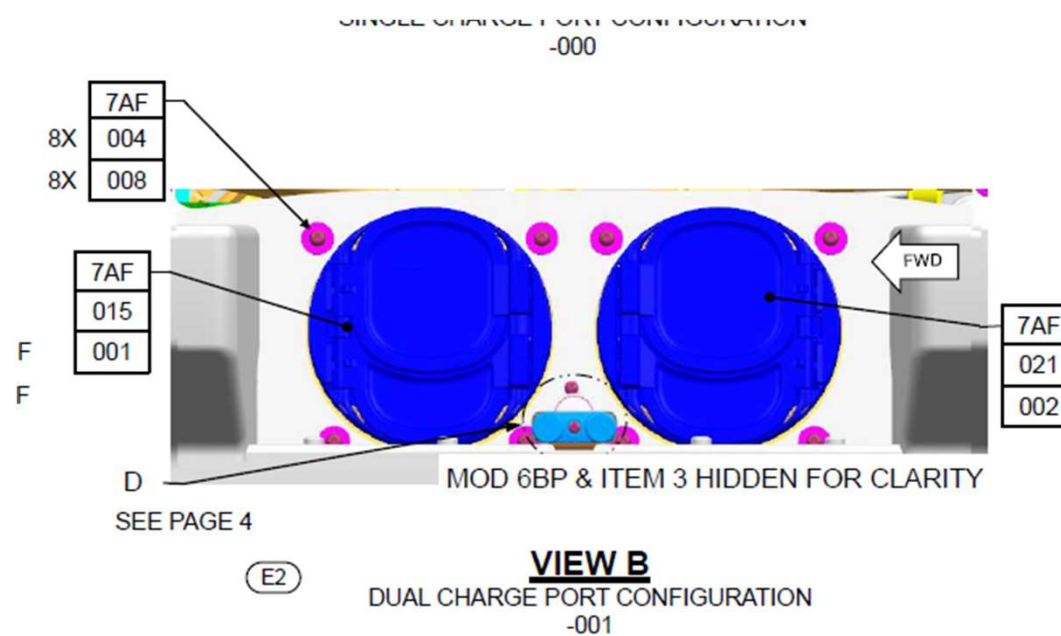
- Mod 7AF - Make sure charge port cover is not broken and lock function correctly

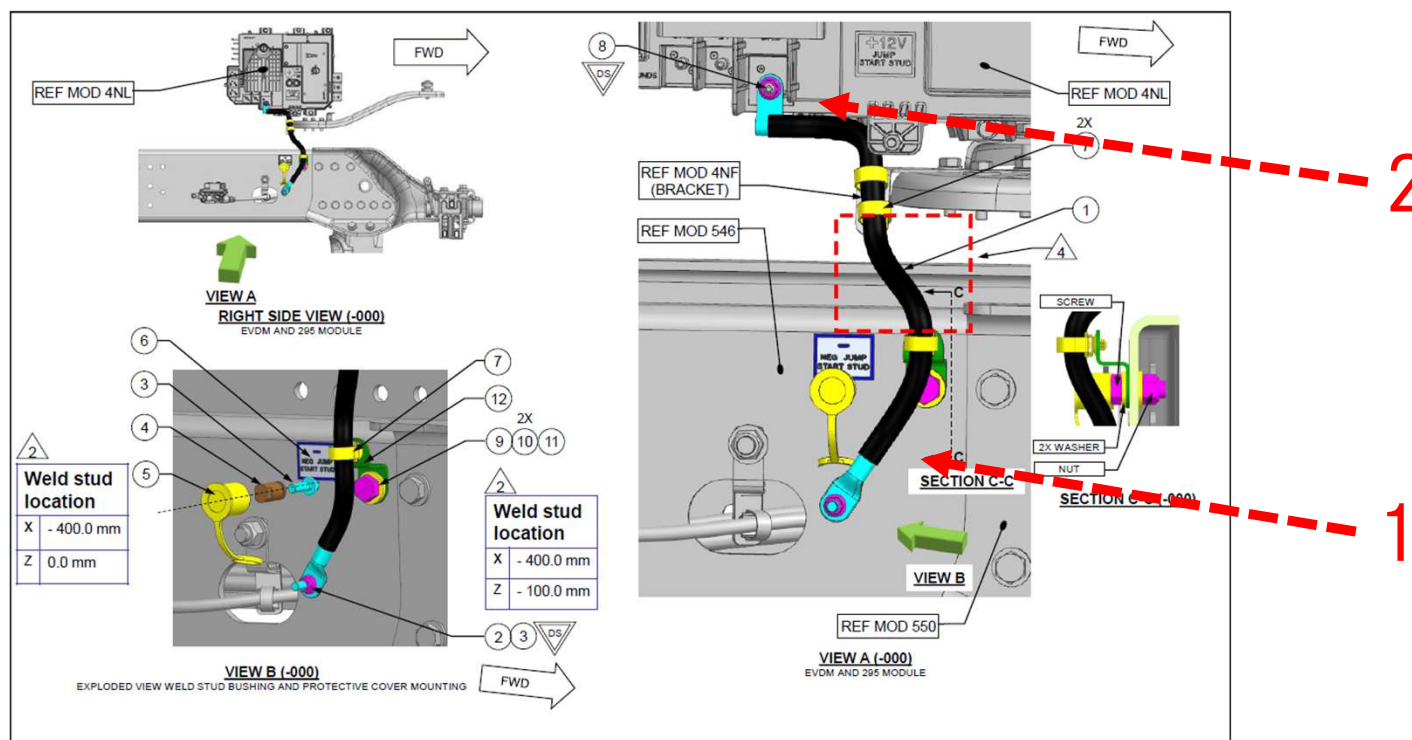
- Mod 295 –
  - 1) Relocate Frame Ground lower on rail (this will be SF694 Campaign when published)
  - 2) Make sure nut it tight at EVDM end.

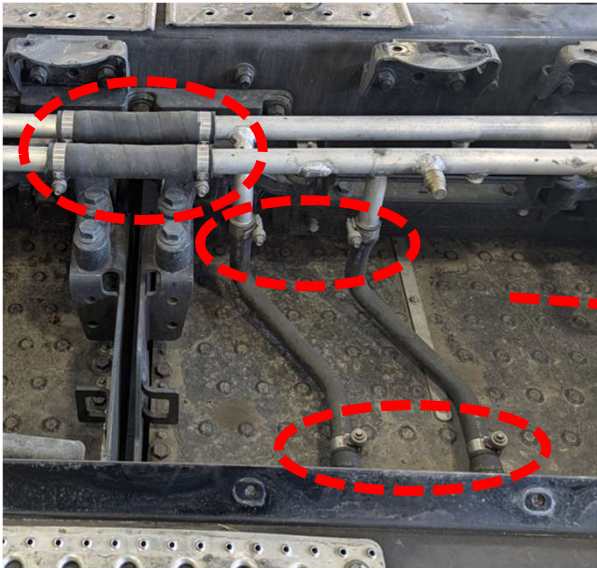
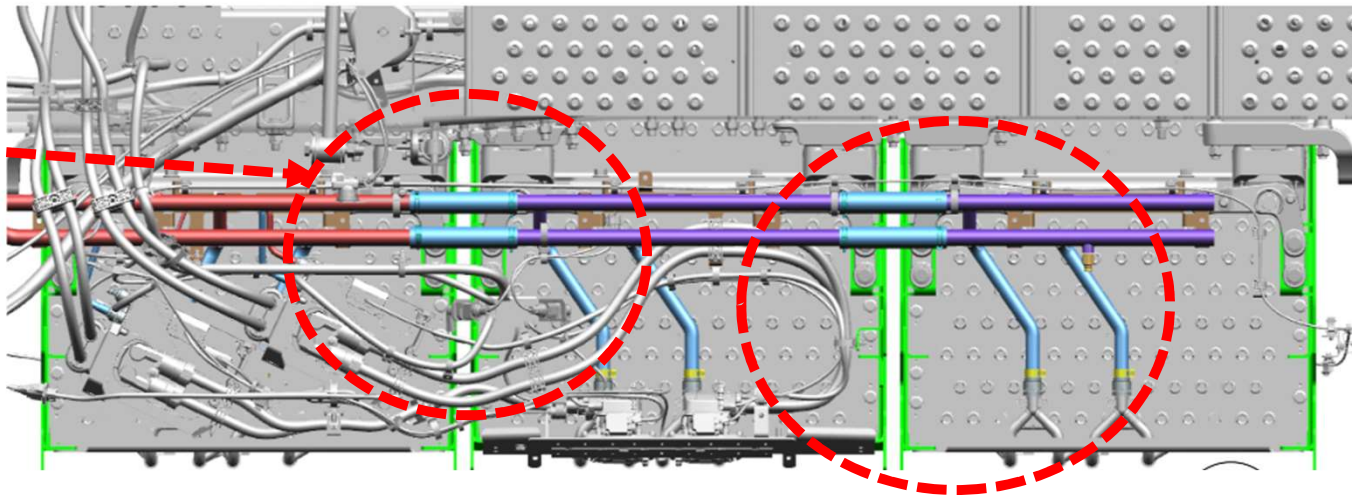
- Mod 4BE – Check Coolant clamps for HV battery plumbing for leaks.
- Also check push to connect fittings where coolant lines attach to the batteries to make sure they are secure.

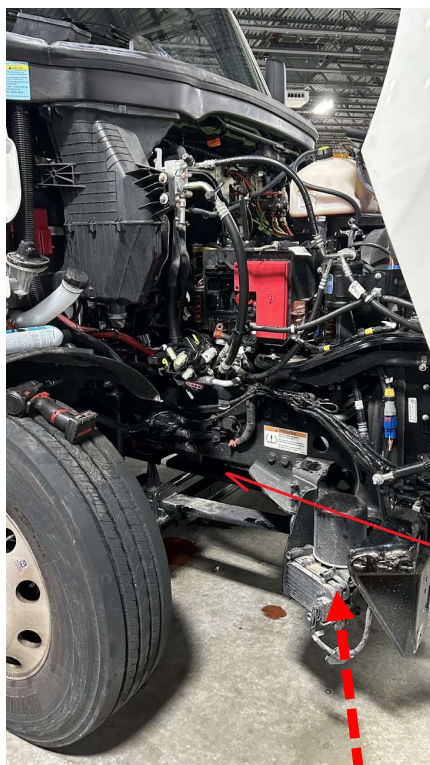
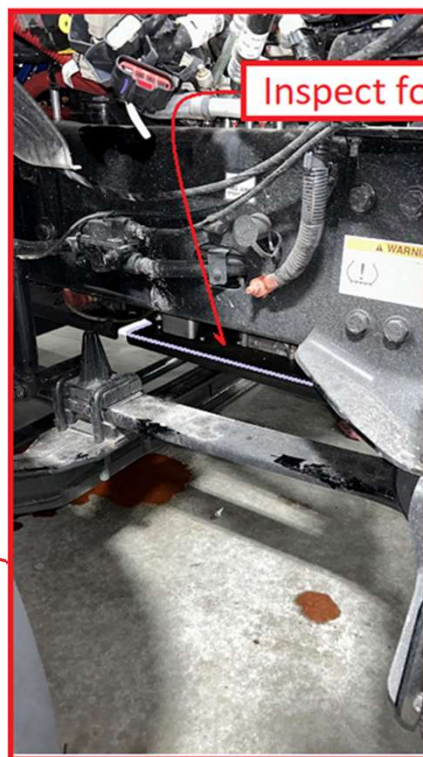
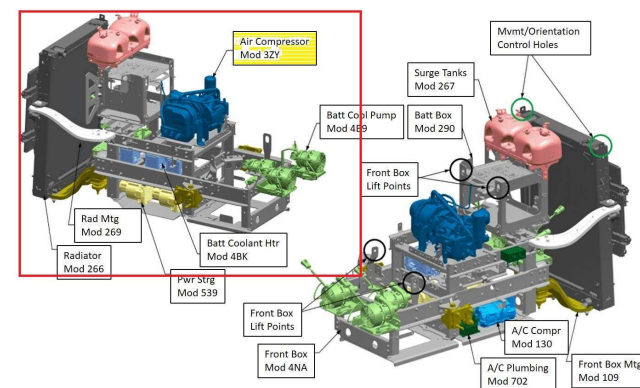
- Mod 3ZY (Compressor) & Mod 38S (EAPU) – Check for signs of oil under EDAC. Check air filter on EAPU if oil seen.

- Change Desiccant Cartridge in EAPU.
  - Reference eCascadia Maintenance Manual **section 11.5.**
- Check Air Filter on Air Compressor and change if needed.
  - Reference eCascadia Maintenance Manual **section 4.3.**
