| <b>HYUNDAI</b><br><b>Technical Service Bulletin</b> | GROUP<br><b>CAMPAIGN</b> | NUMBER<br><b>24-01-073H</b> |
| | DATE<br><b>SEPTEMBER 2024</b> | MODEL(S)<br><b>SONATA (YFA)</b> |
| <b>SUBJECT:</b> REAR COMBINATION LAMP INSPECTION & REPLACEMENT<br>(WARRANTY EXTENSION TXXT) | | |

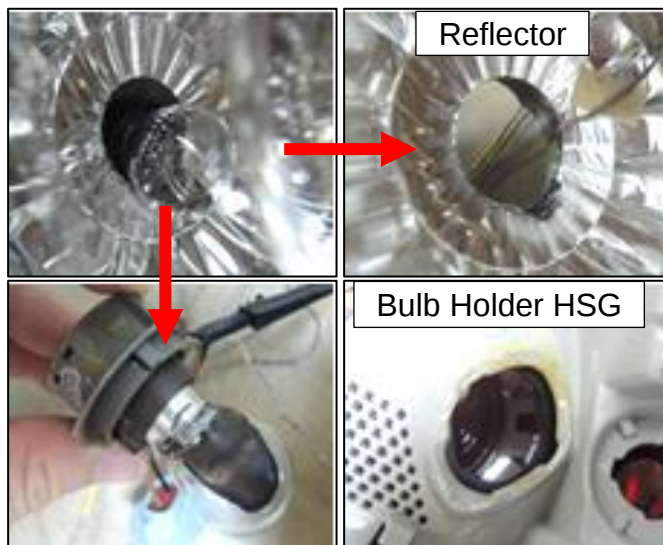
3. Remove the stop lamp socket from the LH and RH housing and inspect for any signs of heat deformation.

Heat deformation around the bulb housing opening may vary. The discoloration of the bulb socket alone does not necessarily indicate this condition.

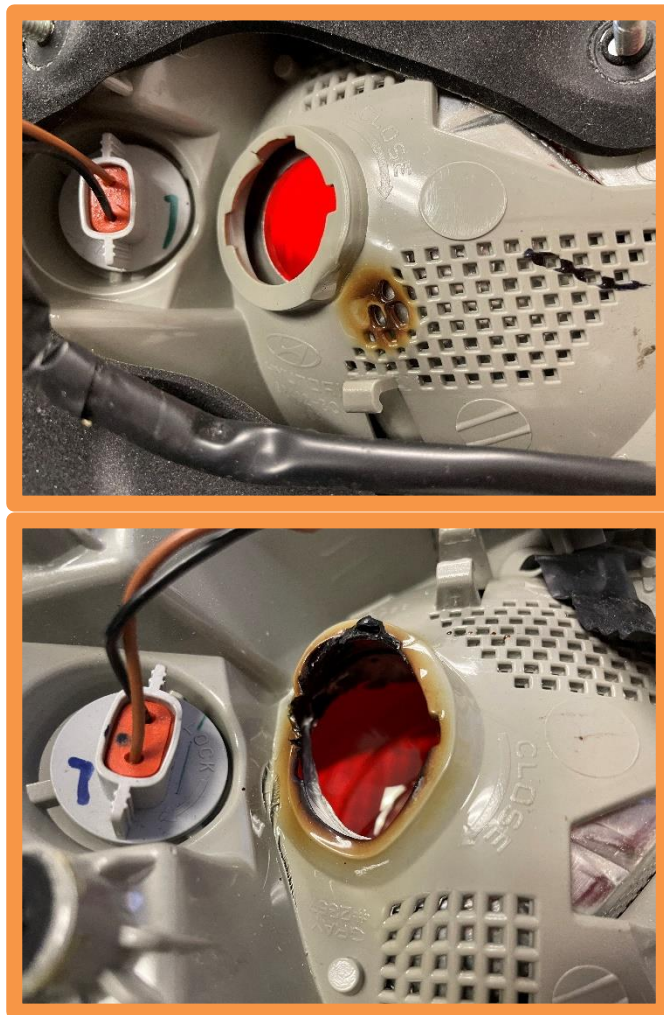
Examples of heat deformation shown in photos on the right.

6. **If heat deformation is present on either lamp**, replace **both** the LH and RH combination lamps.
