Technical Service Bulletin

GROUP	NUMBER
CAMPAIGN	24-01-061G-1
DATE	MODEL(S)
SEPTEMBER 2024	G70 (IK)

SUBJECT: REAR COMBINATION LAMP GARNISH GAP INSPECTION AND REPLACEMENT (SERVICE CAMPAIGN T48G)

This TSB supersedes TSB # 24-01-061G to include 2 part numbers for Verbier White on page 2 (see yellow highlights).

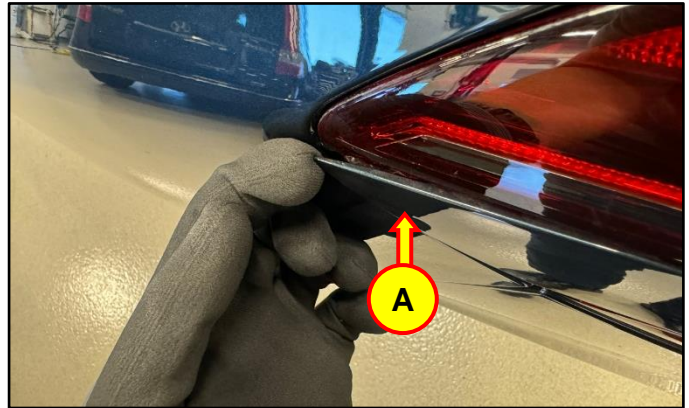
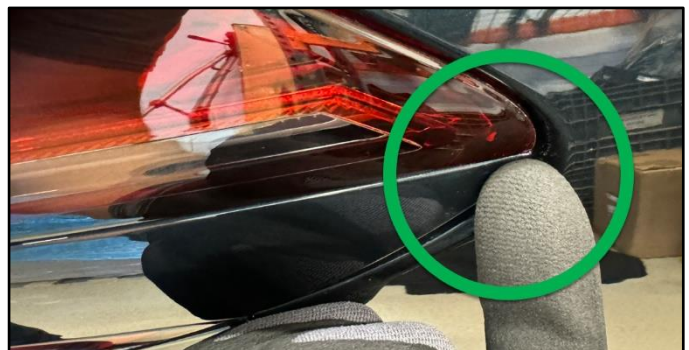
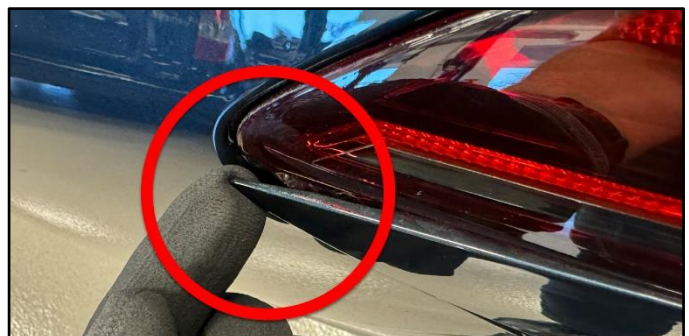
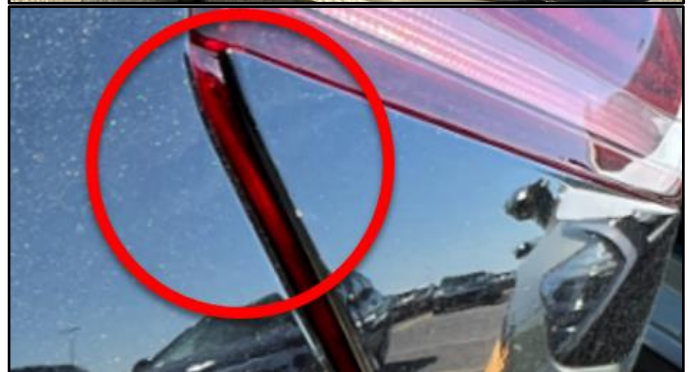
1. On the rear combination lamp garnishes (A), lift up the end closest to the front of the vehicle and check if the garnish lifts off the tail lamp or is already visibly detached from the tail lamp.

GOOD: If both garnishes do not lift when pulled and/or are not visibly detached from the tail lamp, the garnishes do not need to be replaced.

NOT GOOD: If one or both of the garnishes lift off the tail lamp when pulling with fingernail/fingertip and/or are visibly detached from the tail lamp, both of the garnishes need to be replaced.

Proceed to the **Rear Combination Lamp Garnish Replacement** section.
