Technical product information

Topic	Creaking/squeak noise from the front suspension (upper inner lever bushes)
Market area	Australia E04 Bentley rest Asia and Australia (6E04),China 723 Volkswagen (Anhui) Automotive CO (6723),China 796 VW Import Comp. Ltd (Vico), Beijing (6796),Germany E02 Bentley rest Europe (6E02),Japan E03 Bentley Japan (6E03),Korea, (South) E08 Bentley South Korea (6E08),United Arab Emirates E06 Bentley Middle East and Africa (6E06),United Kingdom E01 Bentley UK (6E01),United States E05 Bentley USA and rest America (6E05)
Brand	Bentley
Transaction No.	2064779/4
Level	EH
Status	Approval
Release date

Bentayga series

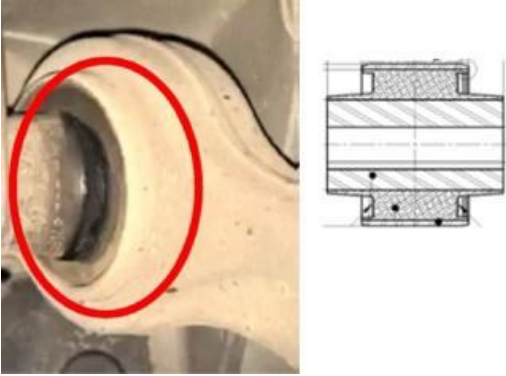
Figure 1

Defective upper inner lever bush (Figure 1)

The noise present in the sound file is caused by defective upper inner lever bush/bushes, the noise can appear in the following possible scenario

- When the vehicle is moved with steering input over uneven surfaces (for e.g. a ramp or speed bump)

1) Replace the left hand front (x2) and right hand front (x2) upper inner lever bushes - Refer to Repair manual Rep.Gr.40 front suspension, upper lever bush/bushes - to remove and fit
