## Field campaign

<b>Topic</b>	Software update to 0042 / 07D2 (Driver door control module) and 0052 / 07D3 (Passenger door control module) - SC24/16
<b>Market area</b>	Australia E04 Bentley rest Asia and Australia (6E04),China 796 VW Import Comp. Ltd (Vico), Beijing (6796),Germany E02 Bentley rest Europe (6E02),Japan E03 Bentley Japan (6E03),United Arab Emirates E06 Bentley Middle East and Africa (6E06),United Kingdom E01 Bentley UK (6E01),United States E05 Bentley USA and rest America (6E05)
<b>Brand</b>	Bentley
<b>Transaction No.</b>	2074063/2
<b>Campaign number</b>	ED09
<b>Note</b>	
<b>Type</b>	
<b>US code</b>

### Bentayga Extended Wheel Base

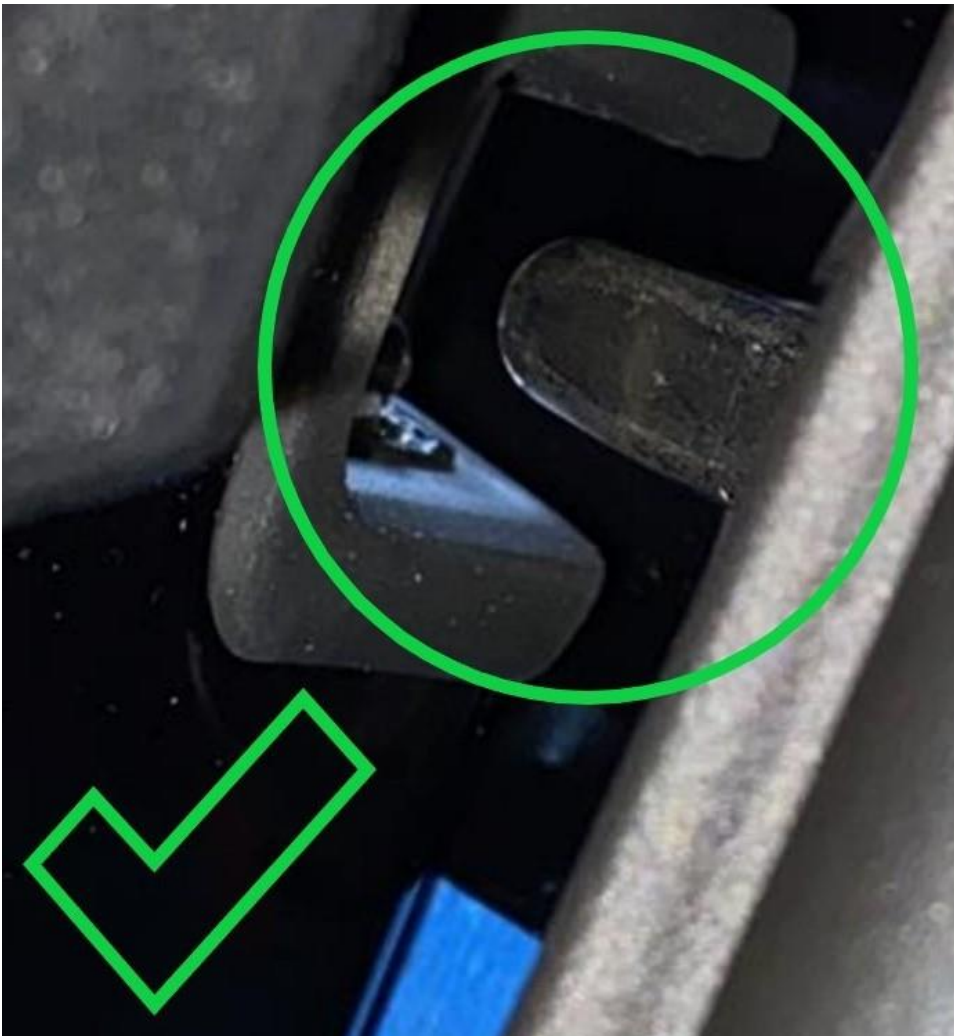
Before proceeding with the instructions the operative must first ensure the left and right hand rear door strikers are centrally aligned to the latch as shown in Figure 1

In the event that one or both rear door strikers are not centrally aligned the operative must take a photograph confirming that one or both of the strikers are not aligned, the operative must then proceed to align the strikers as detailed below before proceeding
