# Technical product information

<b>Topic</b>	EPB Warning light in DIP - Front door/s power latch system intermittent - DTC U112300 within Address 03 and Address 46
<b>Market area</b>	Bentley: worldwide (2WBE),China 796 VW Import Comp. Ltd (Vico), Beijing (6796)
<b>Brand</b>	Bentley
<b>Transaction No.</b>	2075034/1
<b>Level</b>	EH
<b>Status</b>	Approval
<b>Release date</b>

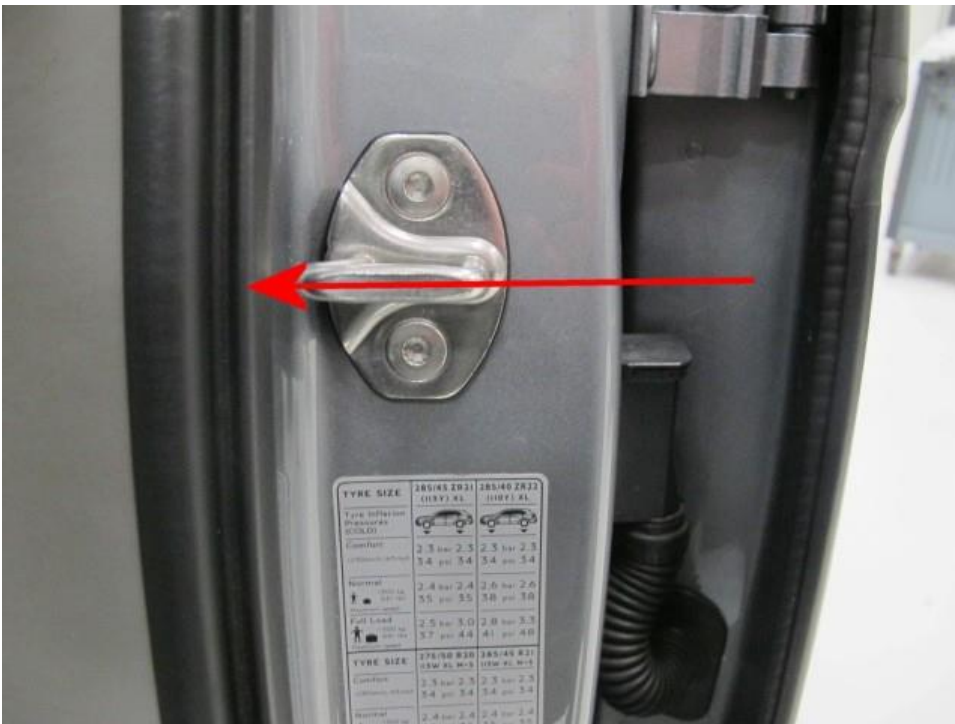
Figure 2

Insufficient back pressure of door (door closing loads / seal load) results in the pawl microswitch signal becoming too short. This short signal is then calculated as an error state by address 0003 -Brake electronics

1) Confirm the striker runs into the centre of the rotary latch of the door lock and adjust as necessary - Refer to Rep.Gr 57 - Door striker - To remove and fit

**In addition, adjust the striker as far as possible (at least 0.5 mm) further inwards (Figure 2)**
