**Technical Service Bulletin (TSB)**  
**Rear Main Crankshaft Oil Seal Leak**

<b>REFERENCE:</b>	<b>TSB:</b> 09-019-24 <b>GROUP:</b> 09 - Engine	<b>Date:</b>	September 5, 2024	<b>REVISION:</b>	—
<b>VEHICLES AFFECTED:</b>	<b>2024 - 2025 (B1) Jeep Renegade</b> <b>2025 (H1) Jeep Commander</b> <b>2024 - 2025 (M1) Jeep Compass</b> This bulletin applies to vehicles built on and after April 04, 2024 (MDH 0404XX) and on and before July 31, 2024 (MDH 0731XX) equipped with a 1.3L I4 Turbo Mair DI Engine (Sales Codes EYF, EYH and EYJ).			<b>MARKET APPLICABILITY:</b>	
<b>CUSTOMER SYMPTOM:</b>	Customers may comment on the following: <ul style="list-style-type: none"> <li>• Engine oil leak.</li> </ul>				
<b>CAUSE:</b>	Rear main crankshaft oil seal

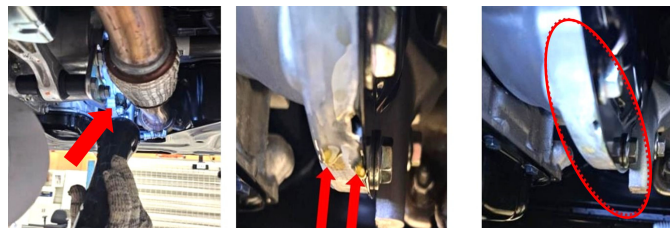
**Fig. 1**  
Area For Oil Leaks

1. Start the engine and using wiTECH ensure the engine temperature reaches 100 °C (212 °F) or higher.
2. Raise and support the vehicle. Refer to the detailed service procedures available in DealerConnect> Service Library under: Service Info> 04 - Vehicle Quick Reference/Hoisting/Standard Procedure.
3. Using a suitable light source, check if there is an oil leak between the transmission and the engine rear main crankshaft seal [Fig. 1](#).

4. Was an oil leak [Fig. 1](#) observed?
  - YES >>> Proceed to [Step 5](#).
  - NO >>> Lower the vehicle. This bulletin has been completed, use Inspect LOP (09-25-75-93) to close the active RSU.
5. Replace the crankshaft oil seal. Refer to the detailed service procedures available in DealerCONNECT/ Service Library under: 1020D39 - Retentor Traseiro - Lado Volante - Remoção/Recolocação e Substituição, para Veículos com Câmbio Automático. Incluso Procedimentos Necessários.
