REFERENCE:	TSB: 08-197-24 GROUP: 08 - Electrical	Date:	September 6, 2024	REVISION:	—
VEHICLES AFFECTED:	2023 (DJ) RAM 2500 Pickup This bulletin applies to vehicles equipped with a 6.4L V8 Heavy Duty Hemi MDS Engine (Sales Code ESB) or a 6.7L I6 Cummins Turbo Diesel Engine.	MARKET APPLICABILITY:			
		<input checked="" type="checkbox"/> NA <input type="checkbox"/> MEA <input type="checkbox"/> SA <input type="checkbox"/> IAP <input type="checkbox"/> EE <input type="checkbox"/> CH			
CUSTOMER SYMPTOM:	The technician or customer may experience: <ul style="list-style-type: none"> While installing the Mopar service battery as a replacement for the factory battery, there is an interference issue with the right busbar cover on the positive terminal side of the battery. 				
CAUSE:	A difference in the placement of the positive busbar terminal over the service battery

This bulletin involves modifying the right busbar cover on the positive terminal side of the battery.

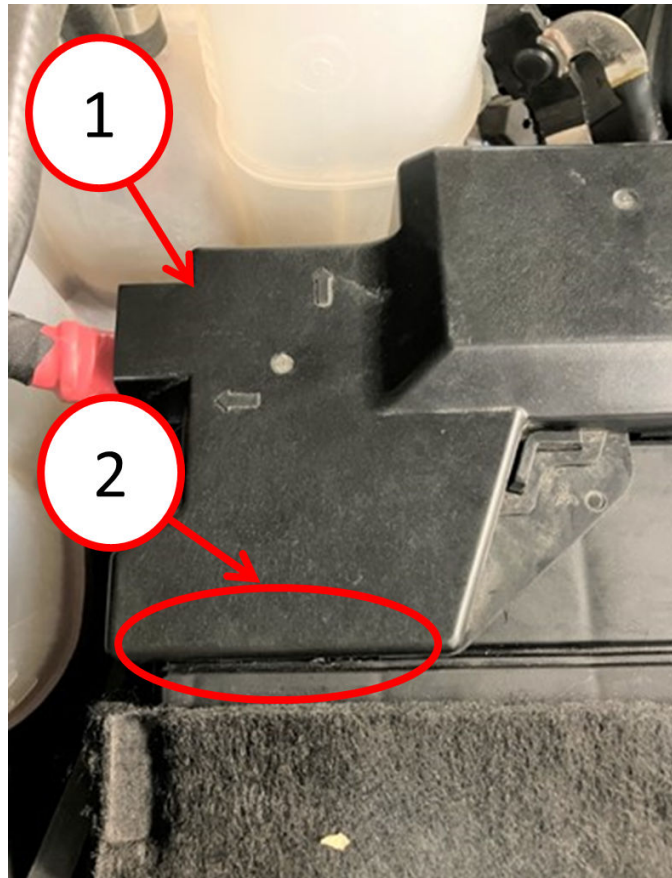
Fig. 1
Right Busbar Cover

1 - Busbar Cover
2 - Cover Area To Be Modified

1. Remove the right busbar cover [Fig. 1](#).

2. Mark the cutting location starting width 16 mm (0.62 in.) from the cover edge and 54 mm (2.12 in.) wide [Fig. 1](#).
3. Using a suitable cutting tool, cut a window into the side of the busbar cover 20 mm (0.78 in.) high [Fig. 2](#) and 35 mm (1.37 in.) wide [Fig. 3](#).
