# CAMPAIGN BULLETIN

## Body Control Module (BCM)

Reference: PD124

# PD124– 2025 ALTIMA BCM REPROGRAM

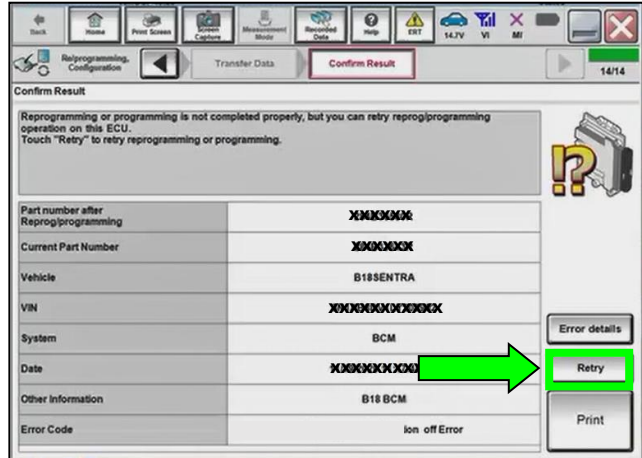
Figure 21

If reprogramming does not complete and the “!?” symbol displays as shown in Figure 21:

- Check battery voltage (12.0 – 15.5V).
- Ignition is ON, Engine is OFF.
- External Bluetooth® devices are OFF.
- All electrical loads are OFF.
- Select **Retry** and follow the on screen instructions.

**NOTE:** **Retry** may not go through on first attempt and can be selected more than once.

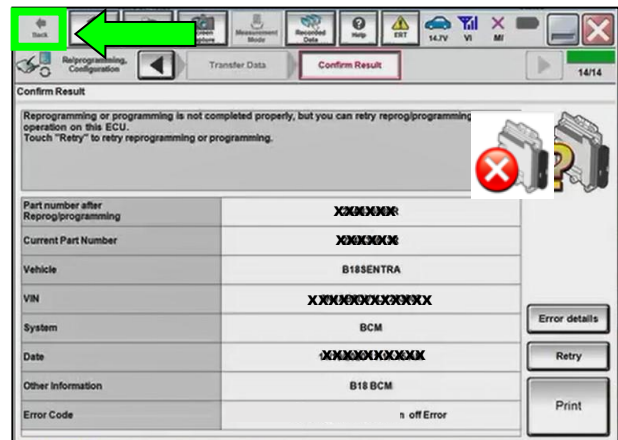
Figure 22

If reprogramming does not complete and the “X” symbol displays as shown in Figure 22:

- **Do not disconnect the VI or shut down C-III plus if reprogramming does not complete.**
- Check battery voltage (12.0 – 15.5V).
- CONSULT A/C adapter is plugged in.
- Ignition is ON, Engine is OFF.
- Transmission in Park.
- All C-III plus / VI cables are securely connected.
- All C-III plus updates are installed.
- Select **Home**, and then restart the reprogram procedure from the beginning.
