**Technical Service Bulletin (TSB)**  
**Bubbles On Rear Door Panel**

<b>REFERENCE:</b>	<b>TSB:</b> 23-049-24 REV. A <b>GROUP:</b> 23 - Body	<b>Date:</b>	September 6, 2024	<b>REVISION:</b>	23-049-24
<b>VEHICLES AFFECTED:</b>	<b>**2023** - 2024 (BV) Jeep Renegade</b> This bulletin applies to vehicles built on or after May 06, 2024 (MDH 0506XX) and on or before June 23, 2024 (MDH 0623XX).			<b>MARKET APPLICABILITY:</b>	
				<input type="checkbox"/> NA	<input checked="" type="checkbox"/> MEA
				<input type="checkbox"/> SA	<input type="checkbox"/> IAP
				<input checked="" type="checkbox"/> EE	<input type="checkbox"/> CH
<b>CUSTOMER SYMPTOM:</b>	<b>Customers may experience the following:</b>				
	<ul style="list-style-type: none"> <li>• Appearance of bubbles on the rear door panel located in the armrest <a href="#">Fig. 1</a>.</li> </ul>				
<b>CAUSE:</b>	Detachment of the PVC

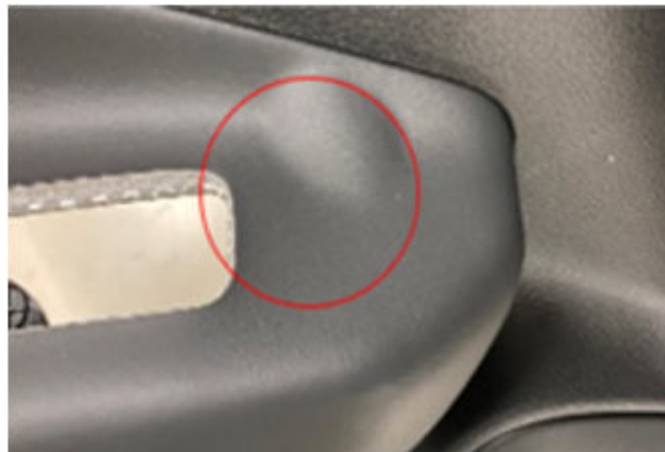
**Fig. 1**  
Bubbles On Armrest

This bulletin involves replacing the left rear door panel.

1. Replace the left rear door panel. Refer to the detailed service procedures available in DealerCONNECT/ Service Library under: Service Info >23 - Body / Doors - Rear / Panel, Rear Door Trim / Removal and Installation.
