Model Series W206 Roof Paneling Deformed

Topic number	LI65.10-P-078300
Version	2
Function group	65.10 - Roof paneling
Date	9/10/24
Validity	Model series 206.0 sedan with no sunroof.
Reason for change	Adding Photo

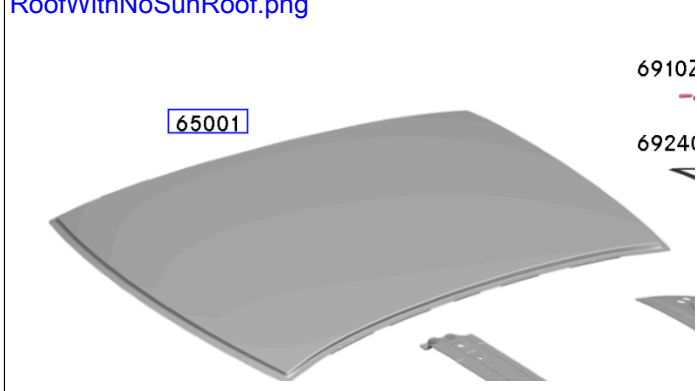
Roof Bow (Roof With No Sunroof)

Indentations in the roof paneling in row bow areas.

Note: This is within the surface area of the roof skin when no sunroof is applicable. See attached photo.

Flexibility of adhesive joint between roof bow and roof paneling.

2 - Cut open adhesive bead in area of visible deformation in roof paneling using a cutting wire at the roof bows.

3 - Relieve tension of outer skin of roof by applying heat (sun or paint drying booth).

7 - Finally, apply adhesive sealing compound using cartridge gun. Apply the material here to the cut open gap and flat onto the surrounding old adhesive sealing compound.

Make sure that the adhesive sealing compound makes contact between the roof bow and the roof paneling.
